MICROPILE UNDERPINNING OVER EXPANSIVE PYRITIC SHALES

- ◆ Project: Evangelical Community Hospital, Lewisburg, Pennsylvania, USA

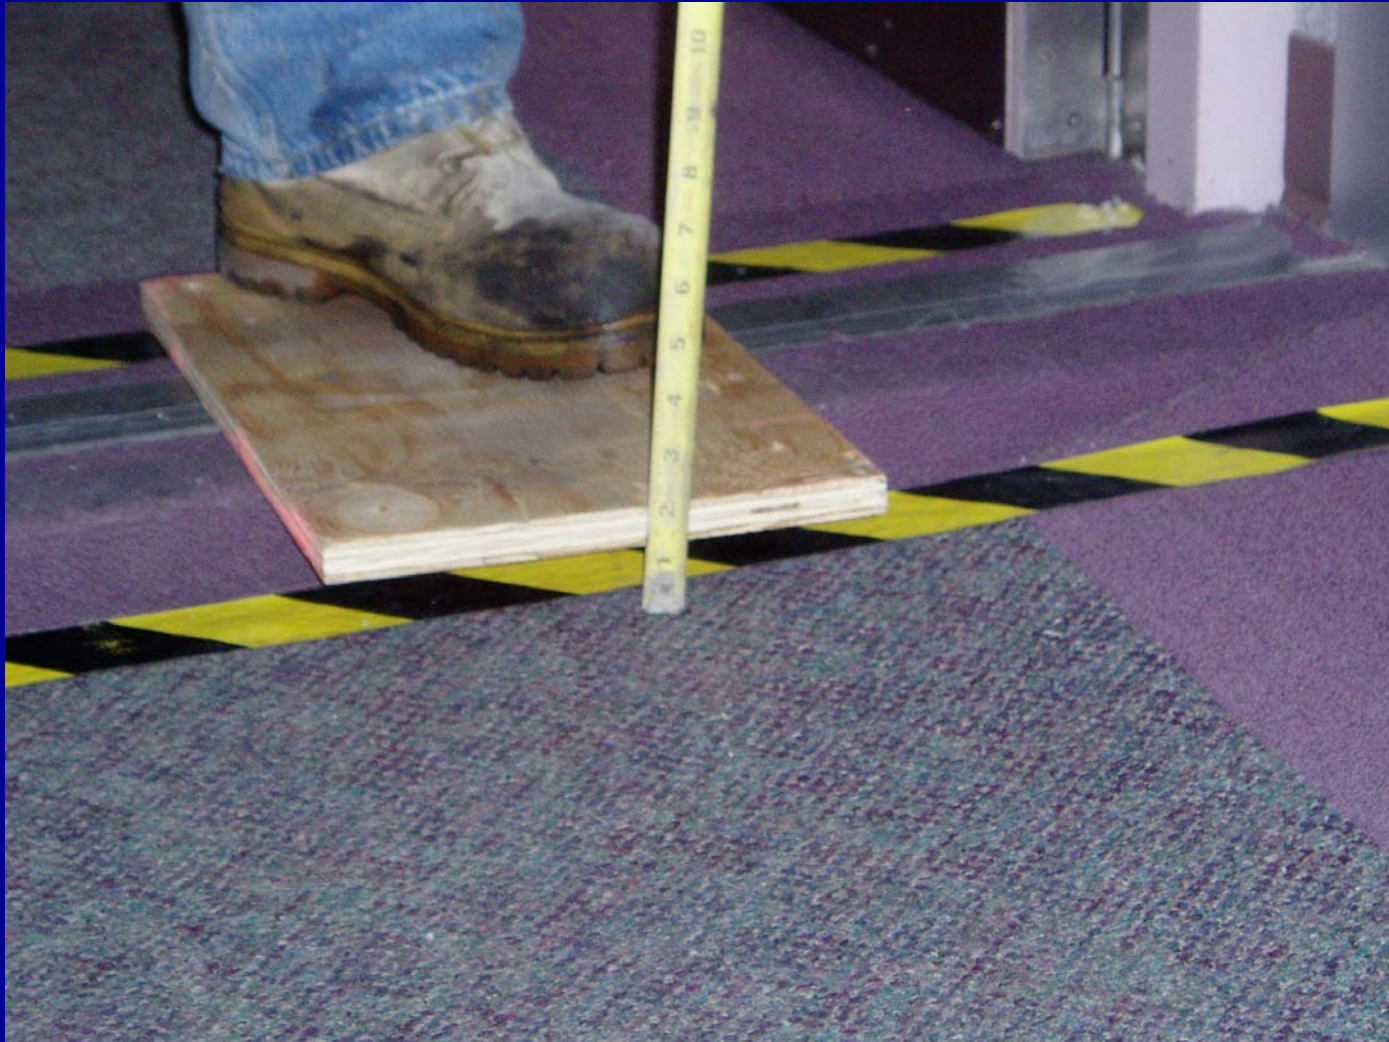
- 1) Cracked floor slab at 1982 and 1996 additions.
- 2) Displaced reinforced concrete walls and conventional spread footing foundations.

First floor transition between 1982 and 1996 additions.

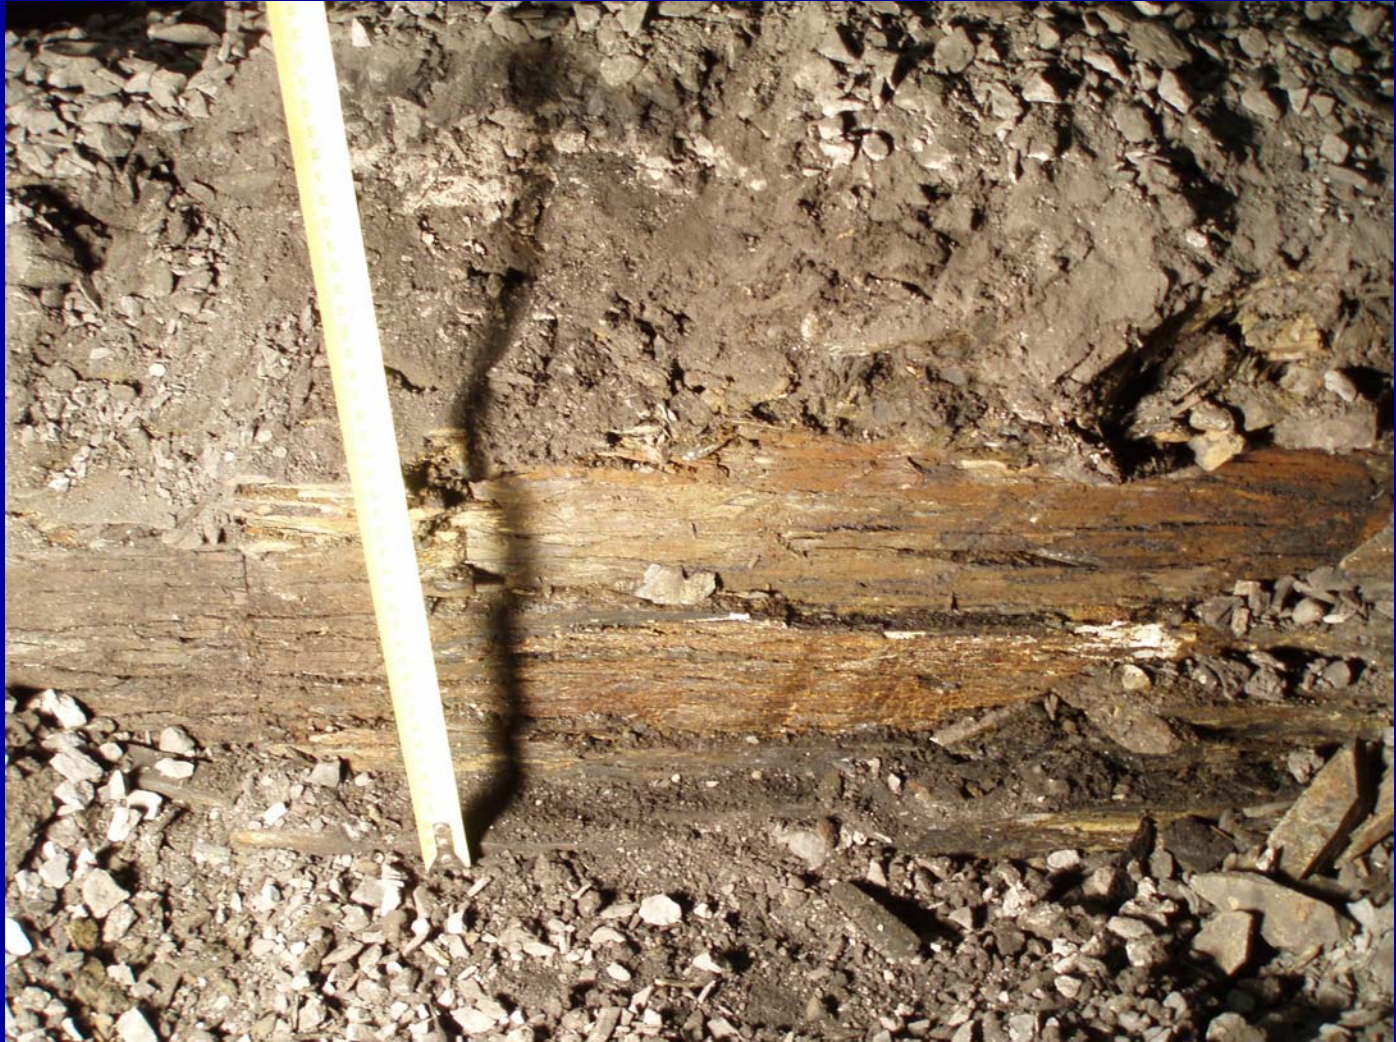
Swelling of underlying fill materials and natural bedrock formation. Bedrock composed of *Pyritic Shale* from the Marcellus formation of the Hamilton group.

In-Situ shale cross section.

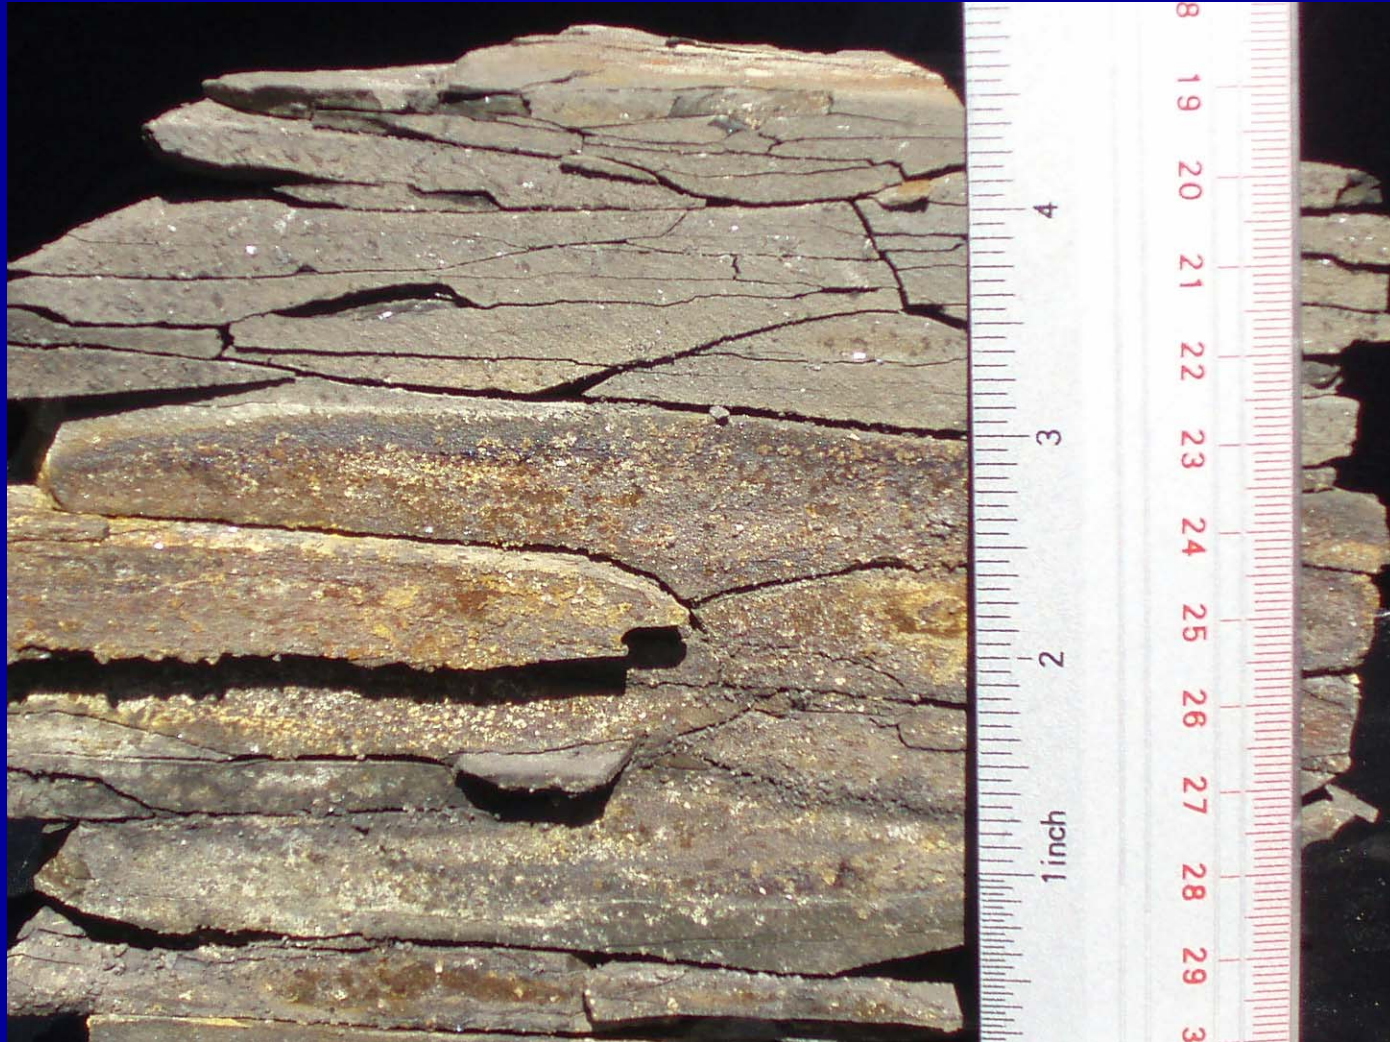
Removed shale cross section.

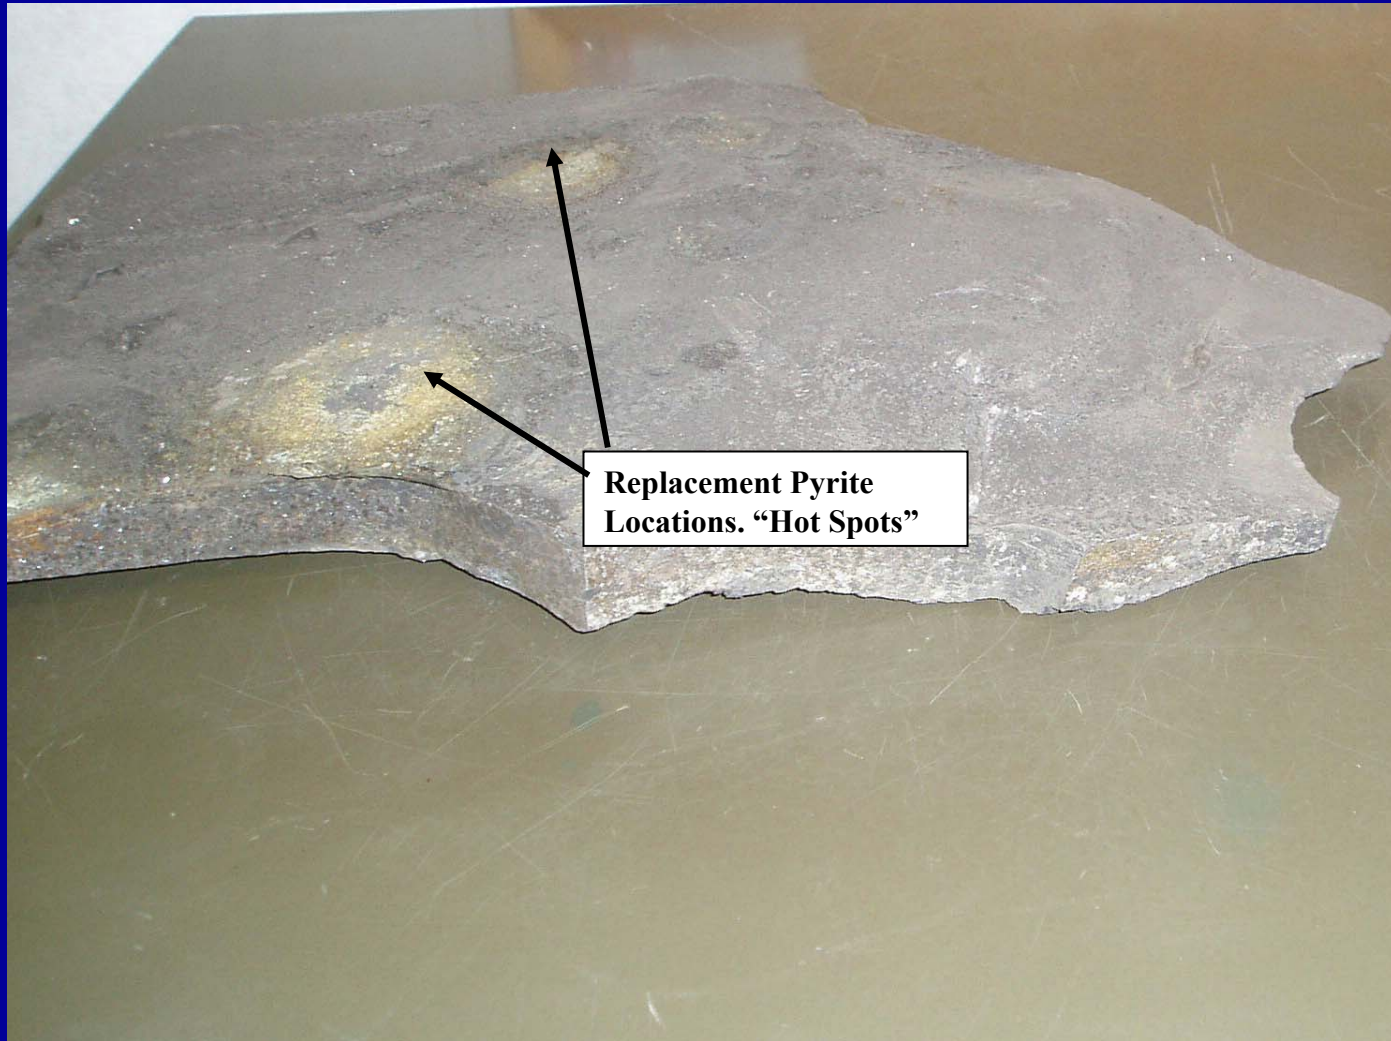
- ◆ Pyrite is found in black, carbonaceous shales throughout the world.
- ◆ Well-documented history of being potentially expansive. Heave due to the conversion of sulfides to sulfates.
- ◆ Pyrite oxidation occurs in two (2) settings:
 - 1) Advective flow controls and oxygenated groundwater enters a layer containing pyrite.
 - 2) Diffusive O-2 flow dominates in the unsaturated zone and resulting sulfate and iron concentrations are huge and pH decreases to values close to 2.
- ◆ The low pH values cause a variety of minerals to precipitate including gypsum and numerous ferric hydrosulfates.

Shale fragment showing evidence of replacement pyrite.

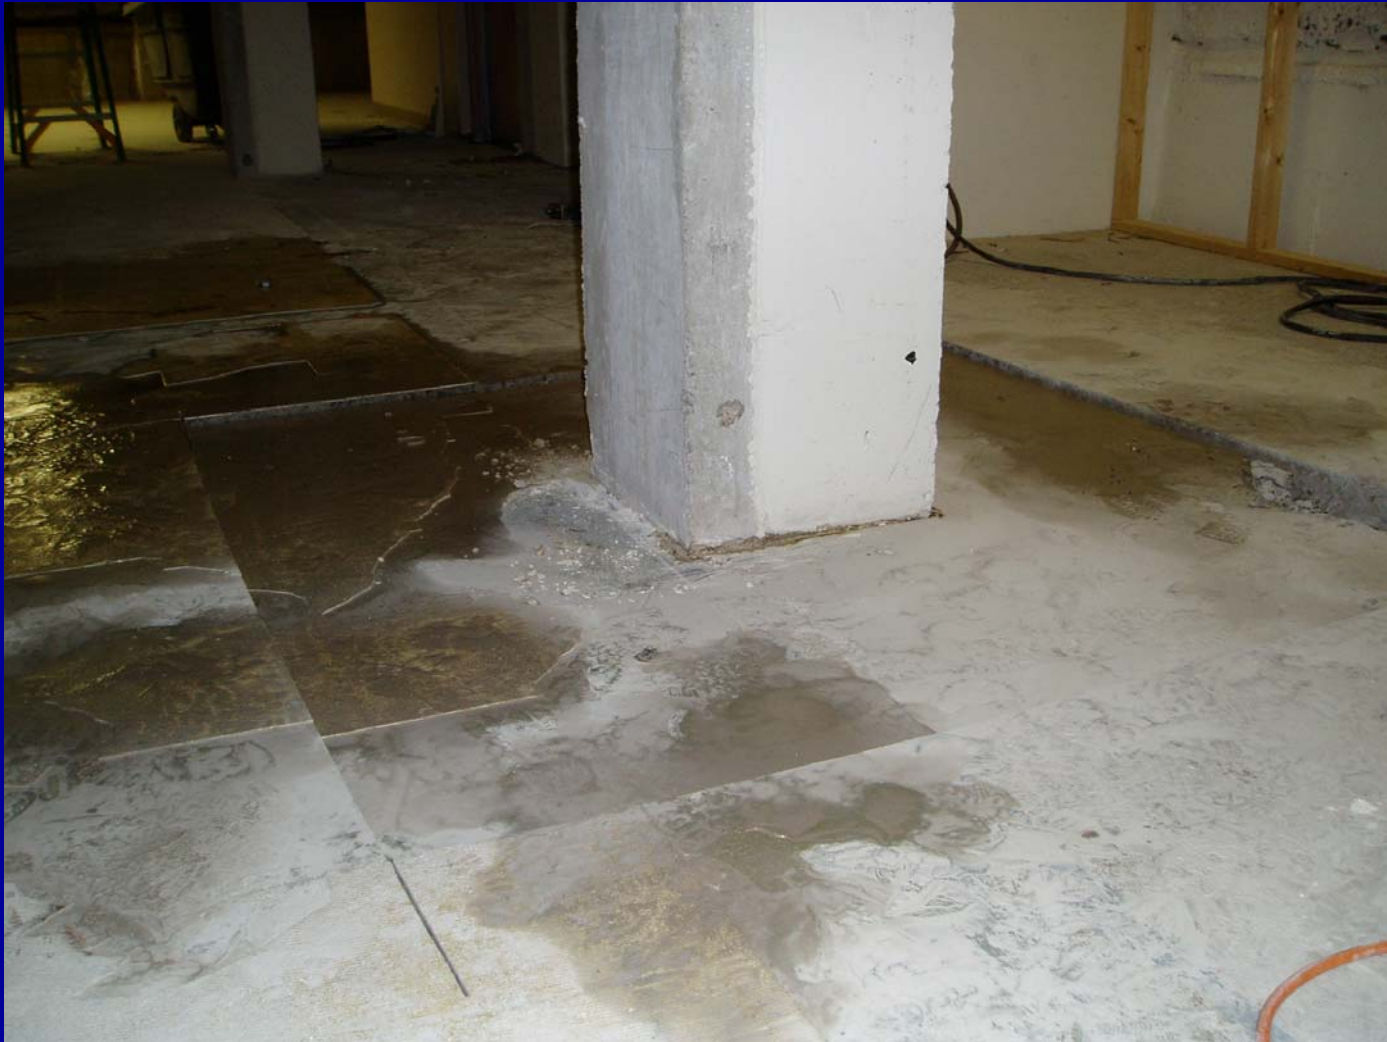
Explosive Beginnings: Upward release of floor slab under pressure.

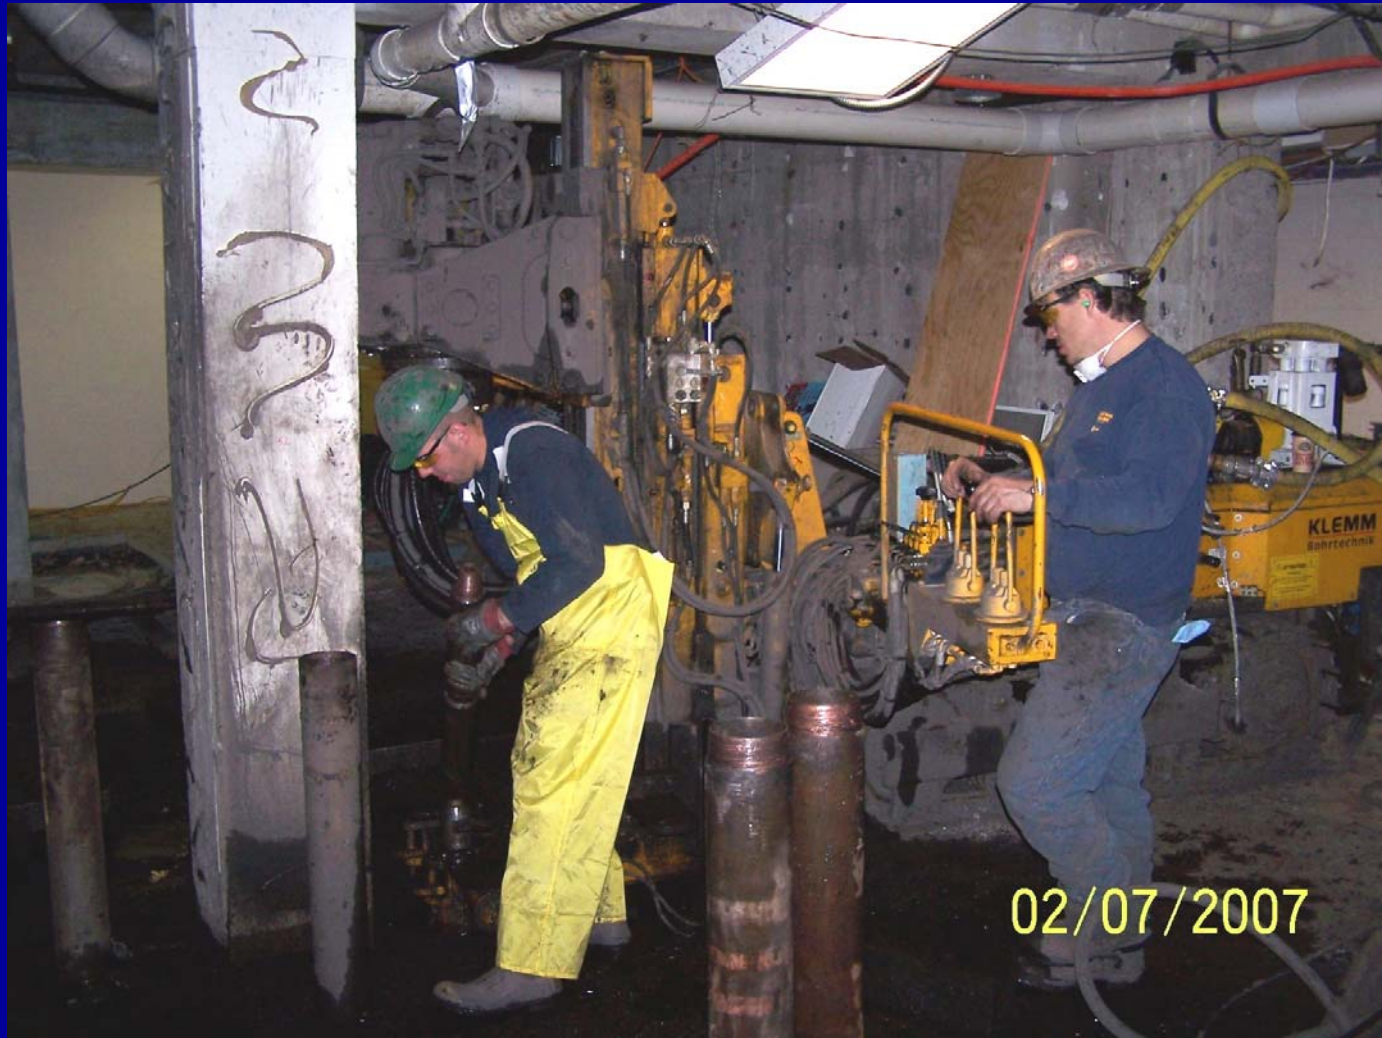
Telephone Room. Drill and crew working in basement.

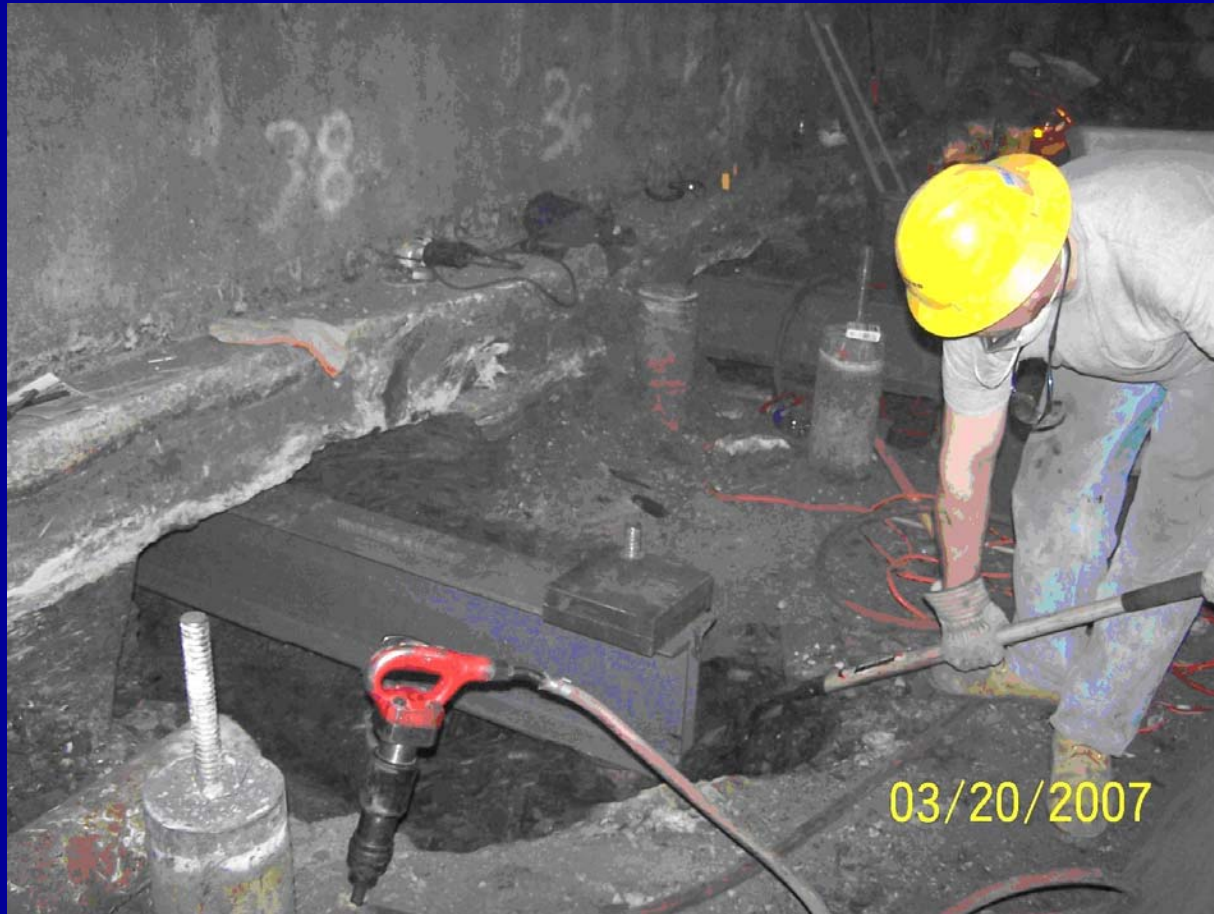
Telephone room. Underpinning excavation around cantilever C-channel beams.

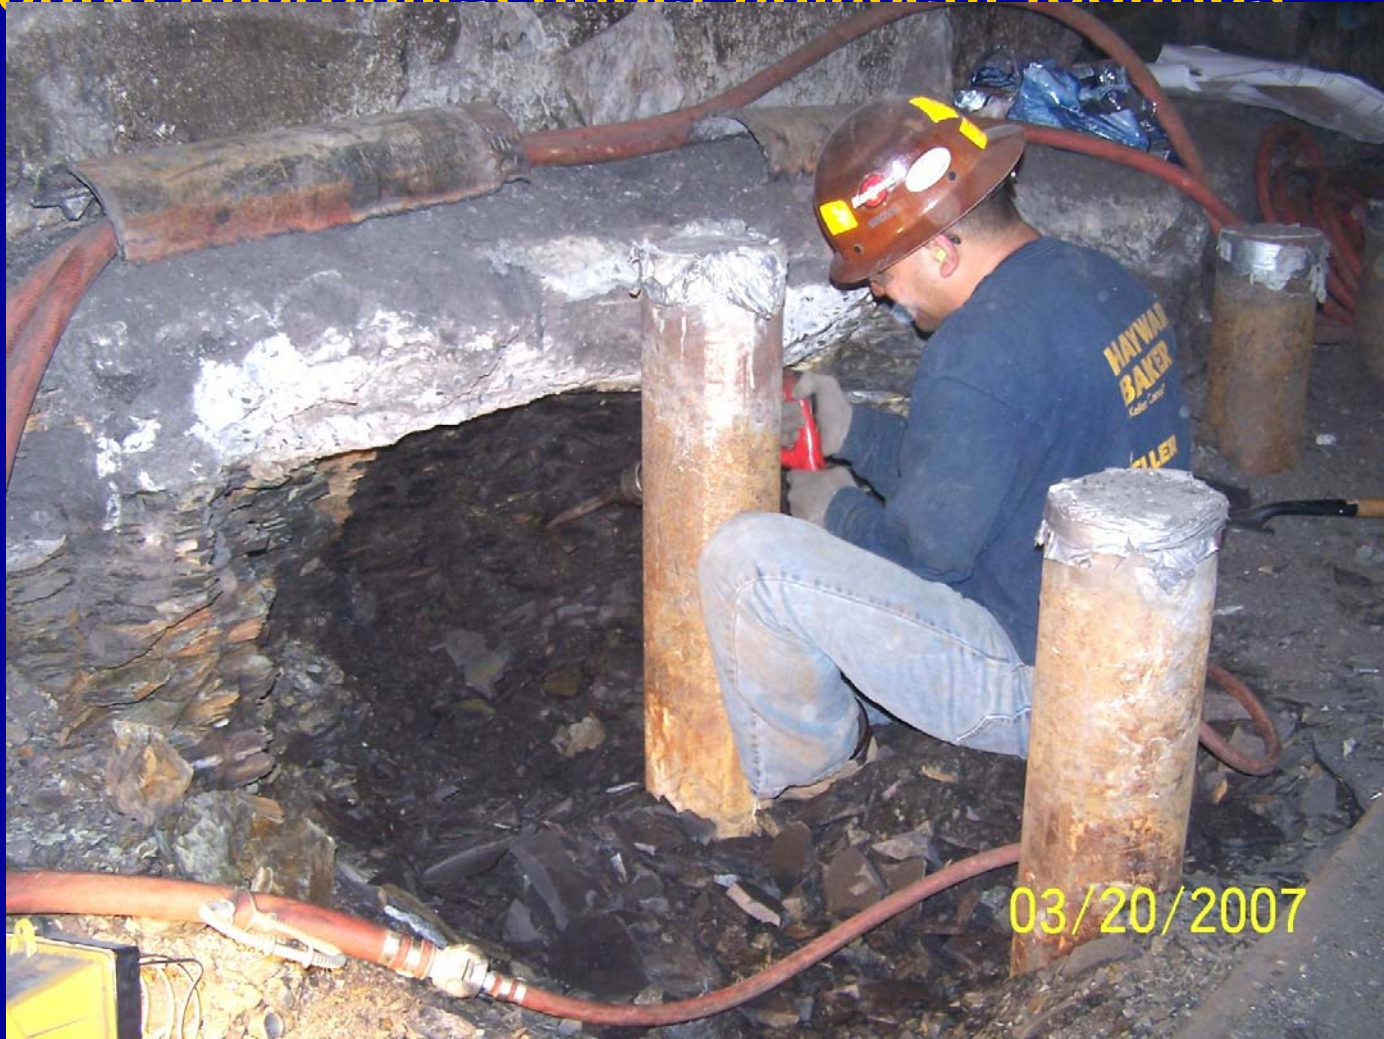
Telephone room. Underpinning excavation around micropiles under adjacent footings

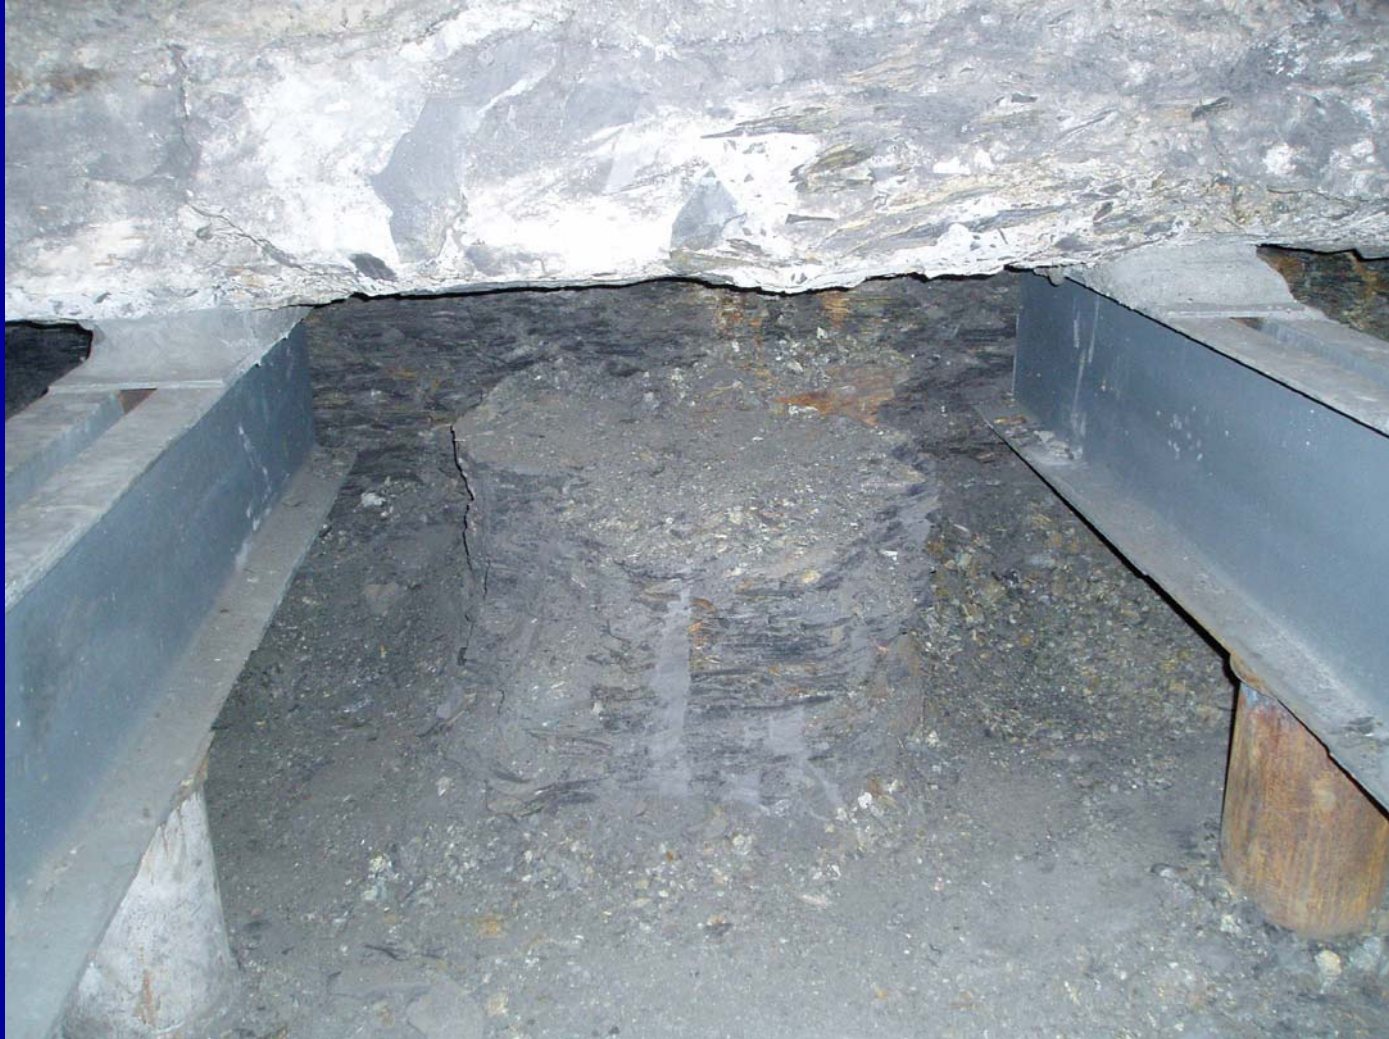
Telephone room. Underpinning close up of cantilever.

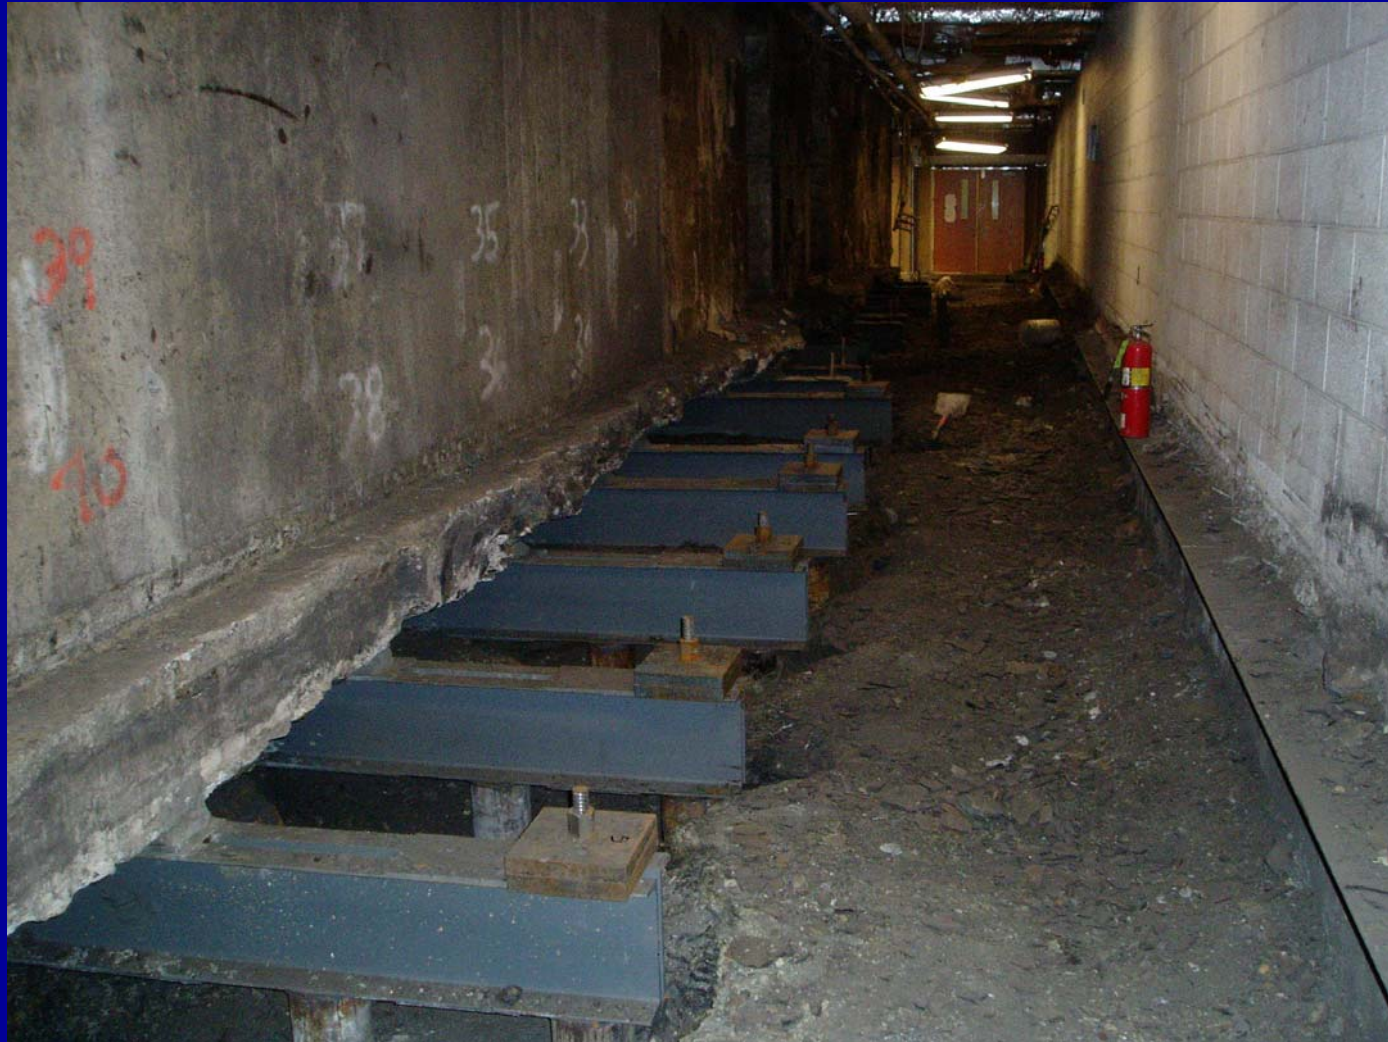
Telephone room underpinning. Broad view.

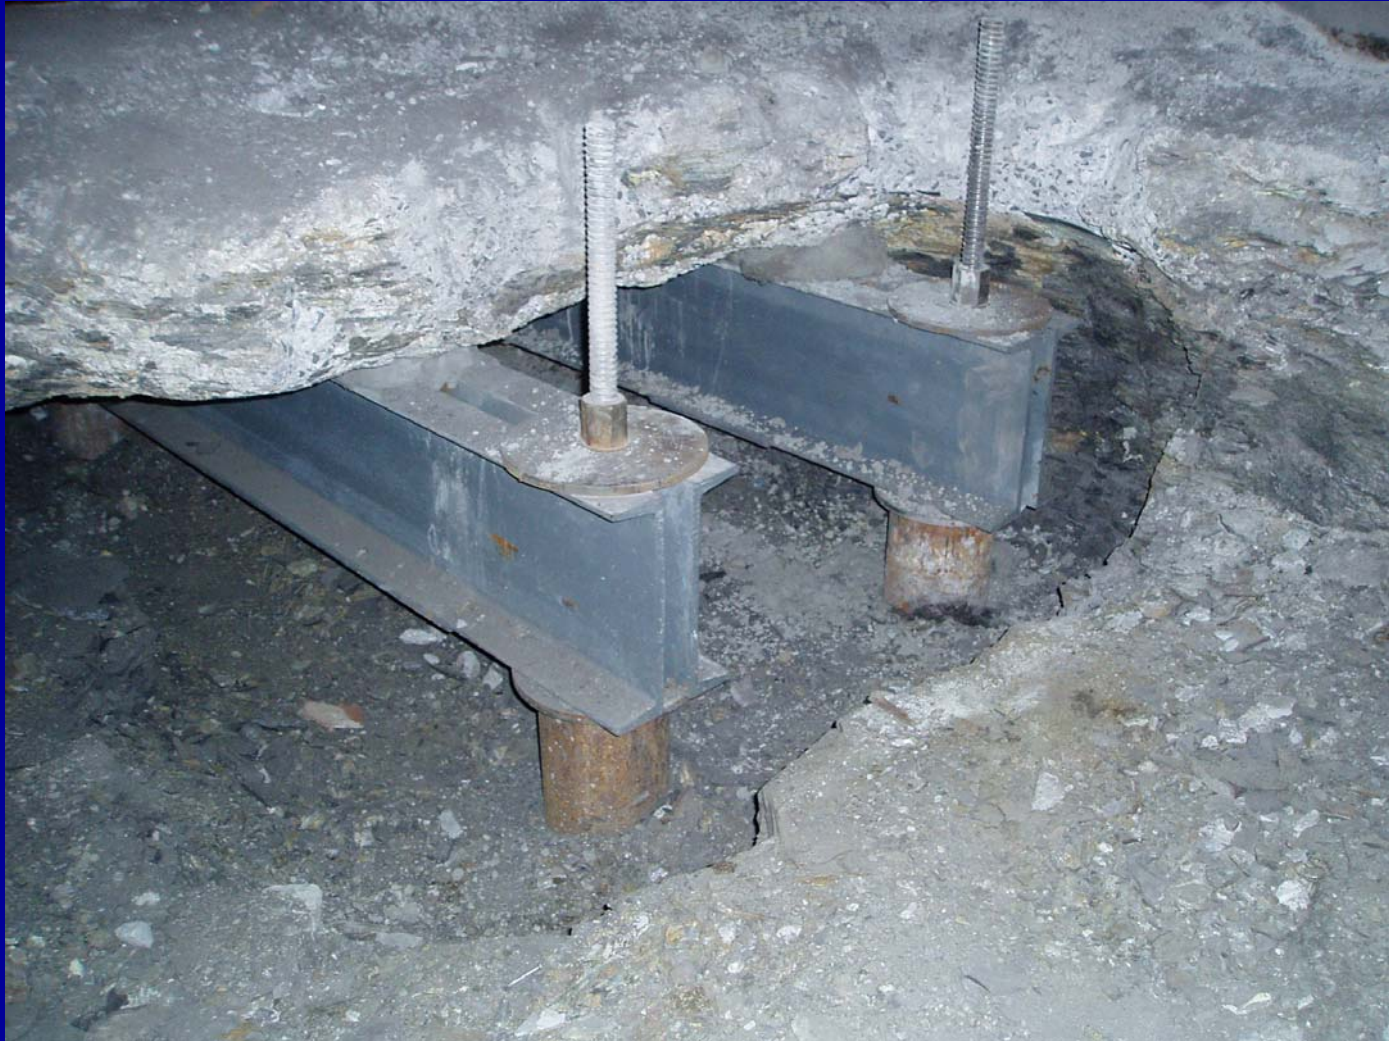
Corridor. Saddle underpinning view from top.

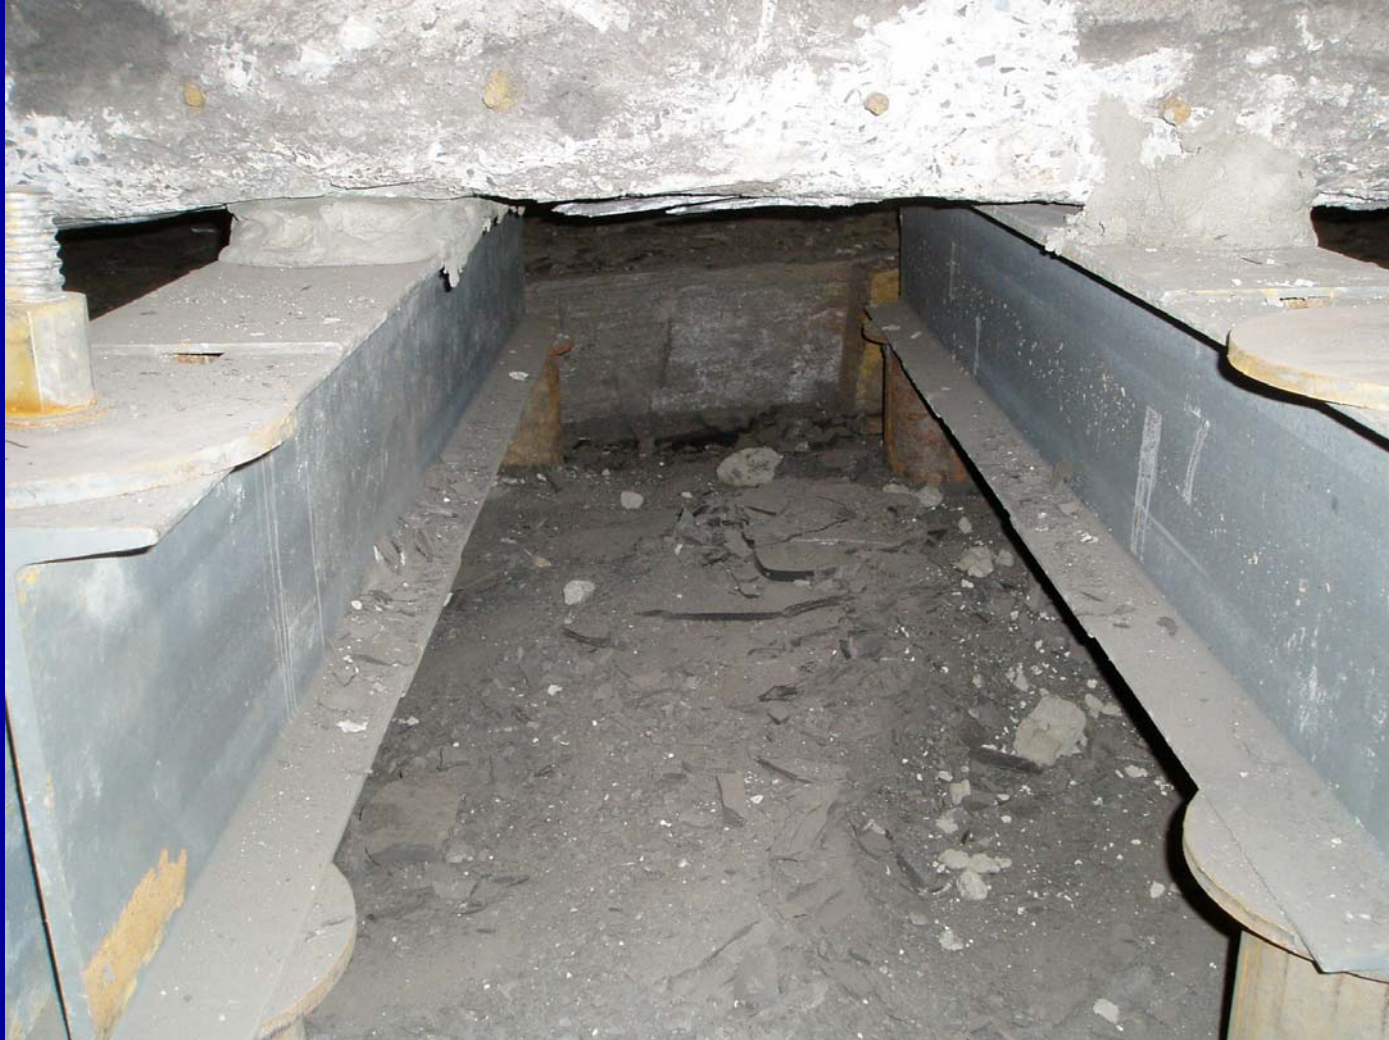
Corridor. Saddle underpinning view from bottom.

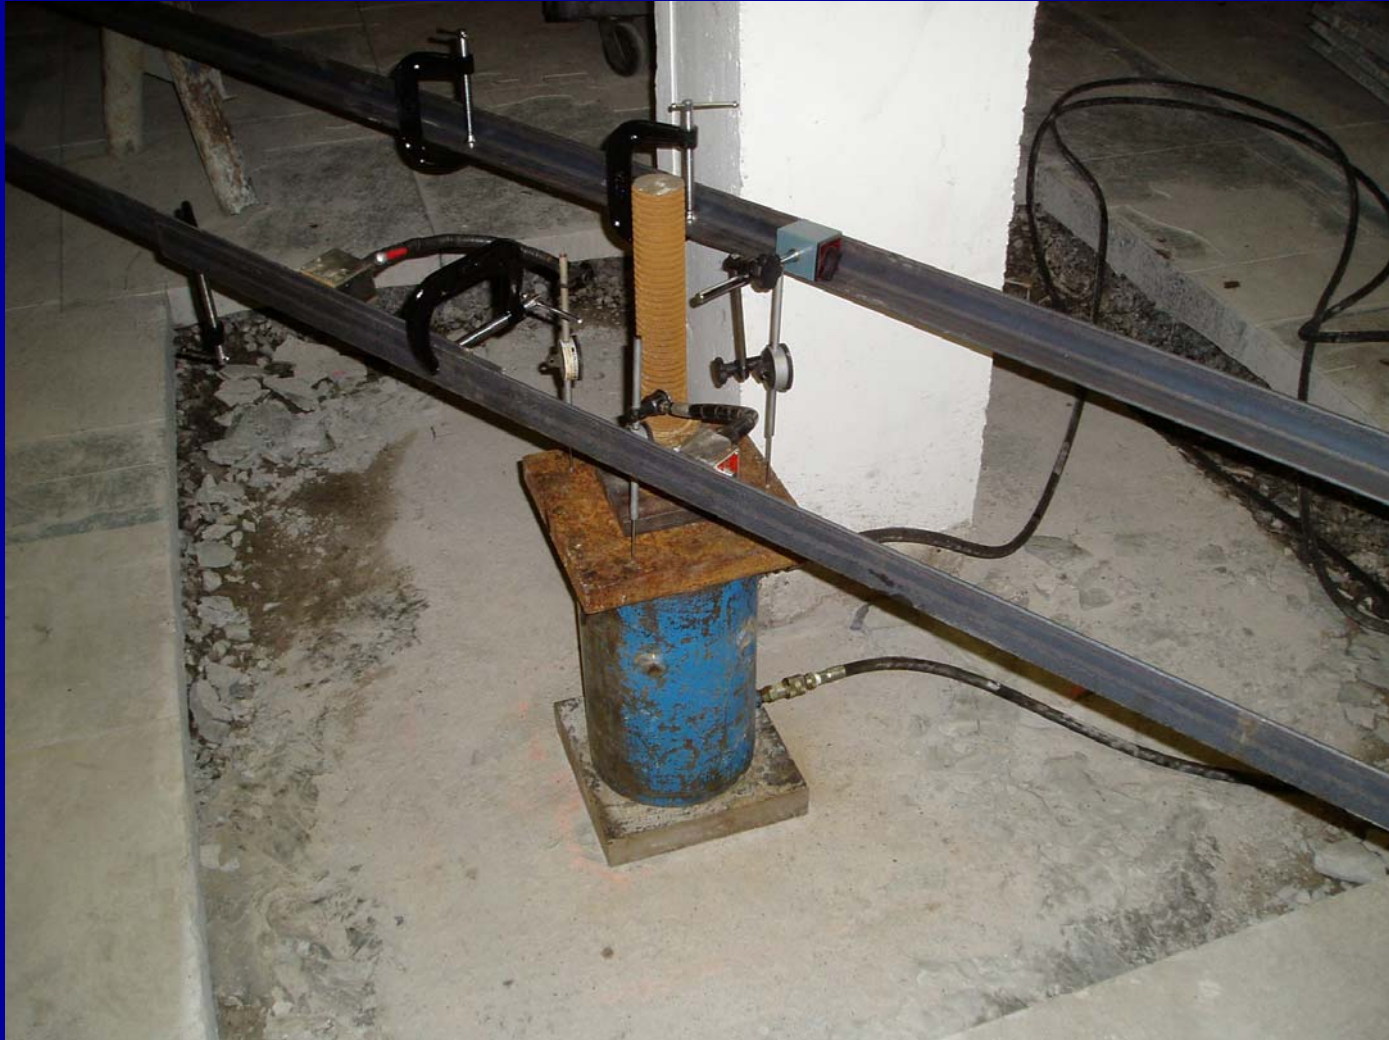
Load test at the 489 kN footing.

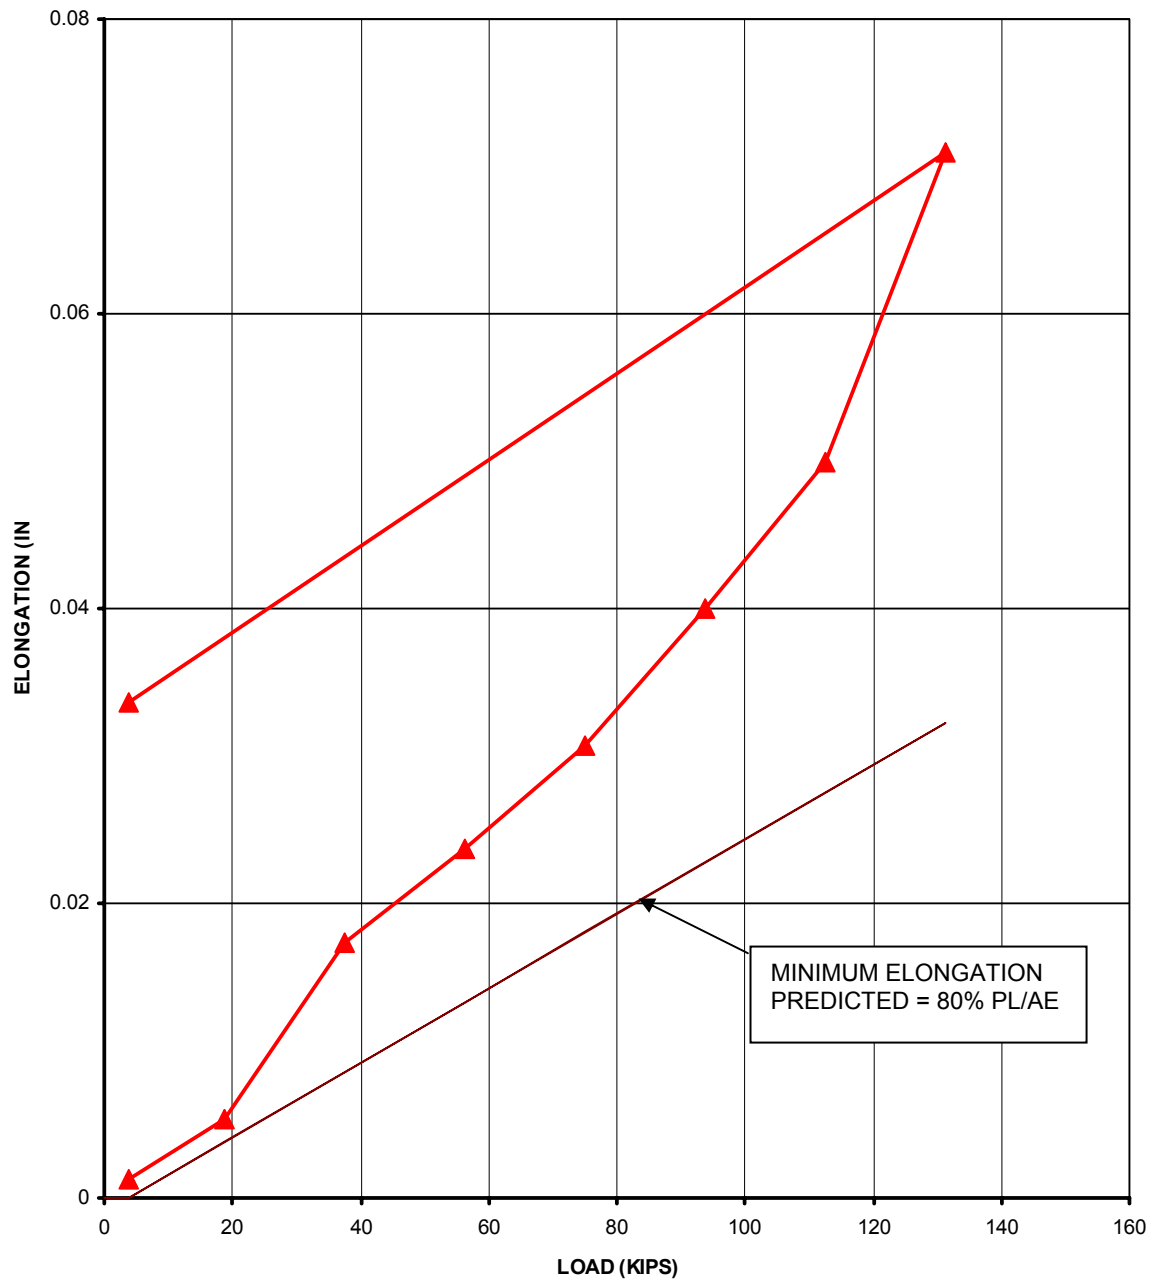
489 kN column footing bond stress load test results.

Recorded movement for the 489 kN (110 kip) column was 0.18 cm (0.071 in), with permanent set of .086 cm (0.034 in).

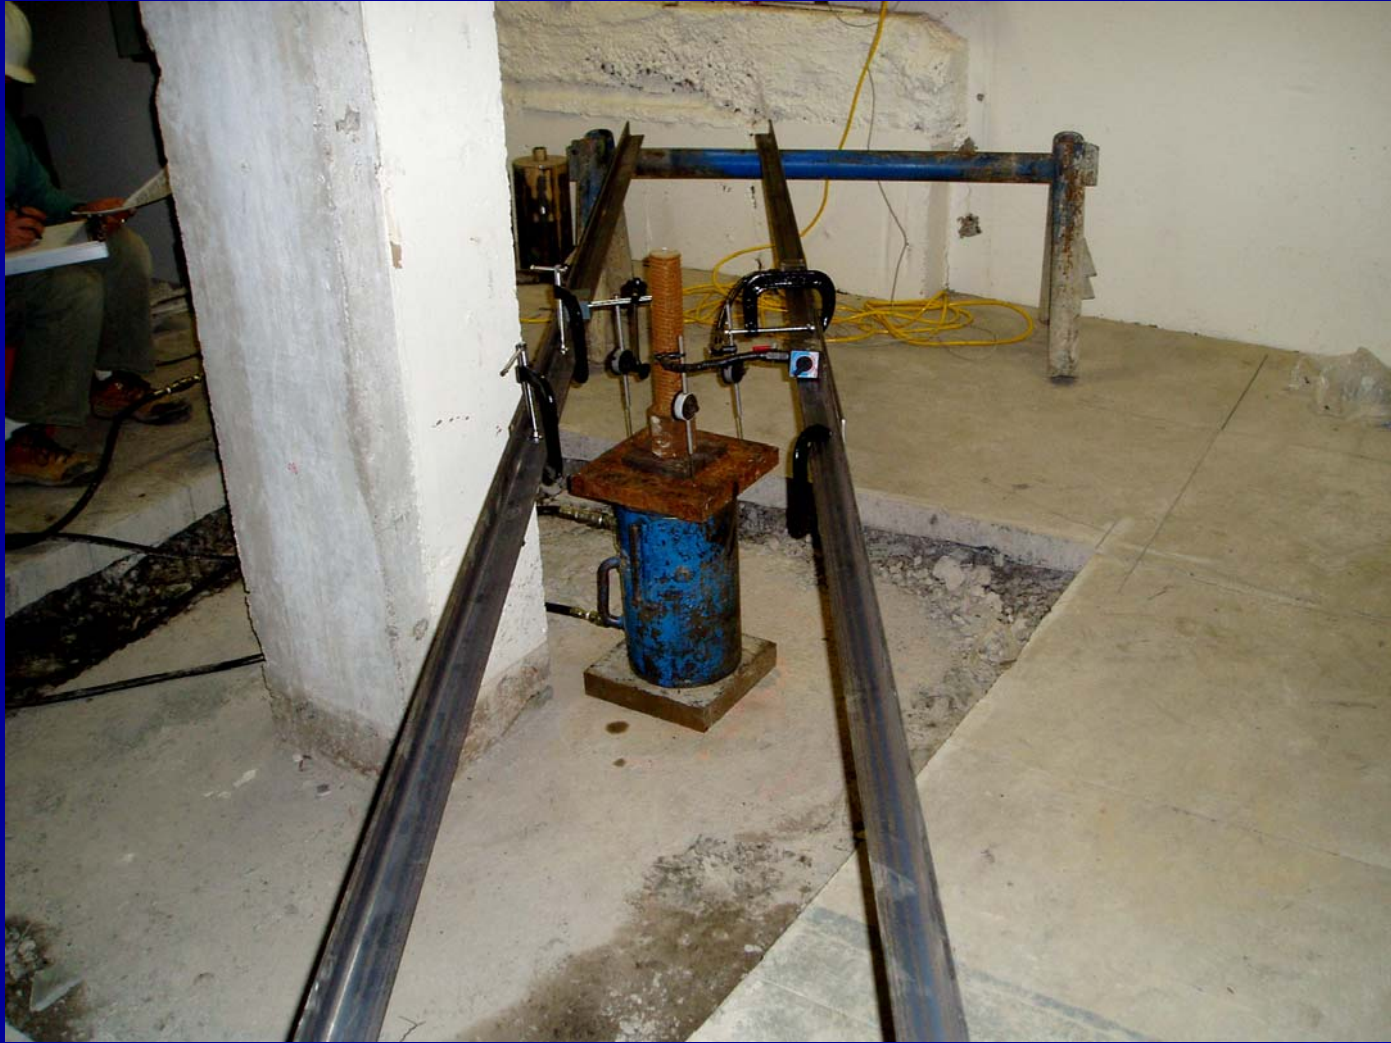
Load test at the 1,285 kN footing.

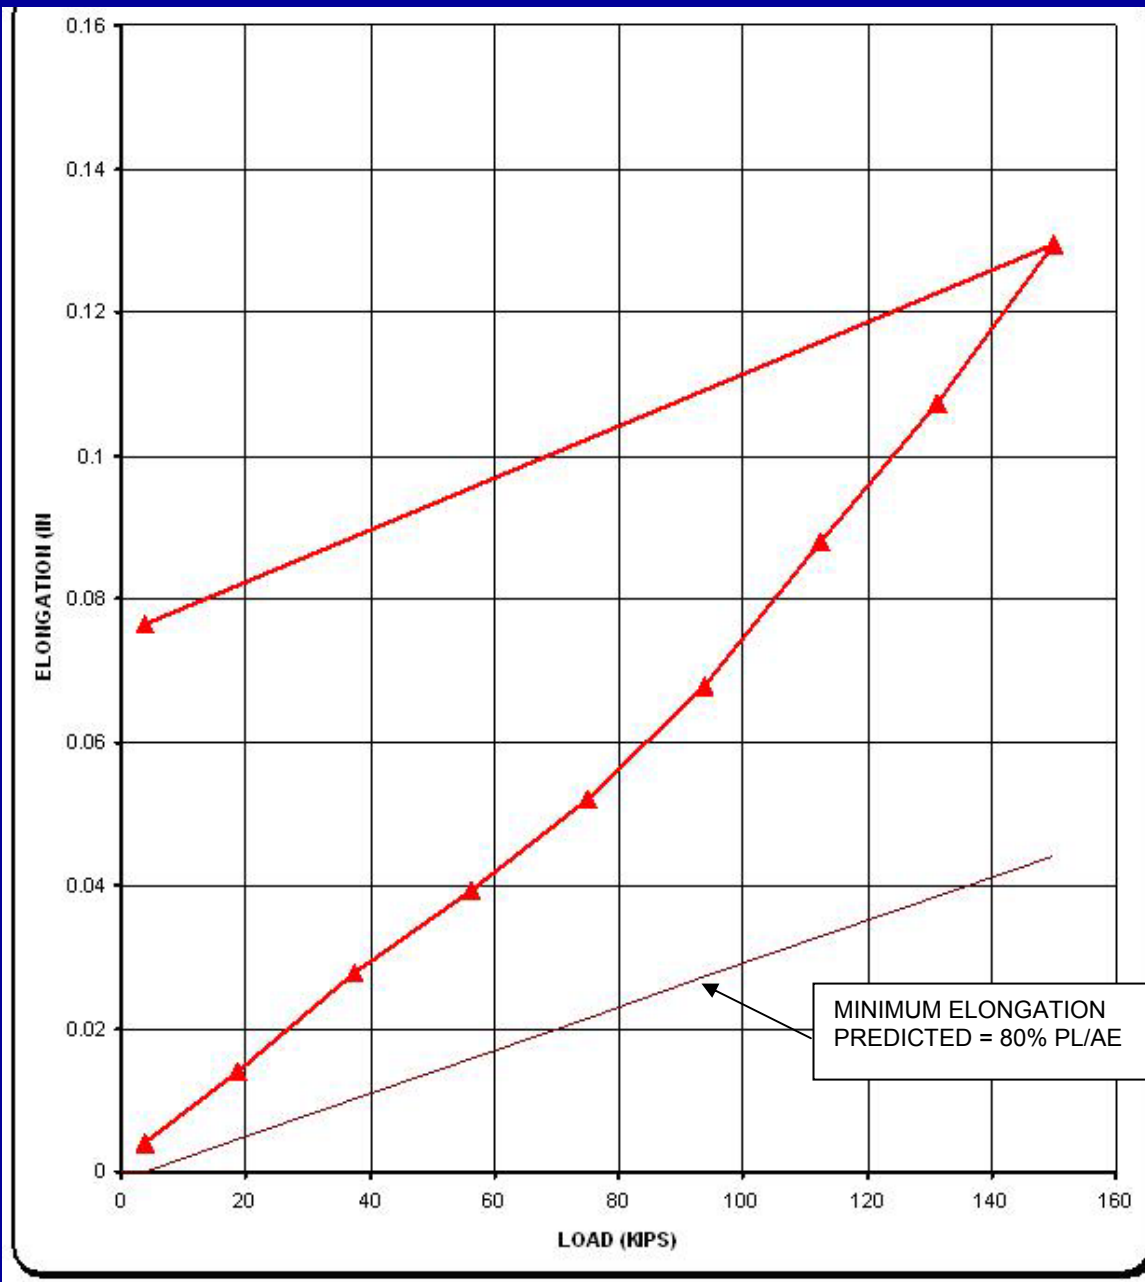
1,285 kN column footing bond stress load test results.

Recorded movement for the 1,285 kN (289 kip) column was 0.33 cm (0.0129 in), with permanent set of .19 cm (0.076 in).
