FOUNDATION REMEDIATION USING MICROPILES AND LOW MOBILITY GROUTING (LMG) AT SANDY COVE CONDOMINIUM, BARBADOS

J.R. Wolosick, P.E., D.GE¹, J. P. Dittrich, Ph.D., P.Eng.², D.A. Bruce, Ph.D., MICE³

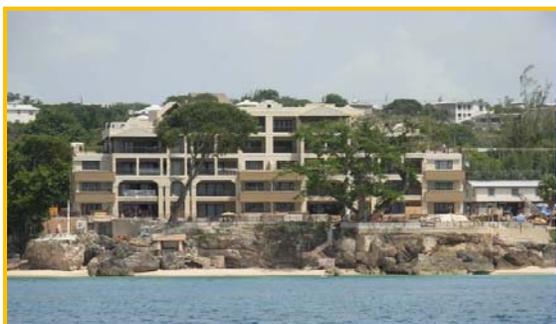
Figure 1: Sandy Cove Condominium

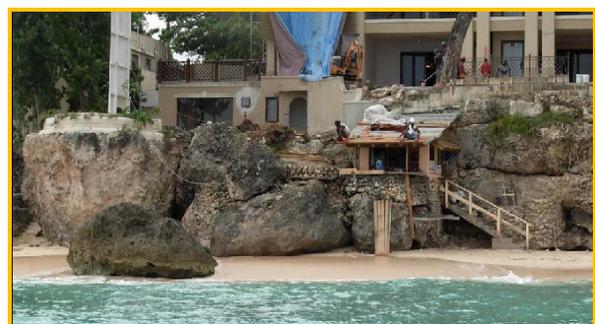
Figure 2: Coral Cliff at Condominium

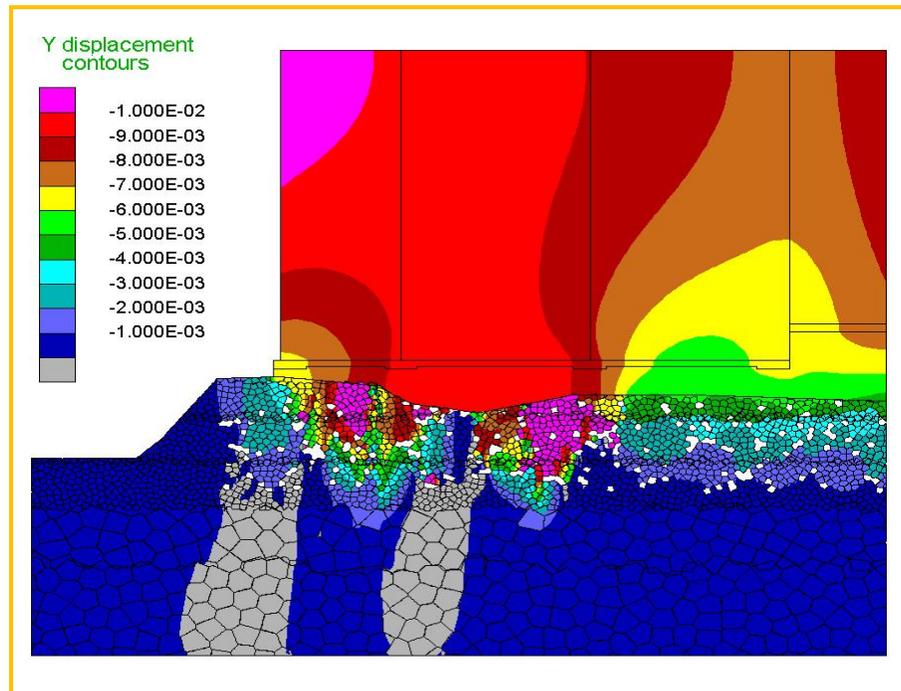
Figure 7: Model of Zones of Vertical Weakness with Displacements (meters)

Based on the modeling, void creation as well as undercutting of the cliff face (from wave action), in conjunction with a weakened rock mass along the sub-vertical jointing, showed the most convincing settlement and interpreted cracking patterns in the building structure. Foundation degradation (i.e. progressive undermining, loss of support and associated building movement) was likely exacerbated by migration of fines from natural fissures and void zones within the coralline rock mass during violent sea conditions. In addition, the fact that the northern half of the structure was constructed with a lower foundation (due to the inclusion of a basement level) was likely a key factor in the observed building behavior. It was concluded that the removal of the more competent coralline cap material in this area, higher foundation loads as a result of the additional level and a founding level in closer proximity to the weak subsurface conditions resulted in the observed building distress. These findings were the basis for the design of remediation approaches.

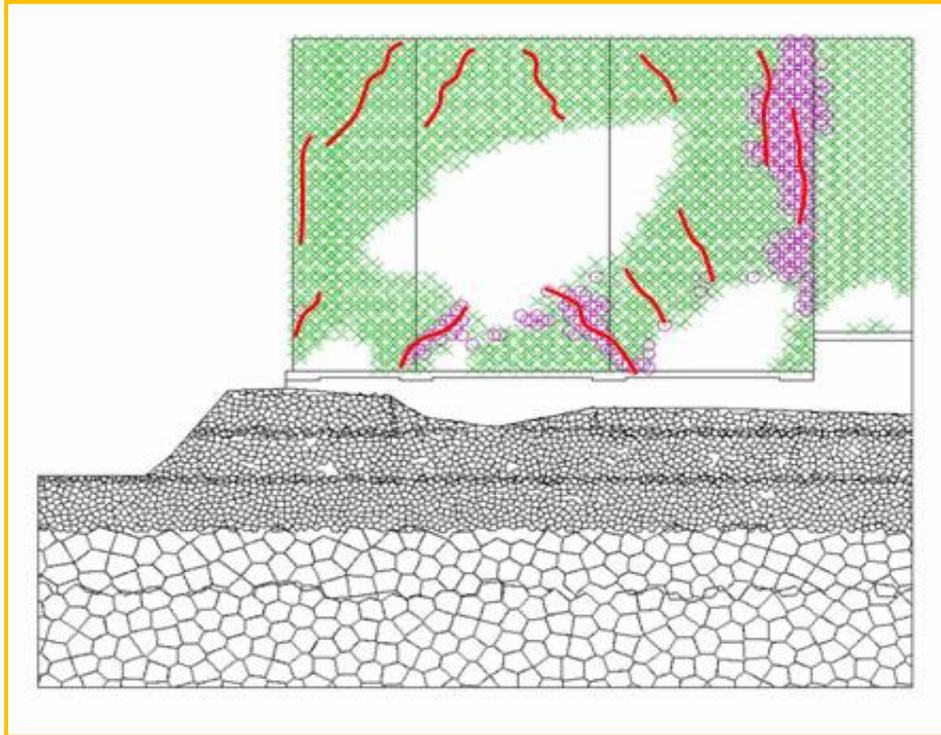
Figure 8: Interpreted Crack Patterns which Matched Observed Cracking

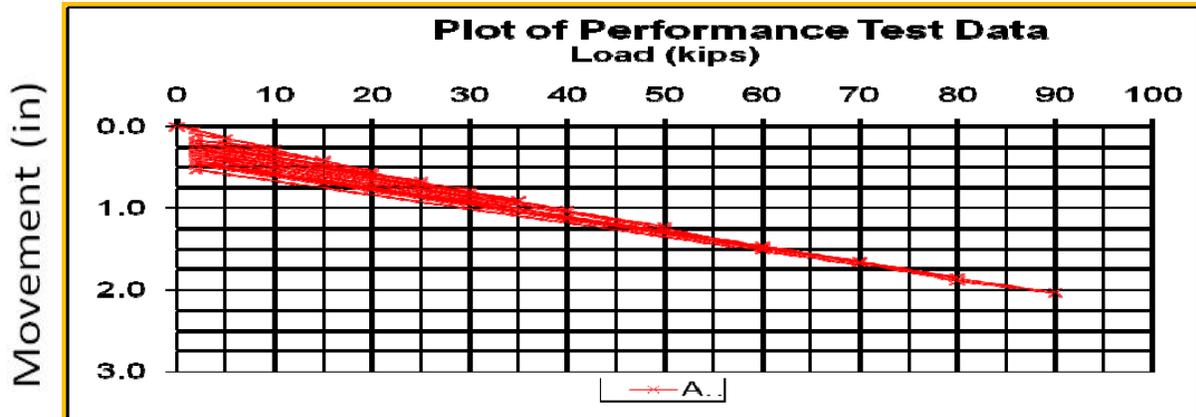
Figure 12: Tension Test Result from 74 foot long LMG Micropile (60 ft free length) Monitoring During and Following Construction

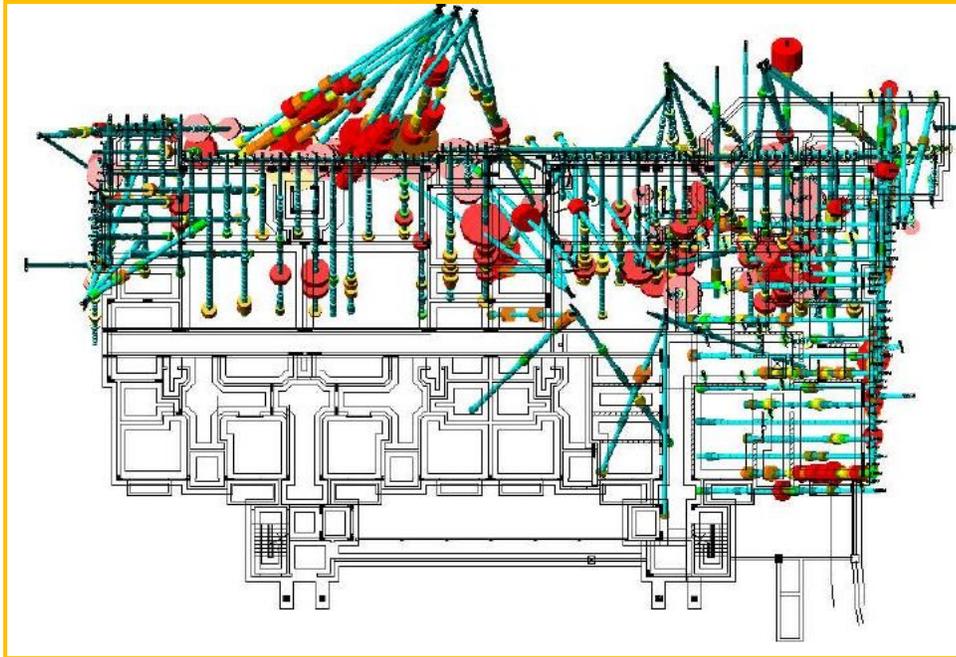
During the course of the remediation work, the conditions encountered during drilling and the volume of grout injected (or 'take') at discrete depth intervals in each hole was carefully recorded. In this manner, the geological model developed as part of the design phase and formulated into the numerical modelling was adjusted and refined as construction proceeded. Refinements to the design and borehole layouts were undertaken in near real-time as additional subsurface information was obtained during the construction. Records were updated daily and the grout-take data was tracked using 2-D and 3-D graphical models so that the weakest conditions (i.e. most voided) in the subsurface could be readily identified. Figure 13 shows the 3-D model, where higher grout take volumes are shown with larger spheres. These areas were then targeted with additional grout-only holes during the course of the production work. At the completion of the works, data had been acquired from the drilling and grouting of 174 micropiles, during which 1000 yd³ (750 m³) of low-mobility grout was injected into the voided areas of the foundation around the perimeter and below the interior of the building.

Figure 13: 3-Dimensional Illustration of Grout Locations and Quantities
