TILTING PREVENTION OF A FOUR FLOOR RESIDENTIAL BUILDING WITH THE ASSISTANCE OF MICRO-PILES BENEATH THE FOUNDATION

Assoc. Prof. **CHAVDAR KOLEV** PhD, University of Transport, 1574 Sofia, 158-Geo Milev Str, Tel: 359 885 256 905, e-mail: ch_kolev@abv.bg

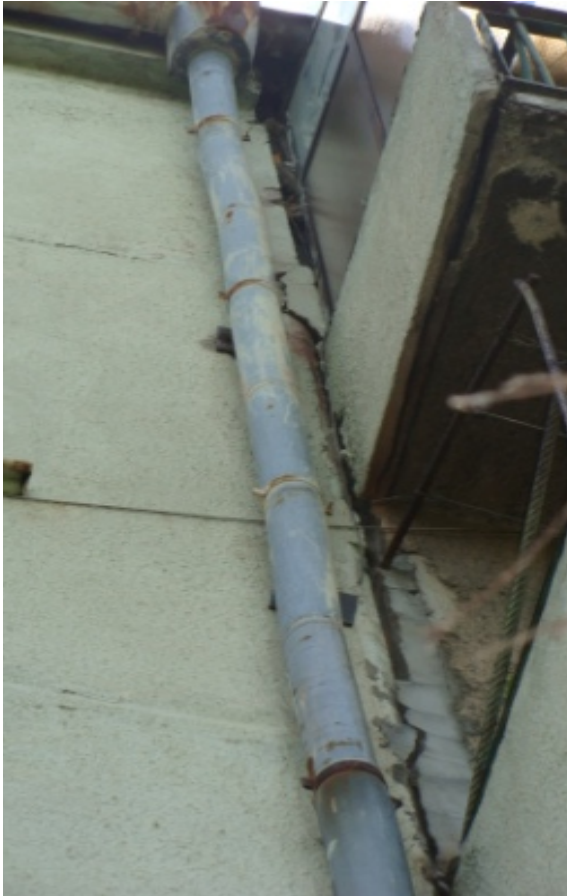
Picture 1: Vertical joints opening between façade panels

- Vertical joints opening between façade panels (7mm wide at 1st floor to 40mm wide at roof level);
- Joints in compounds of internal longitudinal panels at axis No. 8;

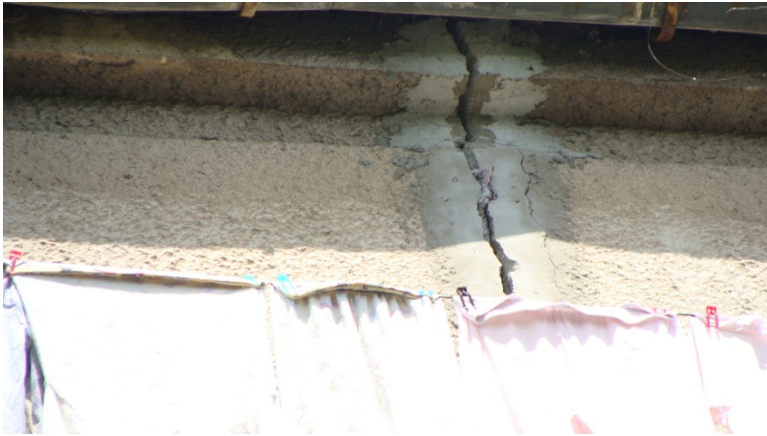
Picture 2: Vertical joints opening between façade panels

- Horizontal joints in the framing between staircase landings and interior panels (14mm wide at 2nd floor to 29mm wide at 4th floor);
- Almost proportionally linear increase in the longitudinal joint width with the height of the building;

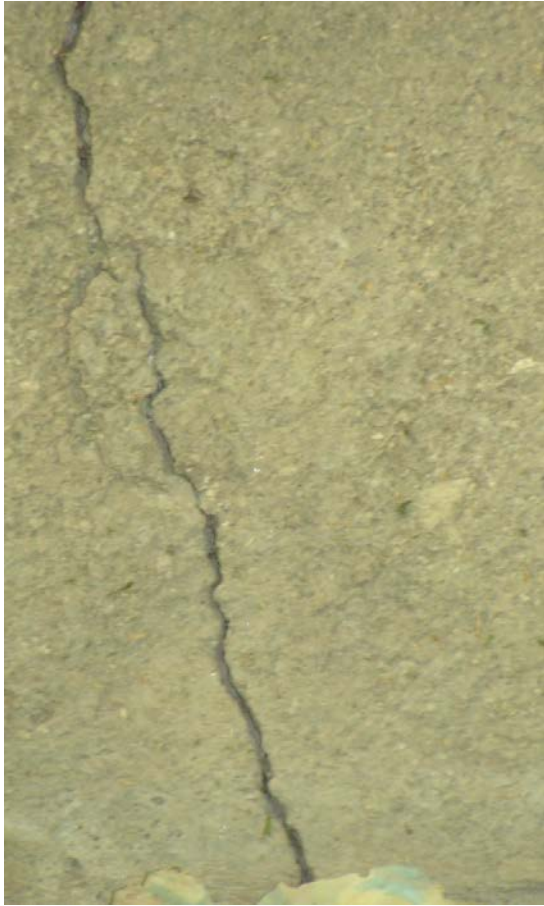
Picture 3: Cracks in the foundations

- Cracks in both section A and B;
- A drop in the south-eastern part of the housing block (35mm in the outer wall)
 - Subsidence depth was 10mm in axis No. 9 and almost no drop in axis 8).

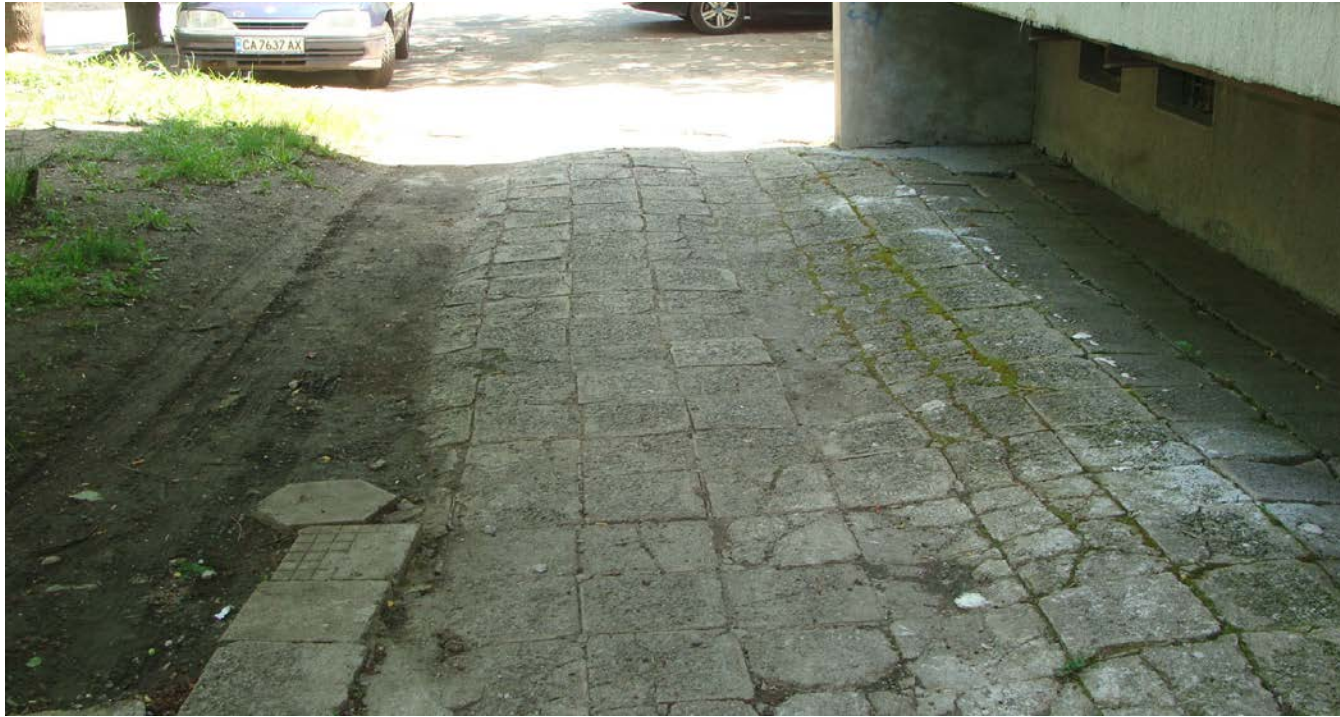
Picture 4: Broken sidewalk pavement around section A
