Use of Micropiles to Rehabilitate High Rise Tower Foundations in Vancouver, B.C.

Matt Kokan, M.A.Sc., P.Eng., GeoPacific Consultants Ltd.

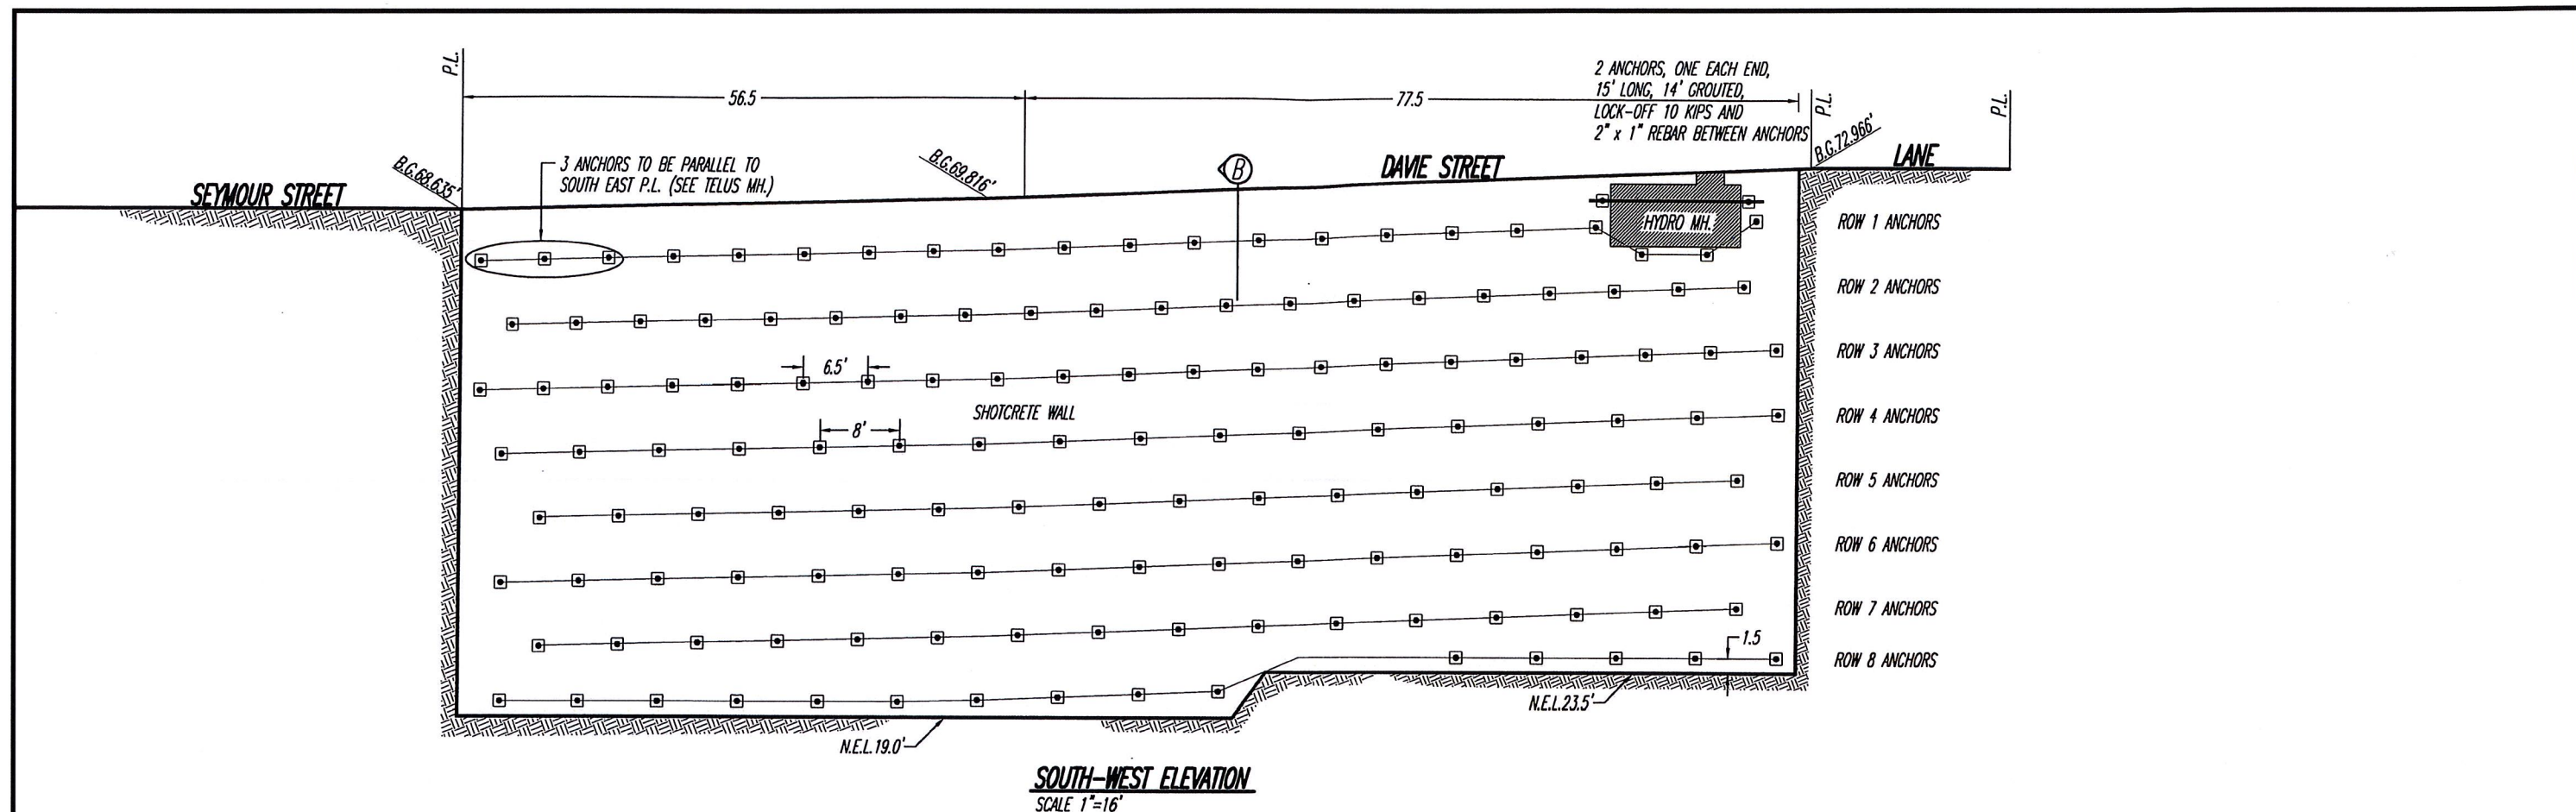
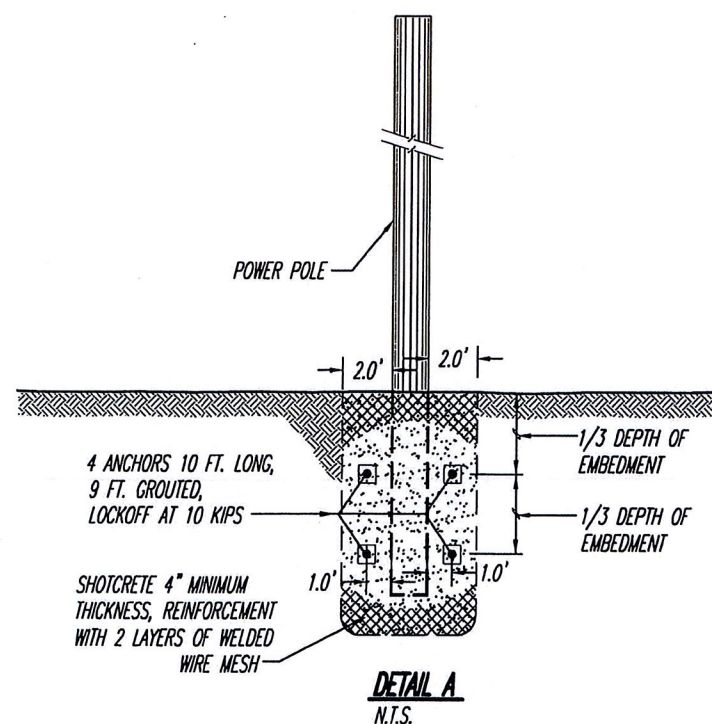
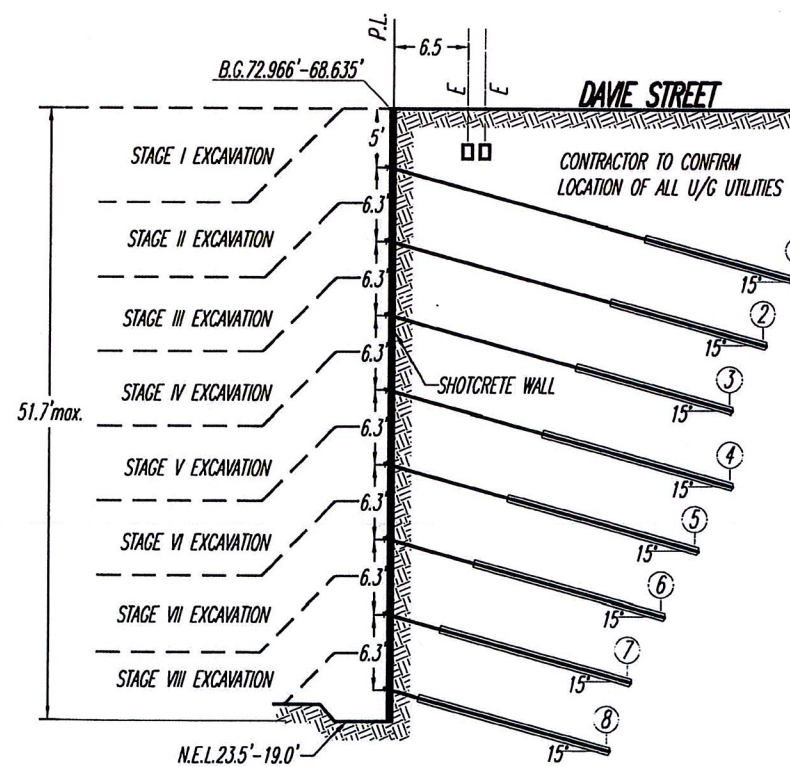
Figure 1. A Design Section - Southwest Elevation of The Shoring

A design section of the shoring attached as Figure 1, shows the depth of the parkade excavation below street grades.

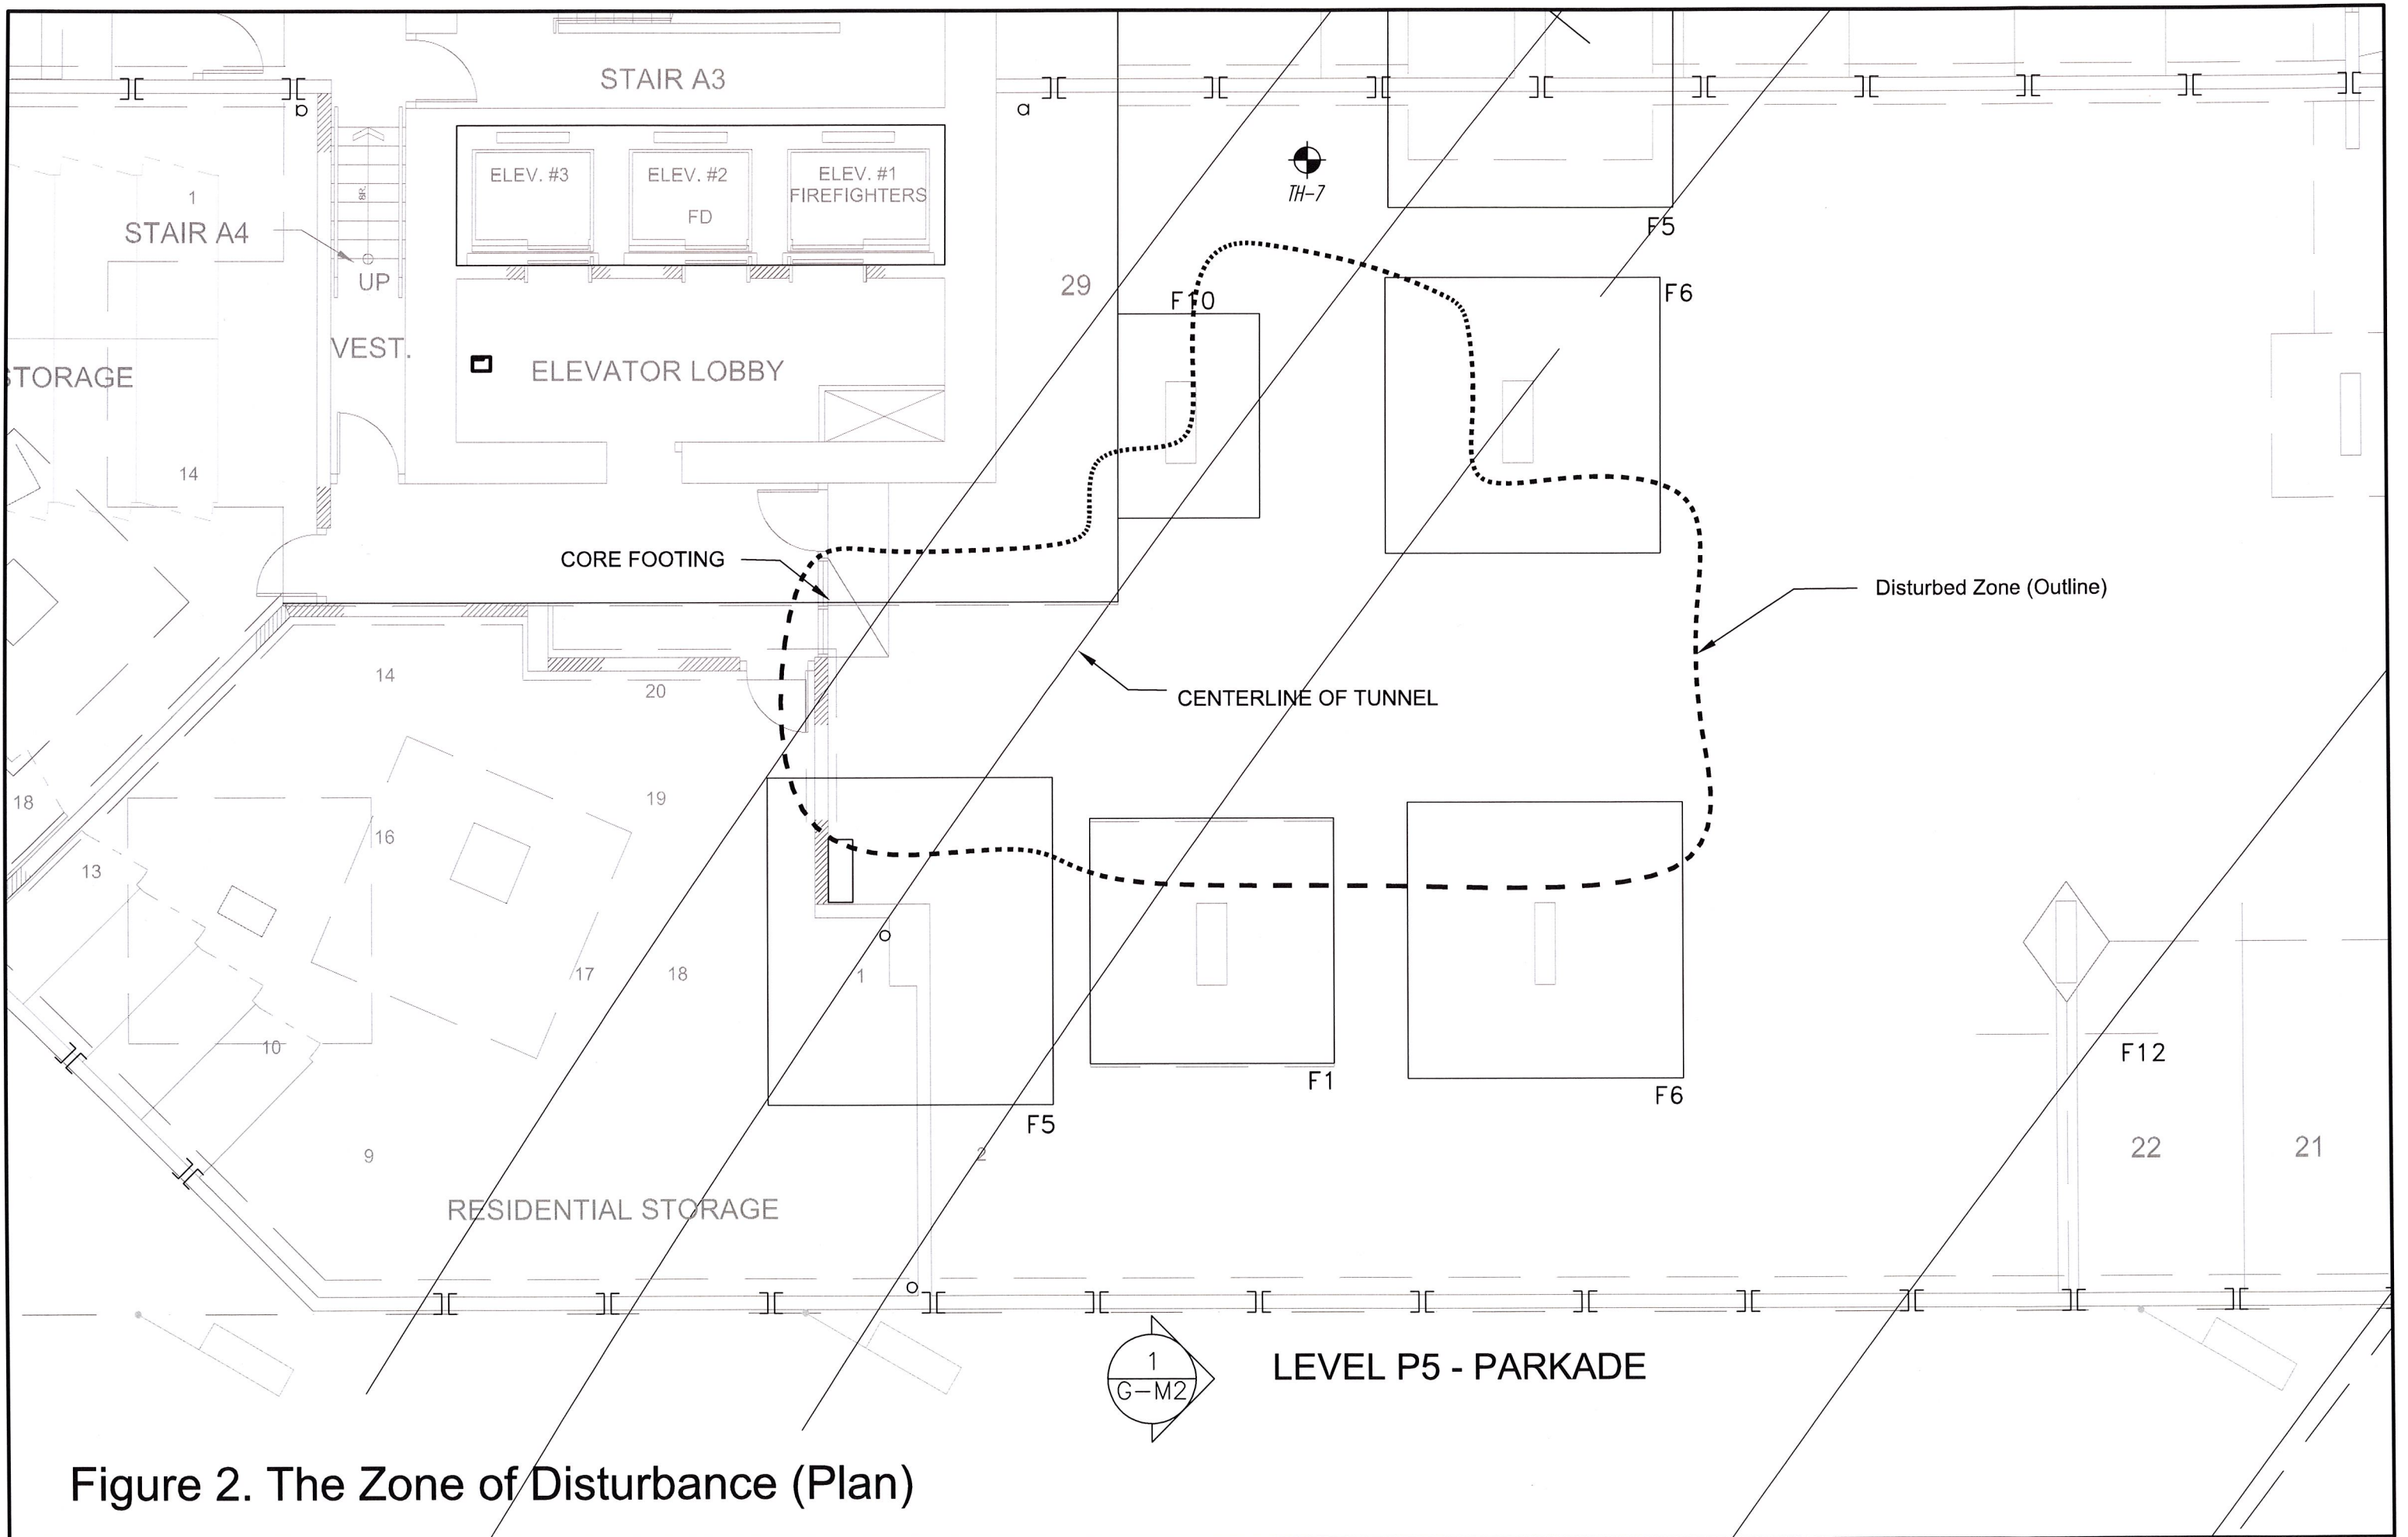
Figure 2. The Zone of Disturbance (Plan)

An investigation program was developed to study the extend of disturbance beneath the south tower. Since the headroom at the P5 level was only 2.5 m, a mini drill was mobilized to complete the investigation. A Titan hollow bar was used to penetrate the lean concrete and high strength concrete fill that had been previously placed and then probe the subgrade below. The disturbed zone was readily identifiable by permitting penetration of the hollow bar anchor with out any downward pressure, advancing the hollow bar with rotation only. The results of the drilling showed an extensive zone of loose sand (disturbed natural subgrade) remained beneath the concrete. The average depth was about 6 to 8 m, decreasing significantly away from the centre of the disturbance zone. The zone of disturbance is shown in plan and section on the attached Figures 2 and 3. Fortunately the centre of disturbance was not located beneath any of the tower columns or the core footing.

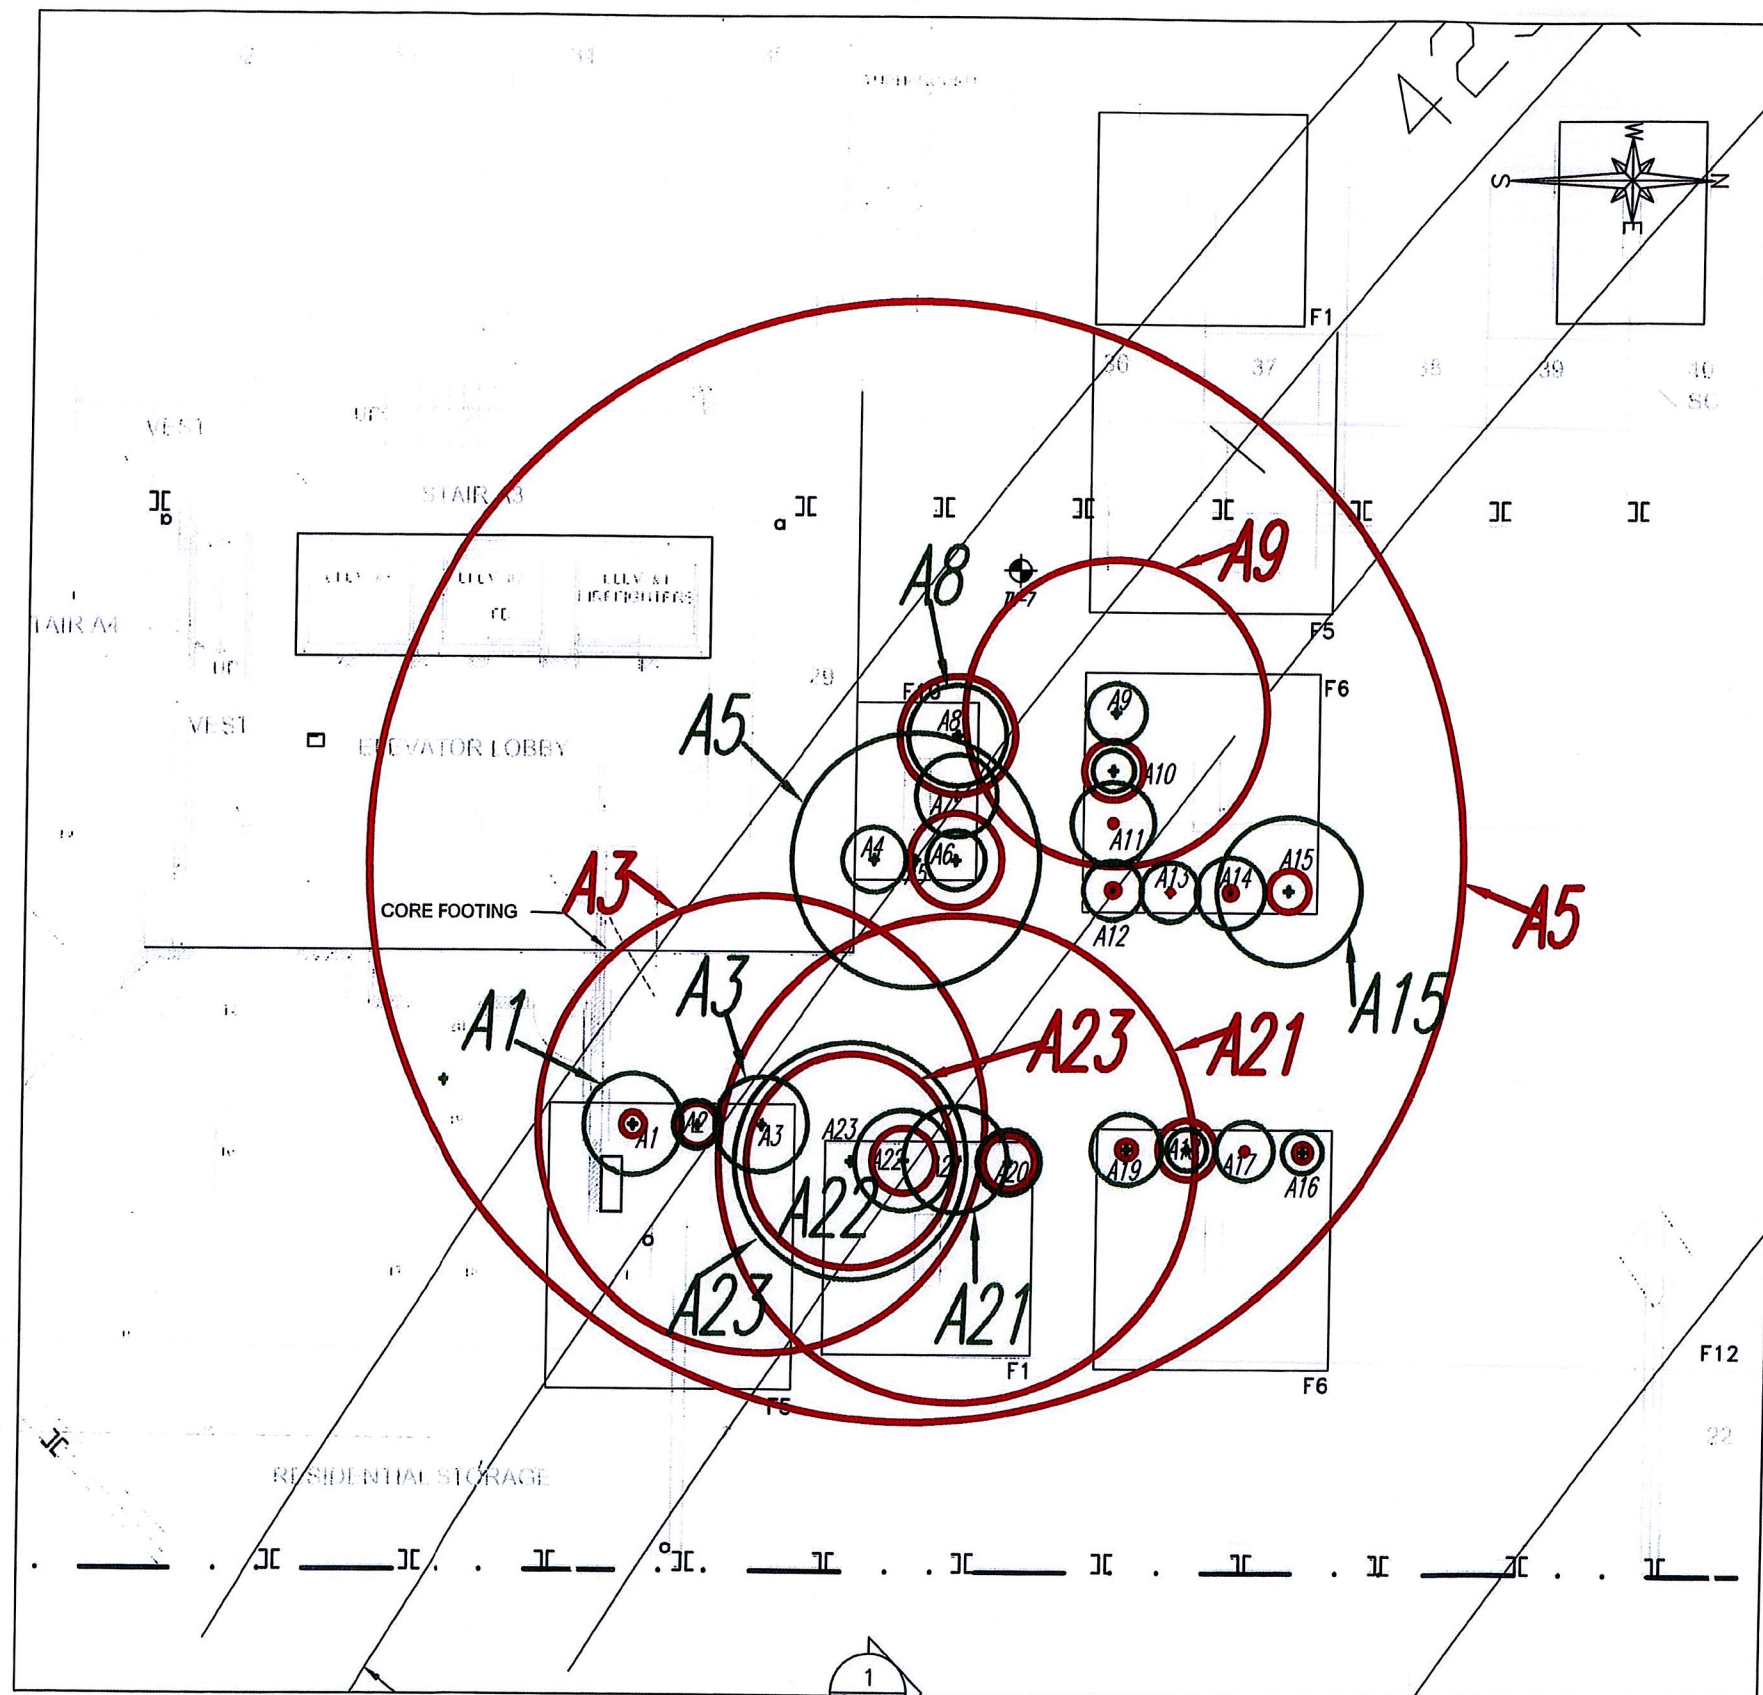
Figure 8. Results of Drilling And Grouting of The Micropile Installation

Reference to Figure 8 shows the results of the grouting recorded during micropile installation. Primary grouting (done at 8.5 bar) consumed 346 bags or 6.2 m³ of grout. Based on a total installed length of 206 m of micropile with a theoretical hole diameter of 150 mm, a minimum grout take of 3.6 m³ was expected. Thus the actual grout take was 72 percent over the theoretical minimum. Secondary and tertiary grouting consumed a further 9.7 m³ of grout (543 bags). The distribution of grout take during secondary and tertiary grouting is shown on Figure 8, with the magnitude of secondary grout take represented graphically by the diameter of the circle. Not surprisingly locations with larger primary grout take had larger secondary and tertiary grout take. One of the micropile locations (A5 on Figure 8) accounted for 47 percent of the grout take (7.9 m³ or 422 bags). This location, between the core footing and one of the tower columns, was assumed to be the centre of the disturbance cone, with the cone likely directed down towards the crown of the tunnel.
