TILTING PREVENTION OF A FOUR FLOOR RESIDENTIAL BUILDING WITH THE ASSISTANCE OF MICRO-PILES BENEATH THE FOUNDATION

Chavdar Kolev¹

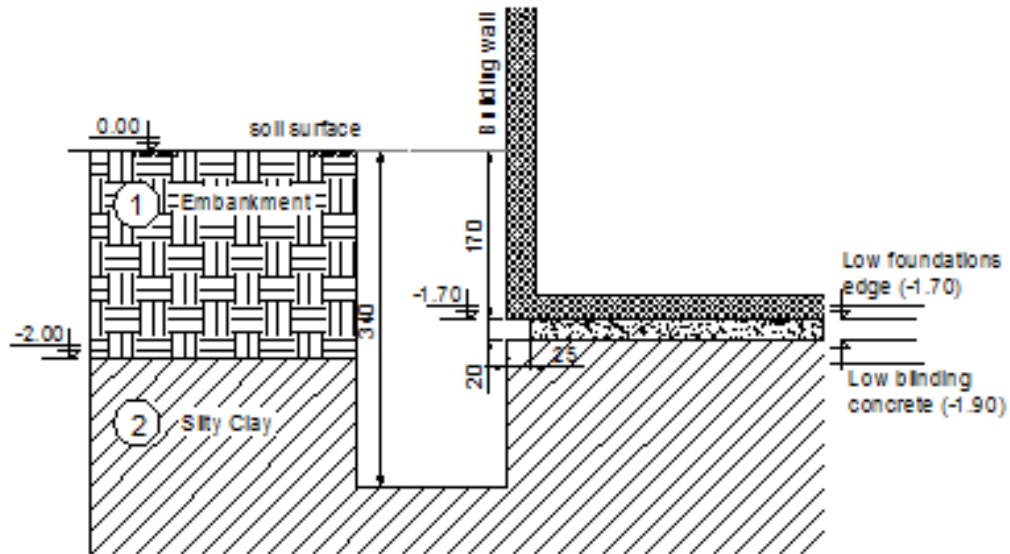
Fig. 2: Profile of the investigating trench at the base of the building

Ground beneath the building consists of expensive silt clay with thickness of about 7 to 8 m. Below, there is a layer of permeable sand with silt of 1m to 2m, but the level of the ground water was deeper than this. There are about 2m organic soil and embankment onto the base layer.

The physical and mechanical characteristics of the 2nd carrier layer (brown silty clay) are the following:

- Bulk Density $\rho_n = 1.87 \text{ g/cm}^3$
- Dry Bulk Density $\rho_d = 1.53 \text{ g/cm}^3$
- Void ratio $e = 0.756$
- Degree of water saturation $S_r = 0.78$
- Natural Water Content $w_n = 21.94 \%$
- Plasticity index $I_p = 30.80 \%$
- Consistence Index $I_c = 1.04$
- Angel of Internal Friction $\phi = 23,8^\circ$
- Cohesion $c = 40 \text{ kPa}$
- Deformation Modulus $E_0 = 17,5 \text{ MPa}$

The average swelling stress was measured by laboratory test at 60 kPa.

The thickness of the lowest 3rd layer varies from 1 to 2m (small damp medium compact sand). Please look at its physical and mechanical characteristics as well:

- Bulk Density $\rho_n = 2.00 \text{ g/cm}^3$
- Deformation Modulus $M = 16 \text{ MPa}$
- Poisson's ratio $\nu = 0.31$
- Angel of internal Fraction $\phi = 36,6^\circ$

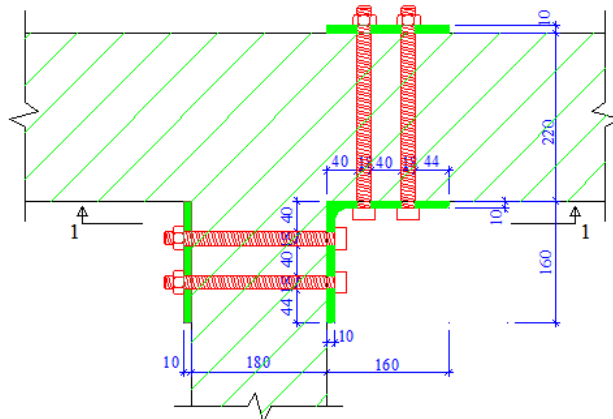
Fig. 6: Embedded panels with steel bars and bolts

After the successful ground stabilization and completion of the injection works, the team proceeded with strengthening and recovery of the top construction of the superstructure. Panels were embedded (Fig. 6) with steel bars and bolts, joints and cracks were restrained and facades were plastered and painted.
