**MATERIALS USED IN MICROPILES IN JAPAN**  
**Mr. Shimazu, Japanese Association for Steel Pipe Piles, Japan**

# Experimental Study On Ultimate Behavior Of Steel Pipe Pile Group

HYOGOKEN-NAMBU EARTHQUAKE

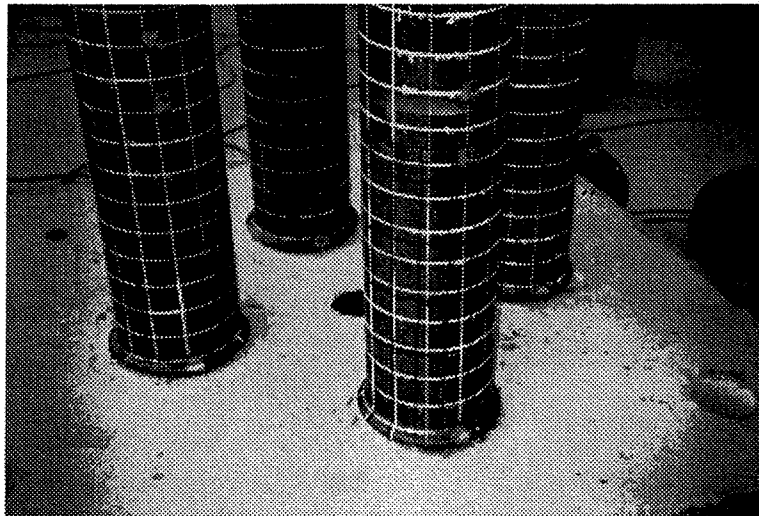
The horizontal load increased until  $\pm 8 \delta y$  and did not reduced in the cyclic loading at the same amplitude. In  $\pm 8 \delta y$  cycle, inelastic buckling at the lower end of the pipe at the compressive side was observed, but when loaded reverse, local buckling was not observed. In the cyclic loading at  $\pm 10 \delta y$ , the horizontal load decreased a little compared with previous cycle, and in the cyclic loading at same amplitude, the horizontal load decreased. At this cycle, the vertical displacement increased and local buckling at the end of the pipe remained when it loaded reverse. In the cyclic loading at  $\pm 15 \delta y$ , the horizontal load of the first cycle dropped to about 80% of the maximum horizontal load and the horizontal load of the third cycle dropped to half of the first cycle load at the same amplitude. After this cycle, the specimen loaded until it developed 170mm of the horizontal displacement and the horizontal load was not lager than half of the maximum horizontal load. Finally the inelastic buckling progressed, resulting into what is called the elephant buckling mode as shown in Photo.2.

Photo.2 Elephant Foot Buckling (CASE 1)

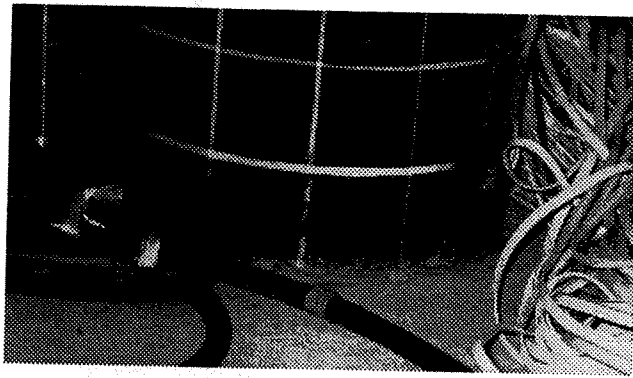
Phot.3(a) End of the Pipe at  $8 \delta y$ (CASE 3)

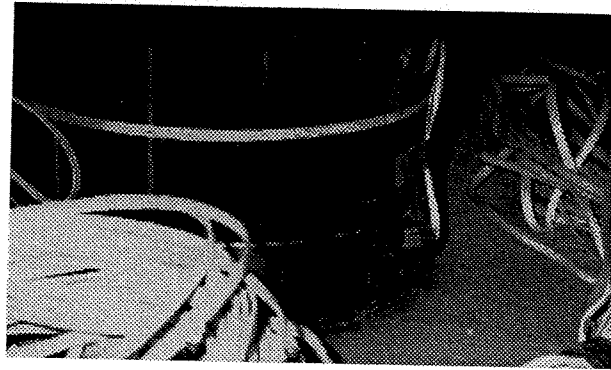
CASE3 recorded the almost same load-displacements relations as CASE1 until the horizontal load exceeded the maximum load. In the cyclic loading at  $\pm 15 \delta y$ , the horizontal load of the first cycle dropped to about 80% of the maximum horizontal load as same as CASE1 but the horizontal load of the third cycle dropped to 80% of the first cycle load. Photo.3(a) and (b) show the deformation of the pipe at  $8 \delta y$  and at  $15 \delta y$ , respectively. After this cycle, the specimen loaded until it developed 250mm of the horizontal displacement and the horizontal load gradually increased to the load of the first cycle at  $\pm 15 \delta y$ . The effect of the filled concrete appeared only after maximum loads exceeded and inelastic buckling occurred.

Phot. 3(b) Inelastic Buckling at  $15 \delta y$  (CASE 3)

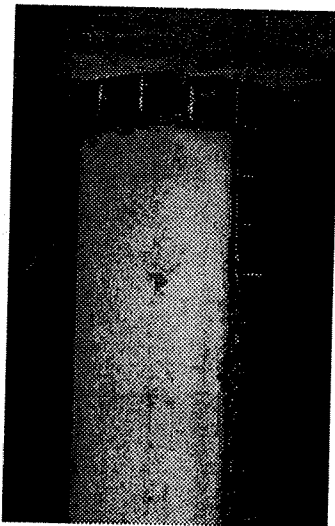
Phot.4 Filled Concrete after the Experiments

Photo.4 shows the filled concrete after the experiments. CASE2, CASE3 and CASE4 had the large crack at the end if the pipes. In CASE2 filled concrete wasn't damaged. In CASE3 the filled concrete had one large transverse crack and in CASE4 the filled concrete had some thin transverse cracks.

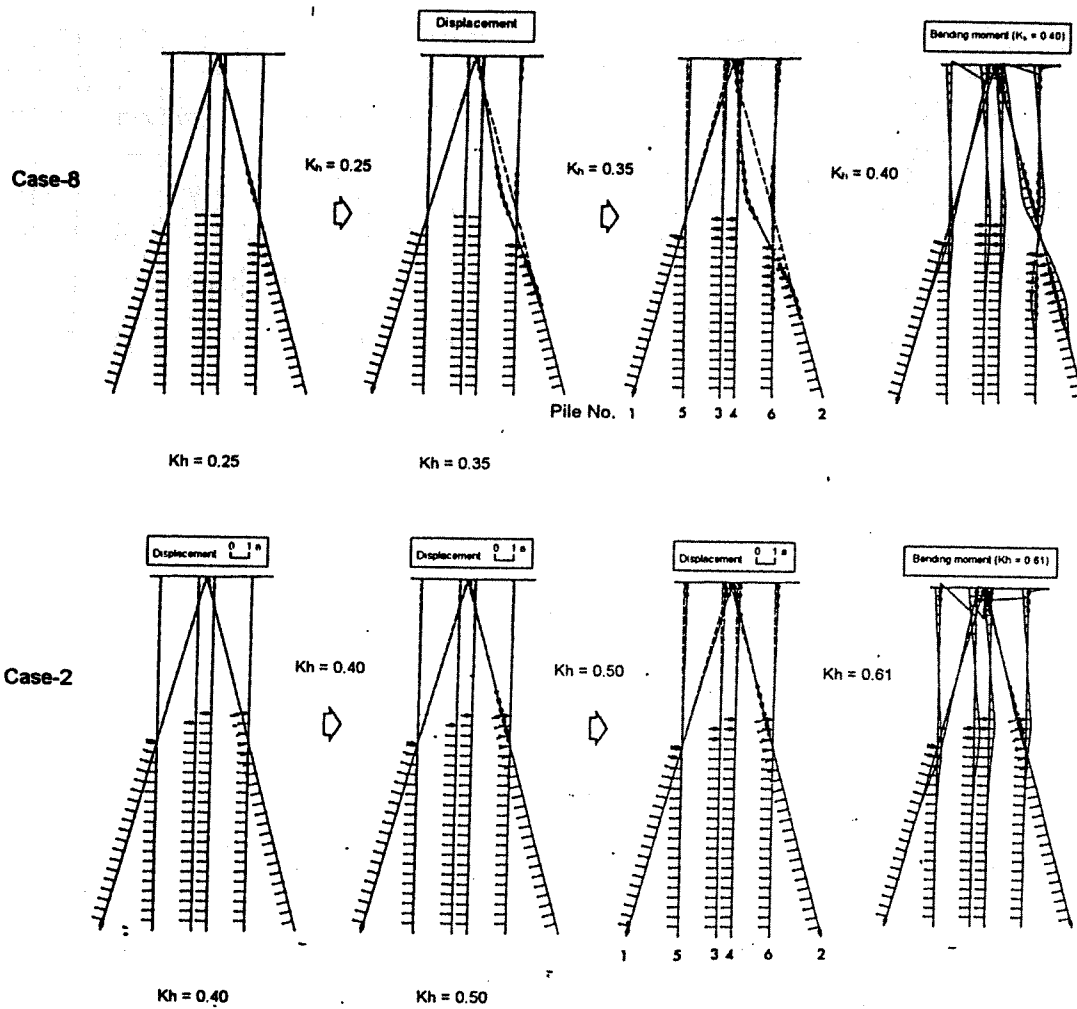
Of the eight (8) cases of analysis, CASE-8 most resembled the actual damage condition of the pier. In comparison with CASE-2, wherein the effect of ground movement was not considered, the displacement diagrams and the bending moment of the piles of both cases are shown in Fig. 8, and the transition of the pile tip axial forces are shown in Fig. 9.

Fig. 8 Case - 8/2 analysis results

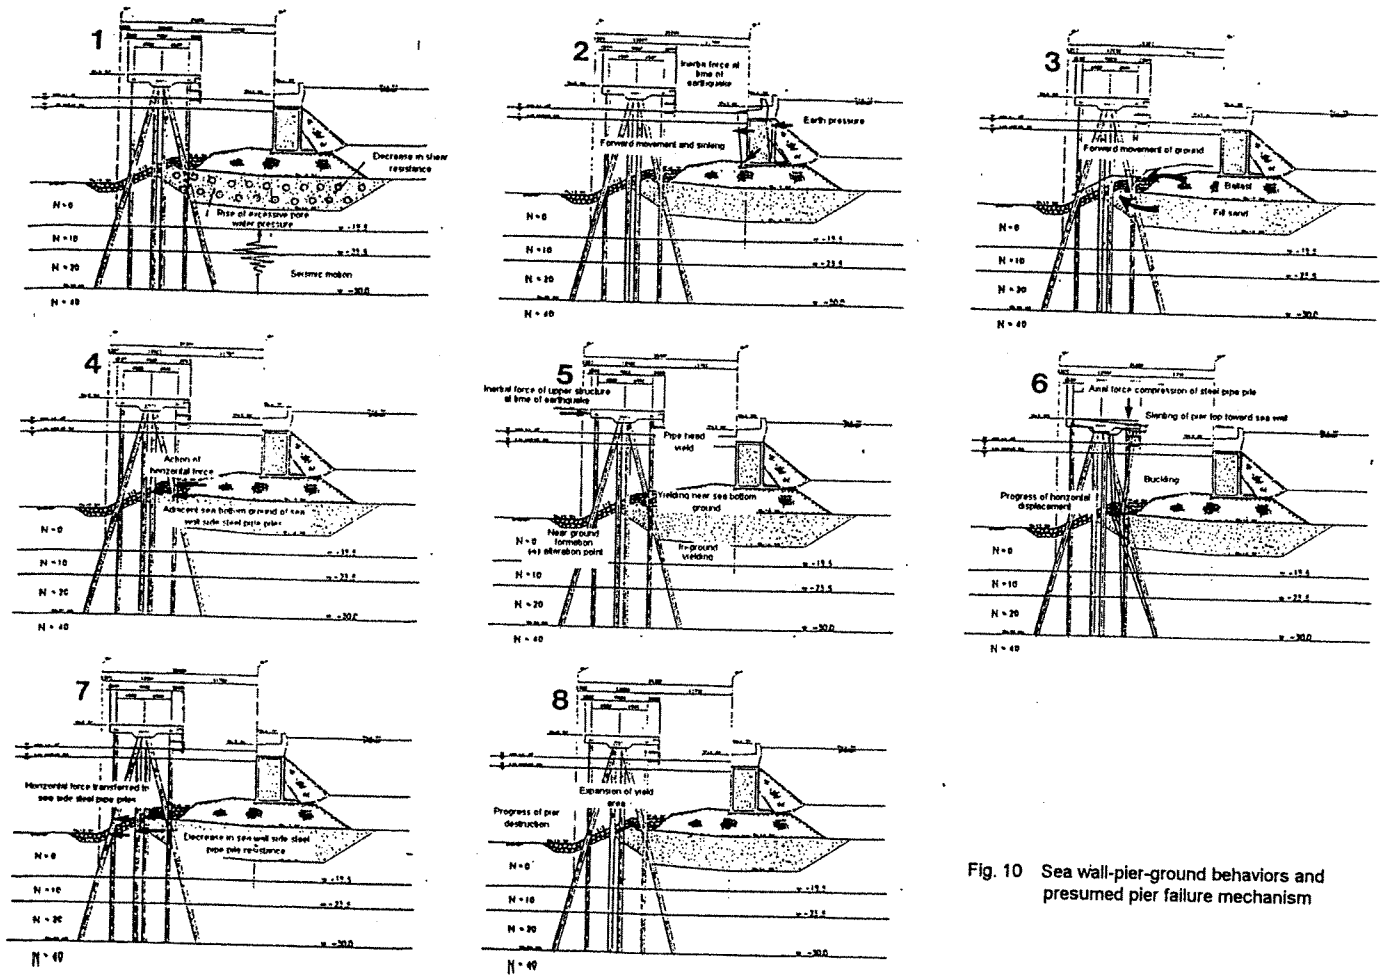
- ① Earthquake vibration raised the excessive pore water pressure in the replacement sand layer portion, reducing the shear resistance (see Fig. 10 ①).
- ② At the time of the earthquake, the inertial force and the earth pressure forced the caisson to move forward, simultaneously generating its sinking into the replacement sand layer (Fig. 10 ②).
- ③ Ground consisting of replacement sand including the rubble mound moved forward (Fig. 10 ③).

- ⑦ Due to the resistance decrease of the sea wall side piles, the ground deformation load was transferred to the sea side piles (Fig. 10 ⑦).
- ⑧ The area in which the sea side steel pipe piles were yielding expanded as the failure of the pier progressed (Fig. 10 ⑧).

Fig. 10 Sea wall-pier-ground behaviors and presumed pier failure mechanism
