# **SLOPE STABILISATION OF A SECTION THE THIRLMERE AQUEDUCT BY THE USE OF SPACED MICROPIES AND PERMEATION GROUTING**

David Preece\*

## **SYNOPSIS**

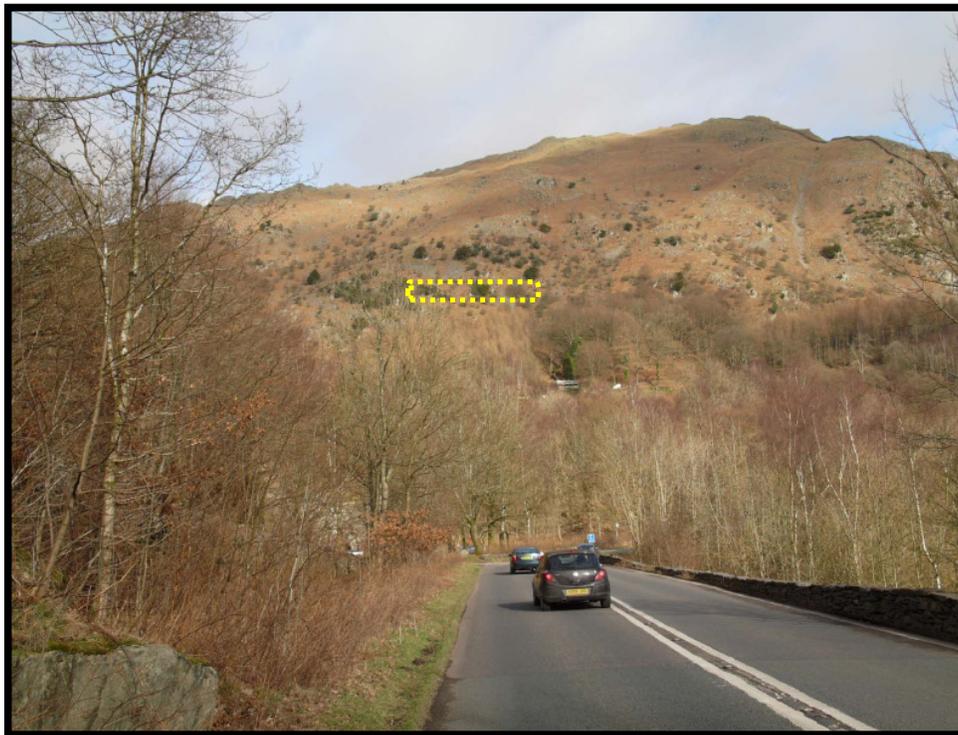
Figure 2. Looking towards Nab Scar, with approximate position of conduit shown

Nab Scar conduit is a short length of aqueduct conduit linking two aqueduct rock tunnels. It is situated on a steep hillside above Rydal Village, north of Ambleside. A photograph taken during the construction of a rock tunnel portal in the area of Nab Scar is shown in Figure 1 and view of the existing Nab Scar hillside is shown in Figure 2.

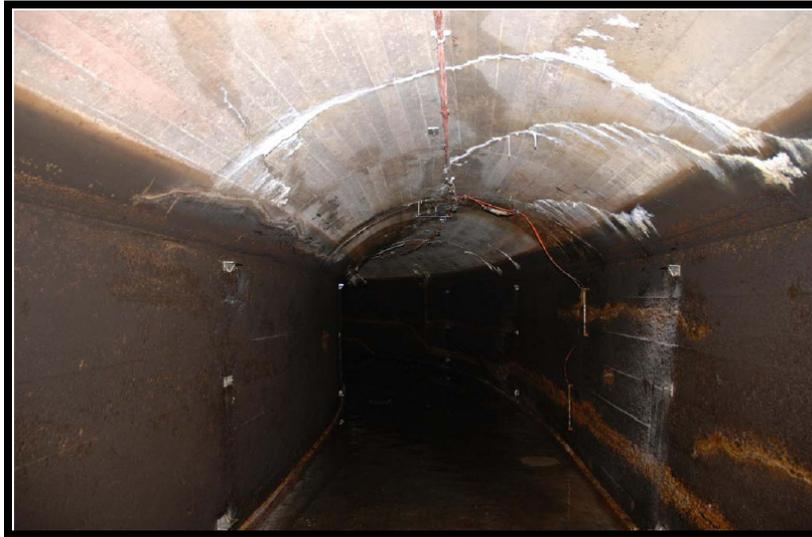
A series of cracks were evident within the conduit structure and the most marked of them comprised of a spiral crack (Figure 4), which ran from the wall/floor joint on the outside of the bend (right hand side) in the conduit and around the barrel of the arch, terminating at the tunnel portal. The crack was first noted in 2005 during the first

outage in the current programme. Remote reading movement gauges were installed across significant cracks to provide early warning of any future movement. The gauges are read frequently and, to date, have not shown any further movement. However, the removal of the manganese deposits, as part of previous internal repair works, revealed other cracks, which were not visible to the 2005 inspectors, particularly an opening of the joint between the base and the wall on the down-slope side of the conduit. The orientation of the cracking, together with the opening of the base wall joint, indicates that the conduit structure has undergone a torsional movement, with the downstream section twisting outwards (down-slope) relative to the upstream section.

Figure 4: Photograph taken inside of the conduit showing spiral cracking

During subsequent outages, a series of surveys and intrusive investigations has established that the floor of the conduit is founded directly on a platform of rock and so the potential for global movement of the conduit was discounted. Instead, it is considered that the displacement is limited to a section of outer wall and roof on the outside of the spiral crack.

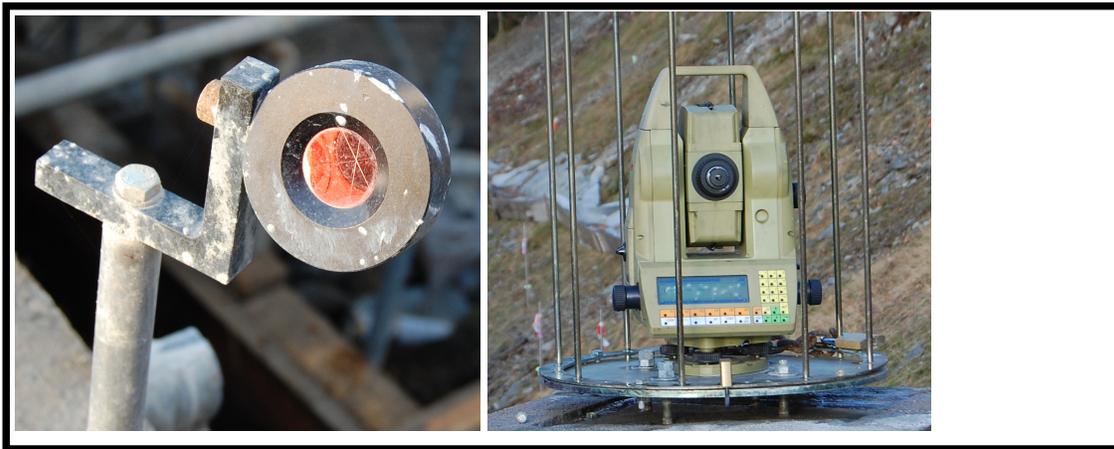
A fully automated total station surveying system was employed to continuously monitor hillside ground movements in real-time. The system is a fully automated, optical monitoring system comprising of a motorised total station that observes prismatic targets fixed to the hillside. The monitoring prisms were installed on a square matrix with prisms at 5.0m centres across the hillside. Photographs of the system are provided in Figure 5.

Figure 5. Automated monitoring system – prism and total station

The total station unit was piloted by a single industrial PC which operates the instrument, logs the results, undertakes the survey calculations, performs quality control checks and then internally stores each prism's observed co-ordinates. The PC automatically downloads the acquired survey co-ordinate data and imports the information into the monitoring database for subsequent analysis.

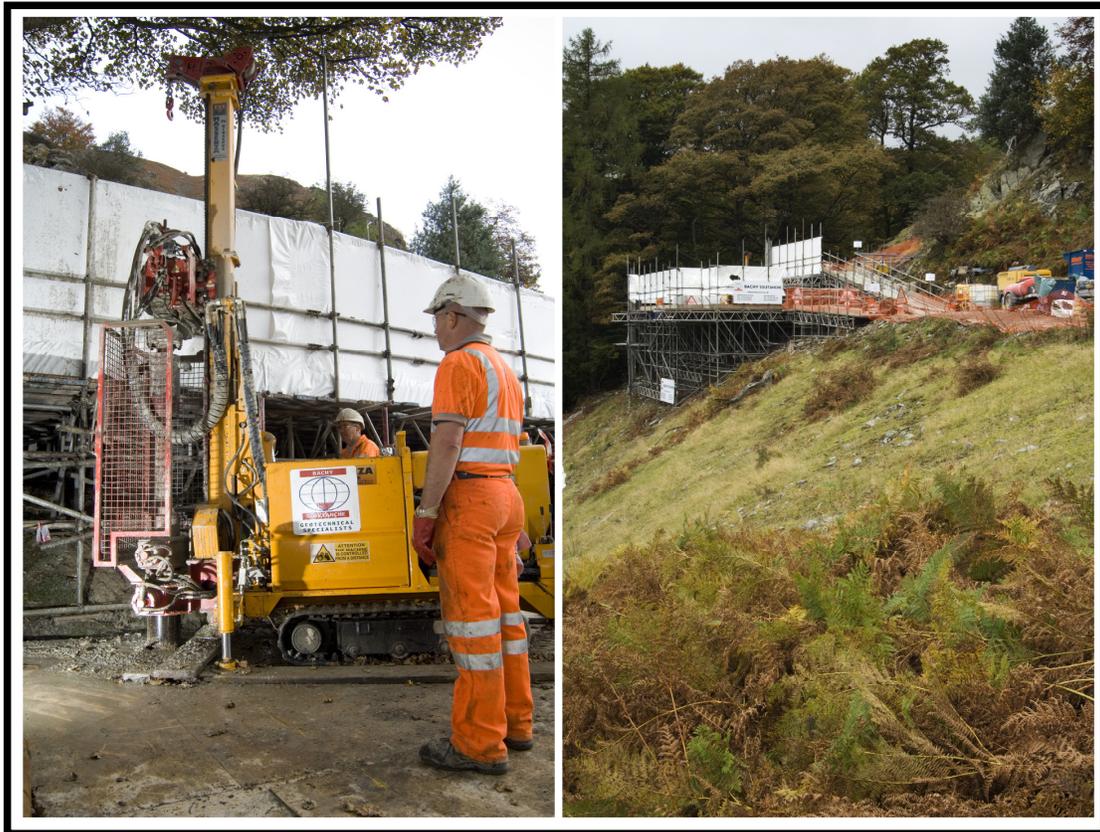
The selected solution was to use spaced piles above and below the conduit to stabilise the hillside and conduit. Direct structural connection to the conduit was not permitted and so permeation grouting via a grid of TaM grouting boreholes were installed between the conduit and the down-slope spaced piles. The permeation grouting would back-fill open voids and to provide an indirect structural connection between down-slope piles and the conduit. The permeation grouting was designed to be installed in isolated blocks to enable the passage of existing groundwater flows to continue unhindered. The works could be undertaken with light weight drilling rigs working off a temporary scaffold platform, which itself, was anchored back to existing stable rock outcrops. See Figure 6.

Figure 6. Light-weight drilling operating of temporary scaffold platform
