BANJO BILL ROCK CATCHMENT BASINS

Paul B. Groneck, P.E. Vice President & Tom Armour, P.E. President
DBM Contractors, Inc. P.O. Box 6139, Federal Way, WA 98063, U.S.A.
Email paulg@dbmcm.com tarmour@dbmcm.com

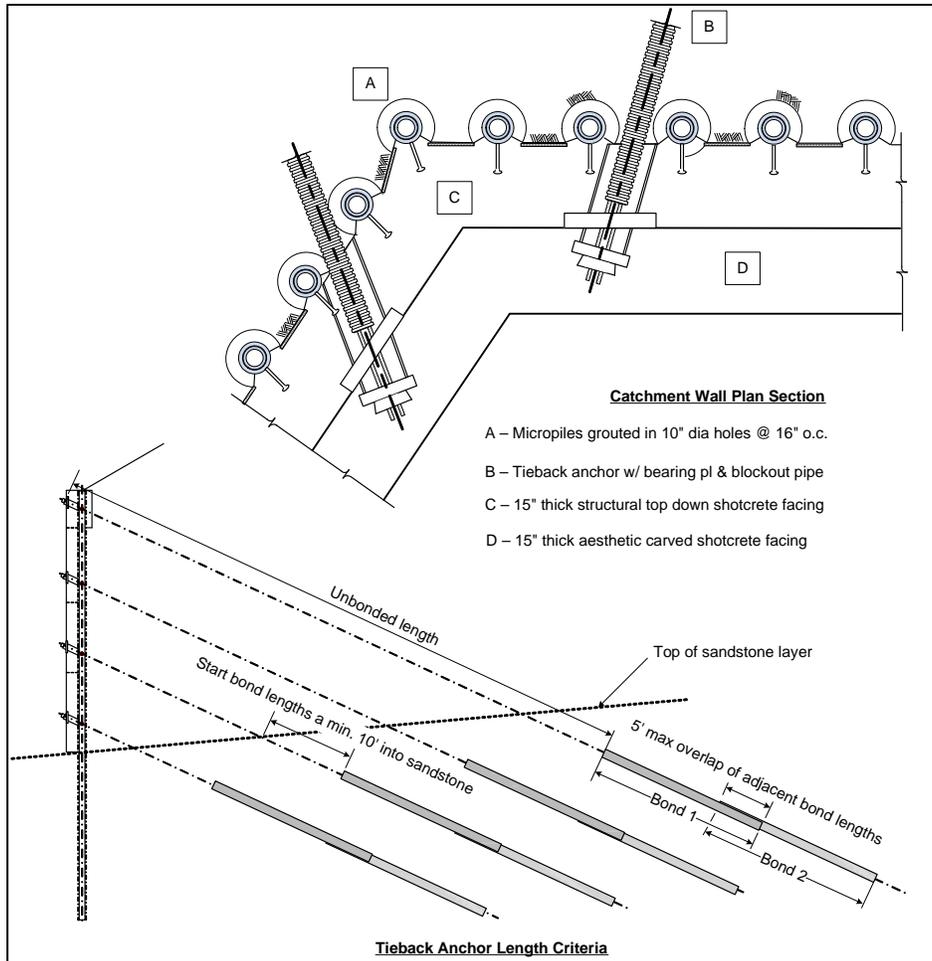
Figure 1 – Wall Design Details

- Vertical micropiles which are spaced at 41-cm on-center along the length of the wall. The piles consist of a 14.3-cm OD steel pile in a 25.4-cm diameter drilled hole grouted with neat cement grout. The micropiles provide vertical support for a shotcrete facing and the vertical load component of the anchors. The micropile embedment also provides lateral support for the base of the wall. The piles were designed to have adequate bending strength to support the full lateral soil design pressure while spanning between each row of anchors.

- A 0.9-meter square reinforced concrete cap beam located at the top of piles to connect the piles together and provide a connection point for the top row of anchors.

- A 0.4-meter thick structural shotcrete facing which served to distribute the soil loads to the micropiles and provide connection points for the remaining rows of anchors. This facing was heavily reinforced to act as a waler along the anchor rows. The facing was installed in a top-down manner in lift heights which matched the anchor row spacing.

- The final walls were anchored with four rows of double corrosion protected tieback anchors. The anchors were connected to the structural shotcrete facing with bearing plates and embedded blockout pipes. The anchor bond lengths were founded in the underlying sandstone bedrock.

- A 0.4-meter thick aesthetic outer shotcrete facing which was carved and stained to emulate the features of the natural rock in the area.

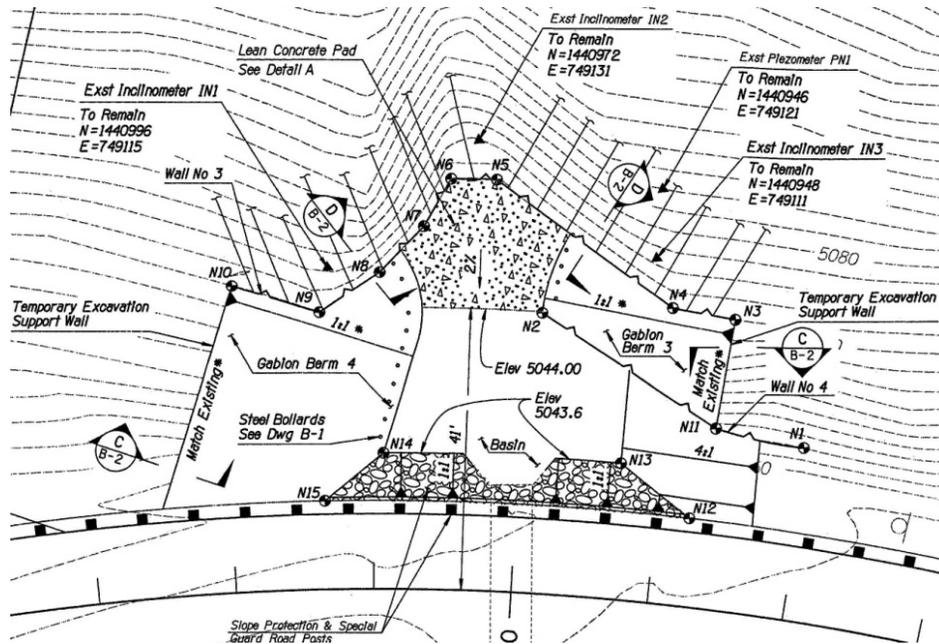
Figure 2 – North Wall Layout Plan

Each wall is approximately 27-meters long, and aligned to follow the contours of each basin location. The walls were installed to support the design height for the full length of the wall. The basic features of the walls are as follows:

- Temporary soil nail walls which support the sides of the excavations from the ends of the micropile walls down to the edge of roadway.
- Gabion berms which form the permanent side slopes of the basins and bury the temporary soil nail walls.
- Drilled horizontal drains were constructed to relieve hydrostatic water pressure at the base of wall.

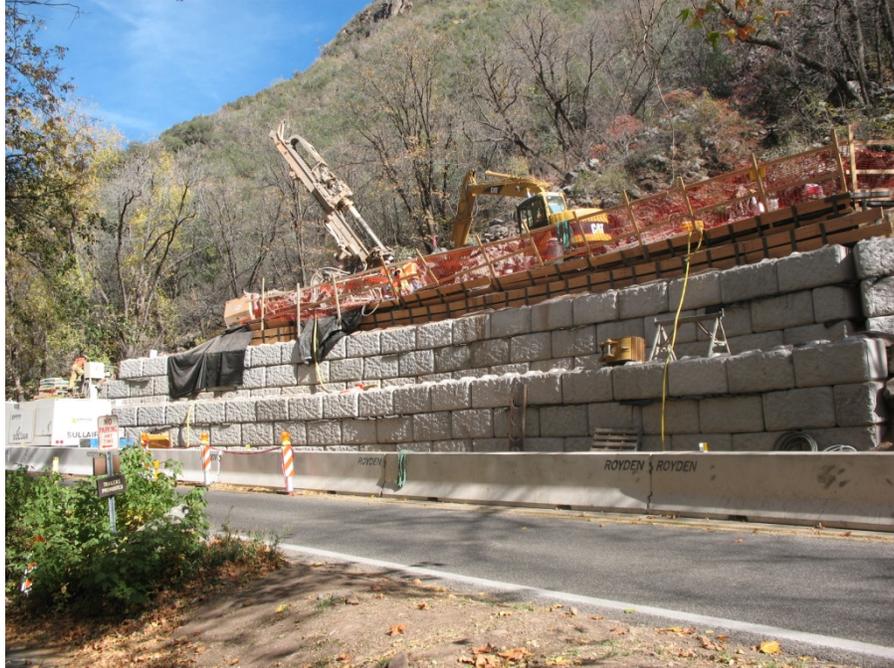
Photo 3 – North Wall Access Bench

- *Equipment Access* – Prior to the start of work the access along the wall alignment was a steep boulder strewn slope (approx. 40-deg inclination). Reinforced soil benches were built to provide a 9-meter plus bench width for access by the drill rigs and excavators along each top of wall location. The bench soils were reinforced with geotextile fabric at the South wall, and ecology blocks plus fabric for the North wall where room to build stable walls was more limited.

- *Slope Stability During Construction* – There was concern for movement of the slopes during the interim phases of the top down wall construction. The support provided by the temporary access benches helped address these concerns. Movement of the slopes was monitored on a daily basis throughout the drilling work with reading of the inclinometers and the surveying of a series of points on the slopes above the walls.

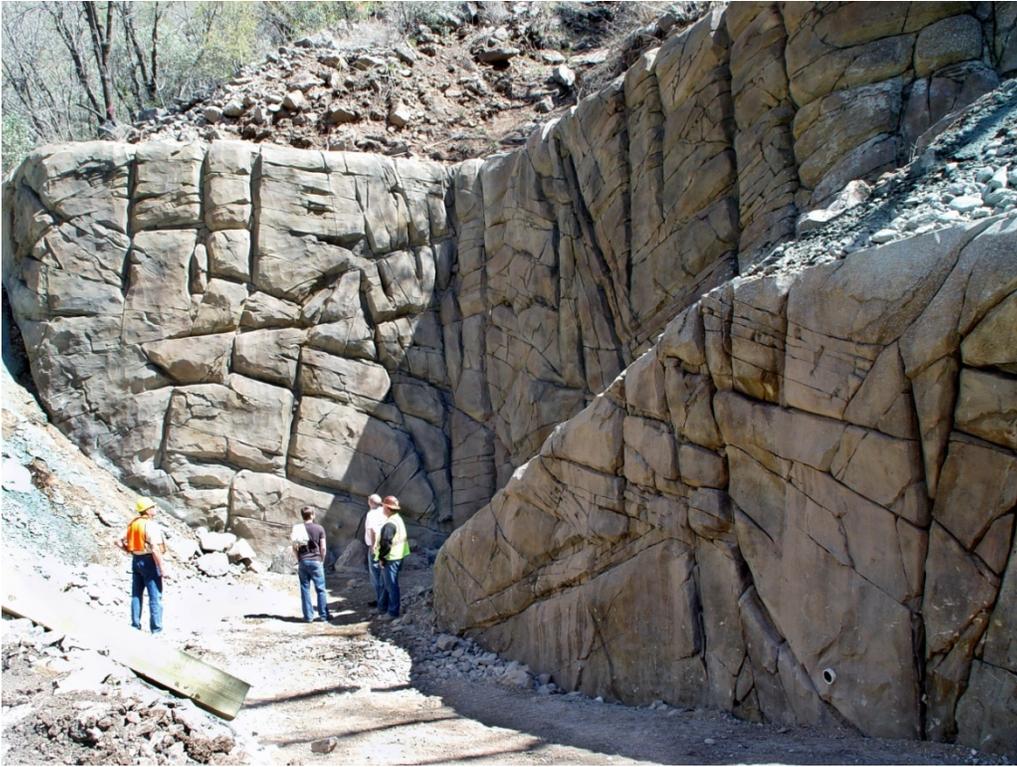
Photo 5 – Completed North Basin

The project was successfully completed in more ways than one. The walls have performed well to date as indicate by the installed instrumentation, which includes six

inclinometer casings located above the wall for monitoring wall movements and two load cells on each anchor row on each wall (8-total) for monitoring changes in the anchor loads. No notable changes in the readings have been reported to date.
