EMERGENCY MICROPILE REPAIR OF THE BIRMINGHAM BRIDGE

Terence P. Holman, Ph.D., P.E.¹ and Scott A. Stonecheck, P.E.²

ABSTRACT: On February 8, 2008, a steel rocker bearing failure at Pier 10 of the Birmingham Bridge caused an 200 mm drop between two adjacent spans. This emergency situation forced PennDOT District 11-0 personnel to retain a general contractor to immediately shore up the steel girders of the spans to prevent further collapse. This case history describes the implementation of an aggressive micropile retrofit solution, developed by the specialty contractor and design consultant, to re-support the failed Pier 10 S and ultimately Pier 10N. The proposed retrofit incorporated the use of thirty three micropiles drilled through the existing concrete pile cap and between steel H-piles in a 4.9 m wide space between the existing false-work towers. An additional twenty two micropiles were placed around the existing Pier 10N crash wall to bolster the structural capacity of the pier. Typical micropile lengths were 25.6 m.

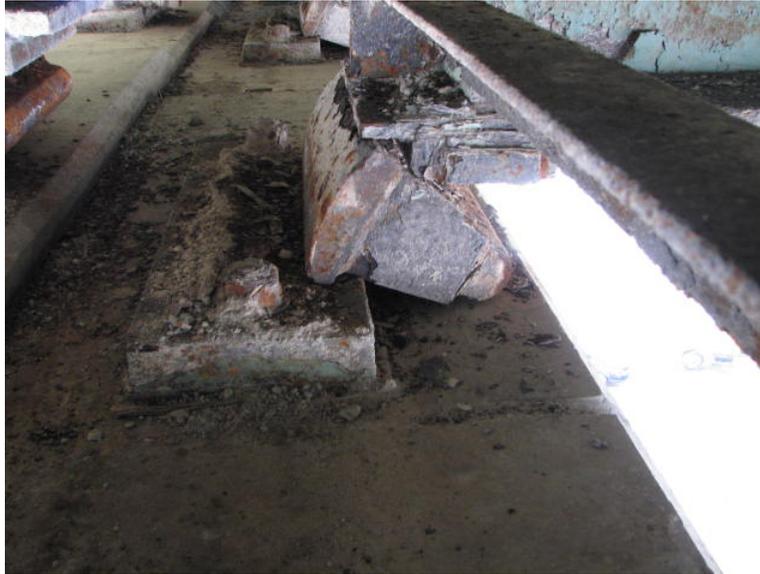
Figure 1. Failed rocker bearing at Pier 10S (adapted from Splitstone et al, 2010)

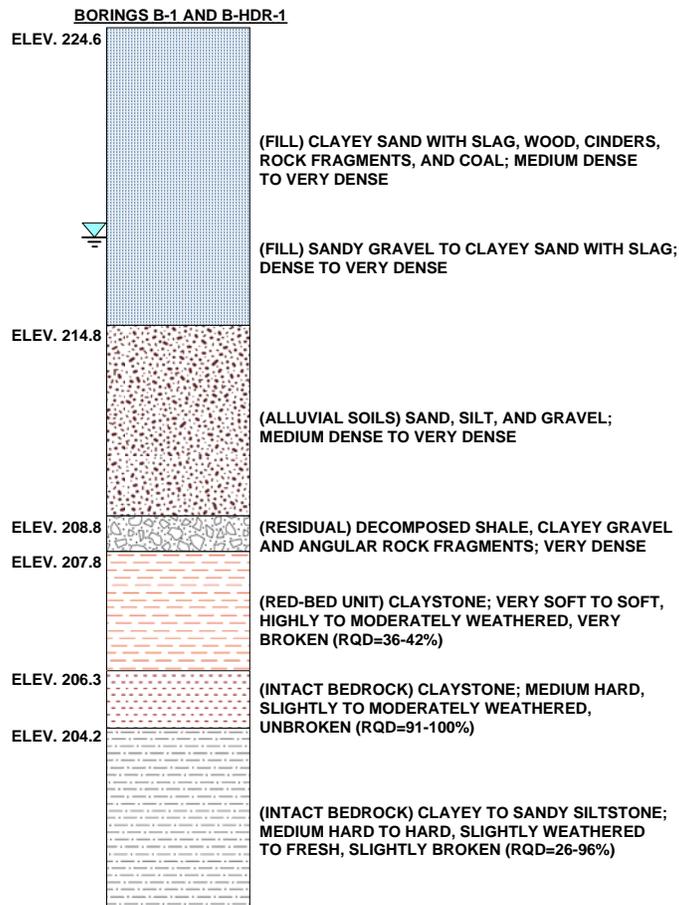
Figure 2. Detailed subsurface conditions at Pier 10S, test borings B-1 and B-HDR-1.

The failure investigation for Pier 10S centered on performance issues with the foundation. As part of the failure investigation, the geotechnical consultant performed an evaluation of the damaged pier below the fallen spans, including the as-built tip locations. Induction Field (IF) testing was performed on two of the original driven piles. This nondestructive test method, detailed in Olsen et al (1998), involves sensing a change in the magnetic field between the deep foundation and a nearby sensing coil lowered into a cased borehole, was used to estimate the as-built pile lengths. IF testing indicated that the existing piles, driven prior to 1976, were above the top of hard rock elevations estimated from the original contract test boring logs. The investigation concluded that a thin layer of hard rock had prevented the piles from being driven through a soft rock layer known locally as the Pittsburgh Redbed into the underlying competent rock layer 7.5 to 9 m lower. Refer to Figure 2 for an illustration of the typical subsurface conditions beneath the project site. The exact cause of the sudden pile group failure and rotation of the pier is still unknown, but calculations indicated that the theoretical margin of safety for service loads was less than one, implying that the bearing area at the base of the pile cap may have been providing significant foundation capacity.

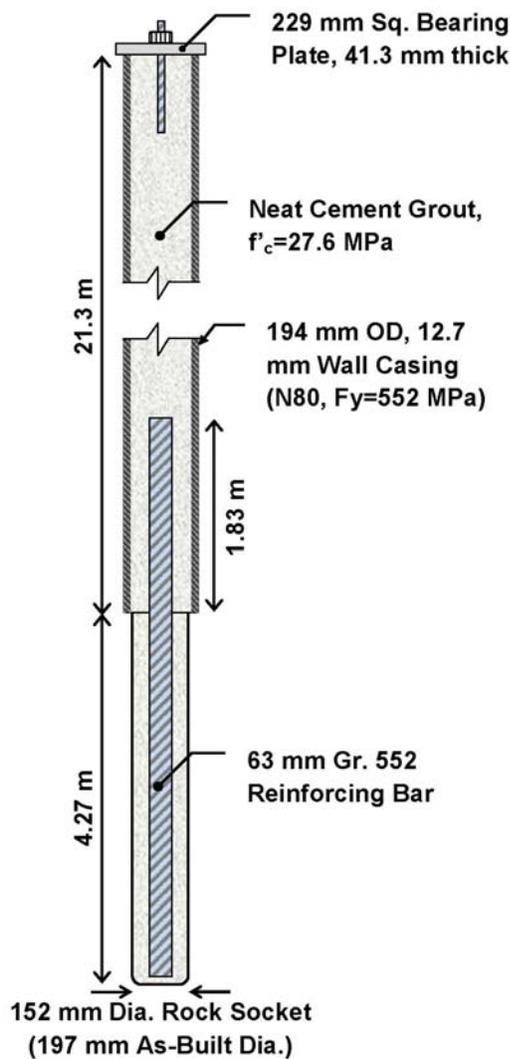
characteristics, the pile geometry was set to allow the structural and geotechnical design of the micropiles to be completed. Figure 3 illustrates a vertical section through the design micropile section. Because of the use of high strength flush joint casing with $F_y=552$ MPa, no centralized reinforcing bar was required for the cased length of the pile except for a 1.83 m development length. For the rock socket, assumed to be 152 mm in minimum diameter, the reinforcing bar was required to be a 63 mm Grade 552 (ASTM A615) threadbar assuming that the design compressive strength f'_c of the neat cement grout was 27.6 MPa. PennDOT's "Micropile LRFD Specification" includes equations and resistance factors for structural and geotechnical Strength Limit resistance of the cased portion and rock socket (uncased length) and is the design specification used for this project. For the micropile cased and uncased zone described above and used in the preliminary design, the Strength Limit resistances of the micropile segments are:

Figure 3. Rock-socketed micropile details

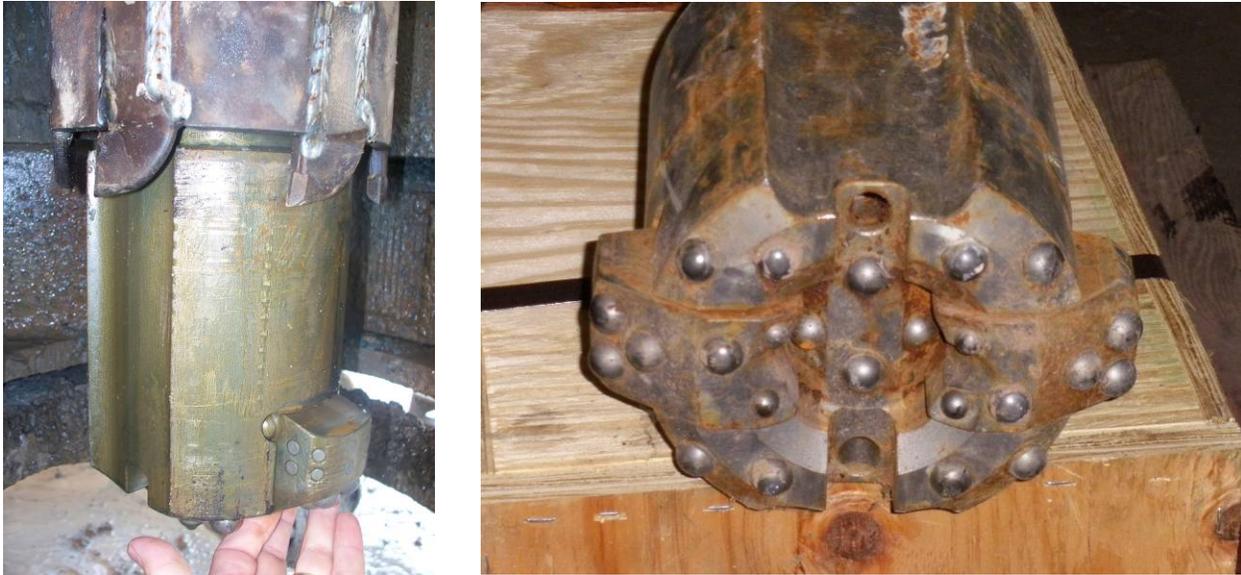
Figure 4. NUMA Superjaws concentric overburden drilling system

system used for this project and matched up to the selected casing size has two wing bits whose expanded diameter was 197 mm. The design consultant had requested that if an overburden drilling system were used that the size be selected to limit the annulus around a micropile and reduce the potential for increased lateral deflection. Furthermore, the use of a drilling system sized to minimize overcut around the casing would provide a tighter seal in the competent rock, lessening the chances of grout loss. The selected drilling system easily penetrated through the soft, broken claystone layers that had caused the problems with the original foundation's capacity.

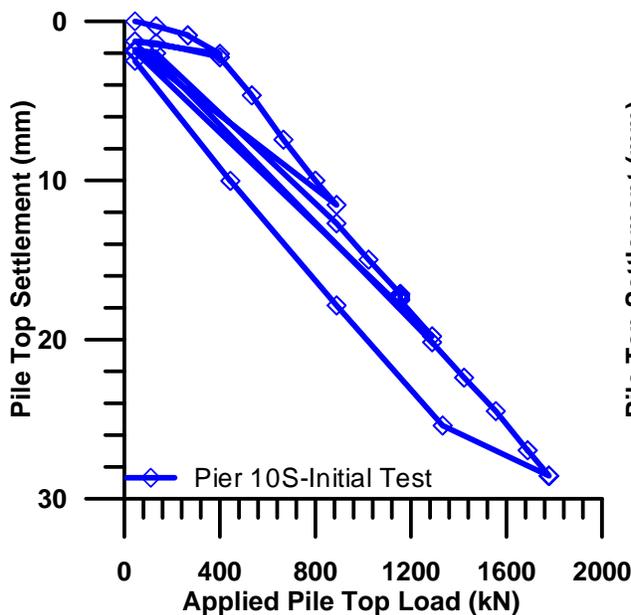
The geotechnical specialty contractor performed a cyclic compression load test on the test pile in November 2008. The load test was conducted to a maximum load of 1,780 kN, twice the design (working) load of 890 kN, in general accordance with PennDOT specifications and ASTM D1143-07 using a quick cyclic loading sequence. Test loads were applied in typical increments of 15% of the design load, with unload-reload cycles initiated at 45%, 100%, 145%, and 200%. The load was maintained for a sixty minute period at 130% of the design load to make an examination of the time-dependent pile settlement (i.e. creep) at an elevated load level. The results of the load test were satisfactory, with measured settlements at design load and test load of 11.5 mm and 28.6 mm, respectively. Upon unloading back to zero load at the completion of the test, the permanent net settlement of the test pile was 2.5 mm, allowing that the gross load-deformation behavior to be classified as pseudo-elastic. A plot of pile top load versus settlement is presented in Figure 5. Further analysis of the load test results will be presented in later sections.

Figure 5. Load-settlement data for initial loading of test pile

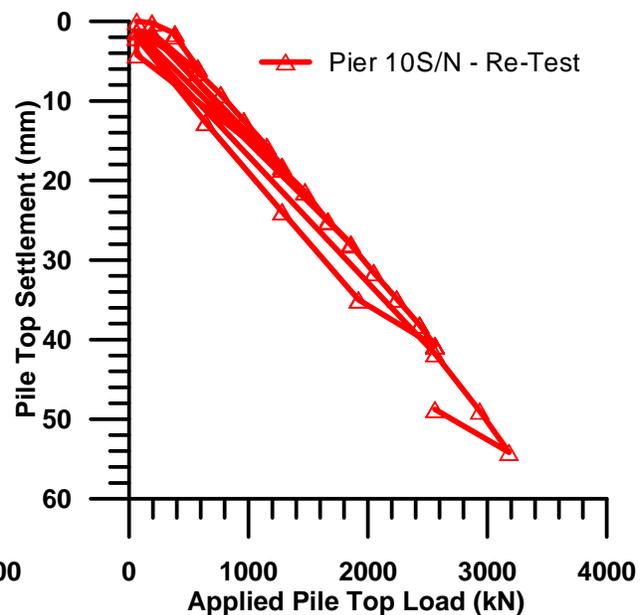
(working) load. A plot of the load test data is included in Figure 6. The results of the re-test verified that the geotechnical and structural capacity and deformation characteristics were still satisfactory under the new, elevated working load of 1,280 kN. At this load level, the pile-top settlement was 18.2 mm. At the 130% load level, a 60 minute maintained load period was monitored to check for creep with less than 0.05 mm of creep movement recorded. At the required maximum test load of 2,560 kN, the vertical deflection was 40.8 mm. After unloading back to an alignment load, the micropile was then monotonically re-loaded up to 3,180 kN, with a maximum measured settlement of 54.2 mm. A net permanent settlement measurement was not made during the final loading cycle up to 3,180 kN, but the permanent settlement after reaching the required maximum test load of 2,560 kN was only 2 mm.

Figure 6. Load-settlement data for re-loading of test pile

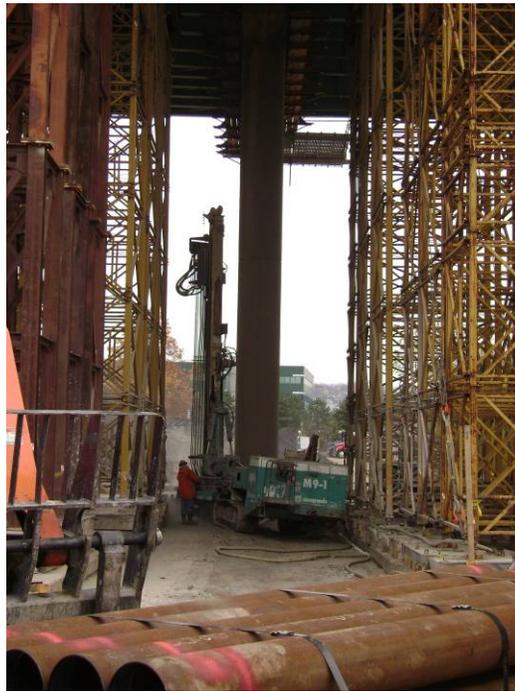
Construction of the thirty three production micropiles involved working within a narrow area while using full-size hydraulic drilling rigs, as shown in Figure 7. While test pile construction and load testing was occurring, the general contractor completed demolition of the Pier 10S substructure and crash wall. The crash wall was demolished down to existing grade leaving only 1.2 m remaining and allowing the specialty contractor full access to the 4.9 m wide work area to begin installation of micropile casings down to the top of the competent rock surface. Conventional air-powered down the hole hammers were used to penetrate from existing grade to the bottom of the existing reinforced concrete pile cap. This drilling system was preferred to penetrate through the moderately reinforced pile cap over a rotary concrete coring system for speed and economy. The presence of a single layer of reinforcement at the bottom of the existing pier pile cap made percussion drilling feasible and ultimately successful. After advancing the 194 mm OD casing through the existing pile cap and crash wall, the inner drill string was switched over to a concentric overburden system to advance down the top of competent rock. Compressed air was the drilling medium used to move drill cuttings to the surface, with water added during the process for dust suppression. The overburden drilling

Figure 7. Casagrande M9-1 hydraulic drilling rig operating within 4.9 wide area at Pier 10S

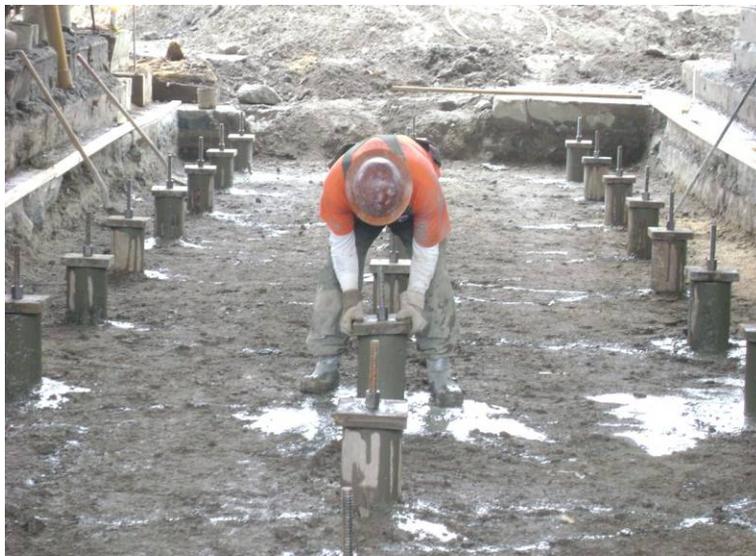
Figure 8. Cutoff micropiles with pile-top connections installed at Pier 10S

Retrofitting of existing structures with micropiles requires special consideration of how to make connections and transfer loads. Due to the substructure damage at Pier 10S and the temporary support of the spans above on shoring towers, the connection of the thirty three micropiles to the new pile cap was simplified. Without tension loads on the piles, a conventional compression connection consisting of a locked-down heavy bearing plate was used. Figure 8 depicts the Pier 10S micropiles just prior to placement of reinforcement and new concrete for the pile cap. The bearing plate on top of each vertical pile consisted of a 228.6 mm square, 41.3 mm thick

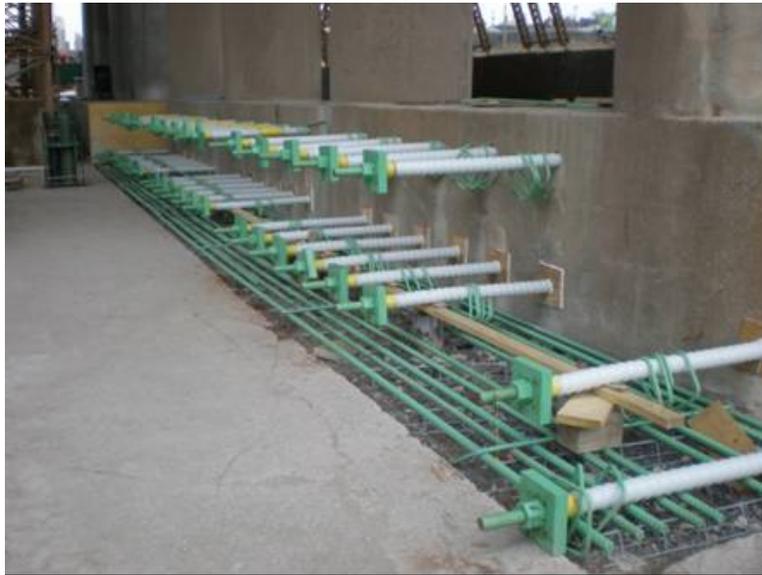
Figure 9. Post-tensioned pile cap (adapted from Splitstone et al, 2010)

The retrofit of Pier 10N depended on making the micropiles integral with a partial pile cap and the existing crash wall, transferring the full loads from the superstructure above. The design consultant initially considered conventional shear dowels, but the installation of nearly 480 mild steel bars would have compromised the integrity of the existing crash wall. In addition, this sort of connection does not provide a high degree of rigidity to the new composite foundation, allowing displacements and degradation patterns not typical of new, complete pile caps. The potential for an open construction joint may have permitted intrusion of moisture, leading to premature degradation. To counteract this situation, the design consultant proposed to use Gr. 1035 post tensioning bars to enhance the shear transfer to the crash wall as shown in Figure 9. The cost of installing larger post-tensioning bars was slightly less than the cost of the mild steel bars, but this solution was thought to provide greater long term serviceability.

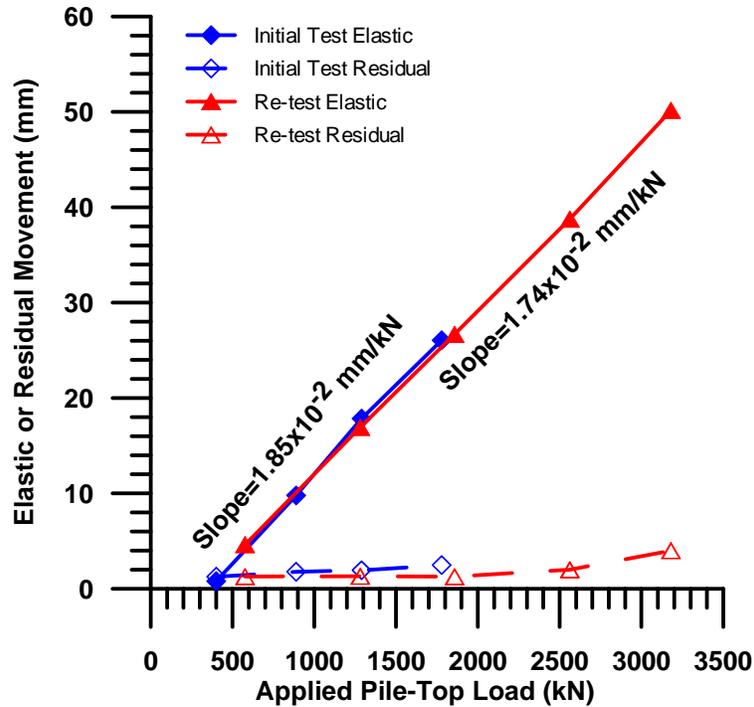
Understanding that the micropile deflection data can be separated into its elastic or recoverable and residual or irrecoverable components provides the pseudo-elastic response under the action of increasing compression load. Figure 10 presents the elastic and residual response curves for the two tests conducted for this project. From each graph it is apparent that the elastic responses contain linear portions within the range of loading to which the piles were subjected. Some slight curvature can be observed in the data sets. Linear regression of the elastic data results in slopes of $k=1.85$ to 1.74×10^{-2} mm/kN, representing the elastic compliance of the micropile. The initial loading cycle appears to have a greater elastic compliance than the re-tested pile, perhaps because of the effects of repeated load cycles on the development of residual loads within the micropile, resulting in “stiffer” loading behavior during the second and subsequent loading cycles. This is contrary to the typical behavior of cyclically loaded deep foundations in soils where hysteretic degradation effect occurs and repeated cycling causes softening of the pile response. Once the number of cycles increases to a significant number (5 or more), Gomez et al (2003) predicts that debonding effects will occur as the rock interface softens, resulting in a decreased stiffness and increased compliance. A slight degree of curvature can be detected for both elastic cycles, but the maximum loading, far from a structural or geotechnical failure, did not allow for any reliable nonlinear trend to be detected. The residual portion of each plot is curvilinear and the residual displacements δ_r are very small, indicating that the majority of the pile’s response is elastic in nature. Again, the re-tested pile demonstrated smaller values of residual displacement than the initial test except as the previous maximum test load was approached and exceeded. Increasing incremental residual displacements, indicating debonding of the rock socket, were observed at the end of the re-test when the pipe-top load exceeded 2,500 kN. The slope of the elastic data is significant in that it is believed to contain the real pseudo-elastic load-deformation behavior for these micropiles in a certain range of loading.

Figure 10. Decomposed cyclic loading and unloading data from Birmingham Bridge initial test and re-test

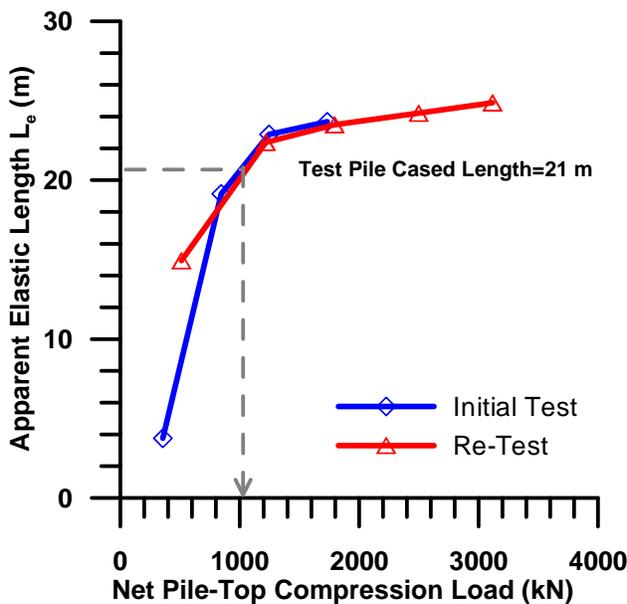
Figure 11. Development of total apparent elastic length L_e

The development of the apparent elastic length is nonlinear as a function of applied pile-top load. From the calculated response of the pile presented in Figure 11, the transition between load transfer from the cased length to overburden and the initial development of load transfer in the rock socket can be seen to occur in the vicinity of an applied load of 1 MN. This is a significant load magnitude considering the frequent and near impossible assumption that no load is shed between casing and the overburden soils. For this project, where the outside diameter of the overburden drilling system is essentially the same as the casing diameter, 194 to 197 mm, there would be significant contact area between soils and weak rock and the casing exterior. As an extension of the overall elastic length concept, the rock socket's apparent elastic length was determined and plotted versus the pile-top load for both testing cycles. Referring to Figure 12, three important observations can be made: the rock socket load transfer is nonlinear, there are behavioral differences in the initial versus re-test loading, and it appears that there may have been some load development toward the bottom of the rock socket at the maximum sustained load of 3.18 MN. The estimated load transfer in the cased length and rock socket will be discussed below in further detail. Gomez et al (2003) found in cyclically loading a rock-socketed micropile that with added hysteretic loading the apparent elastic length appeared to increase, with significant increases appearing after 5 cycles. The computed elastic length in the rock socket at the conclusion of the test approached 4 m, close to the bottom of the test pile's rock socket. While the apparent elastic length concept cannot predict the actual development of end-bearing conditions, it can signal that an elastic interaction front between pile and the rock mass is approaching the rock mass beneath the pile tip.

this piece of information, and the “soft” nature of the load versus effective length relationship in Figure 11, it can be presumed that the load began to transfer to the top of the rock socket near or after this pile-top load. An average load transfer rate from the pile casing to the overburden soils and weak rock can be estimated as 44 kN/m, equating to a mobilized uniform bond shear stress τ_{mob} of 72 kPa. This may not represent a true ultimate bond stress τ_{ult} because the overall deflection near the top of the rock socket is not sufficient to permit the entire cased length to experience relative pile to soil movement needed to develop interface failure conditions. It is notable that, contrary to assumptions made to simplify load test data, there is real, measurable load transfer from cased length to the surrounding ground. In the case of this project, the calculated load transfer is nearly enough to sustain the entire pile design (working) axial load or Strength Limit load.

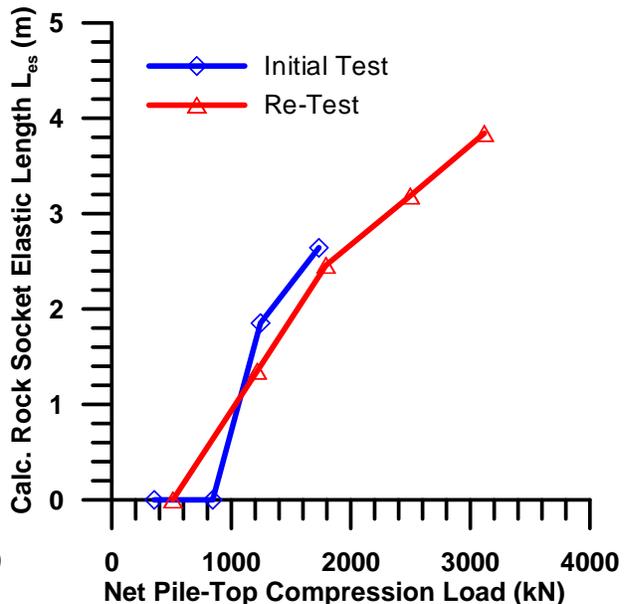
Figure 12. Development of apparent elastic length L_{er} in the rock socket

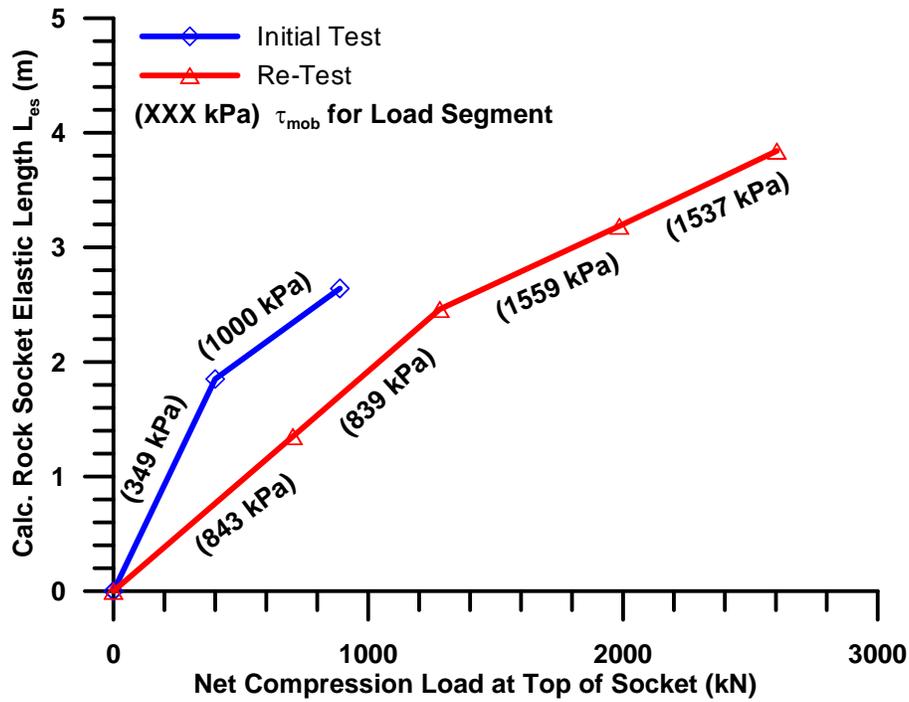
The patterns of load transfer revealed in this pseudo-elastic analysis, in Figure 13 and Table 3 demonstrate that a transition in socket behavior occurs during the loading process. For the initial load test, load begins to develop in the rock socket beyond a net pile-top load of about 850 kN, with a transition in apparent load transfer occurring at a total test load of 1,244 kN. Based on the calculated socket elastic length of 2.64 at the conclusion of the initial test, the increase in load transfer is meaningful because it corresponds to the beginning of the micropile interaction with the stiffer, higher RQD rock near and below Elev. 202. On reloading the micropile for the subsequent re-test, the load rapidly transfers through the overburden to the rock socket, followed by a transition to a stiffer response at a pile top load of about 1,800 kN, very similar to the maximum test load of the original test. The elastic length to which this load level corresponds indicates the mobilized bond length is in or very near to the more competent, unweathered sandy siltstone making up the lower portion of the rock socket. Based on these observations, it can be seen that graphical depictions of L_e in the rock socket can denote changes in load transfer rate which can be related to changes in rock mass characteristics.

Figure 13. Incremental load transfer behavior of rock socket
