## **Emergency Micropile Repair of the Birmingham Bridge**

International Society for Micropiles  
10<sup>th</sup> International Workshop  
Washington, D.C.  
September 23, 2010

Terence P. Holman, Ph.D., P.E.

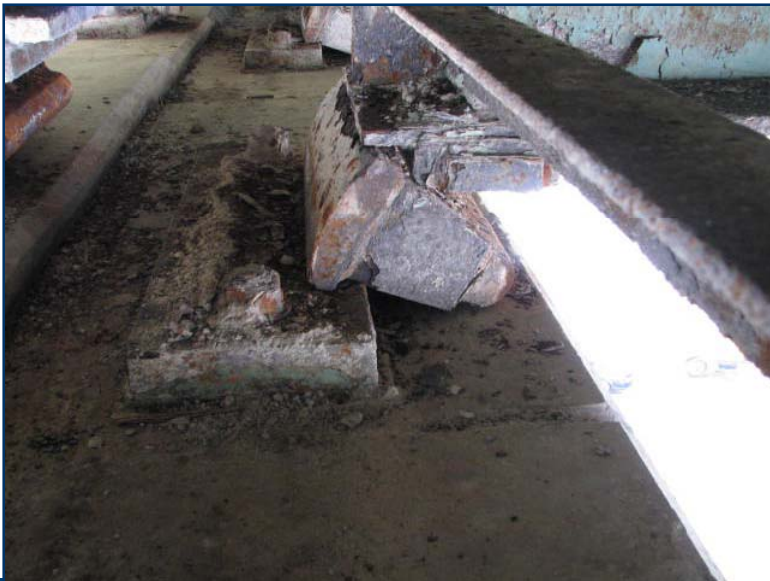
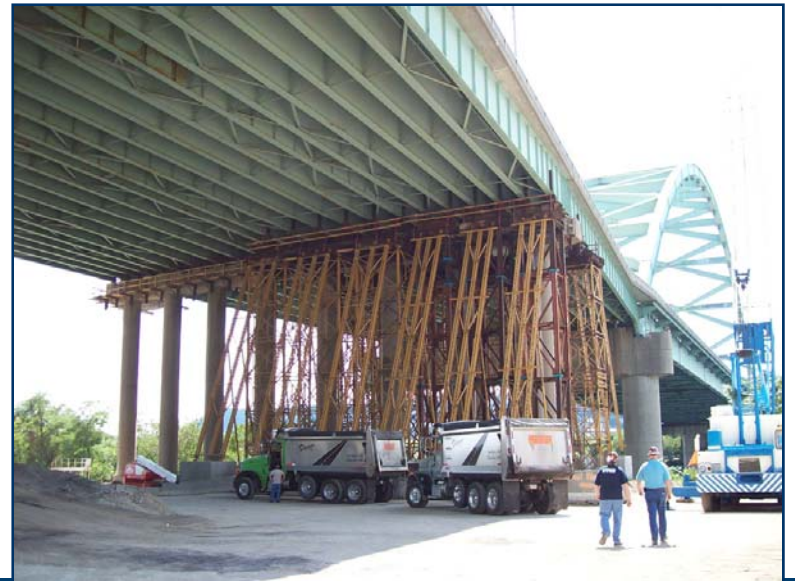
- Birmingham Bridge is critical link in Pittsburgh area transportation system, built in early 1970s
- Pier 10S dropped 200 mm on 2/8/2008
  - Bearings over-rotated, pier columns cracked
  - Emergency shoring operation

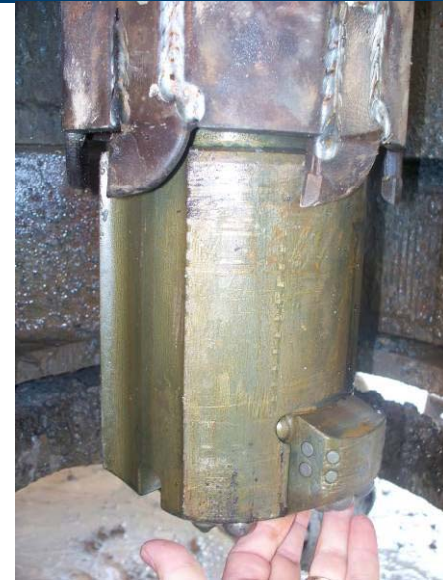
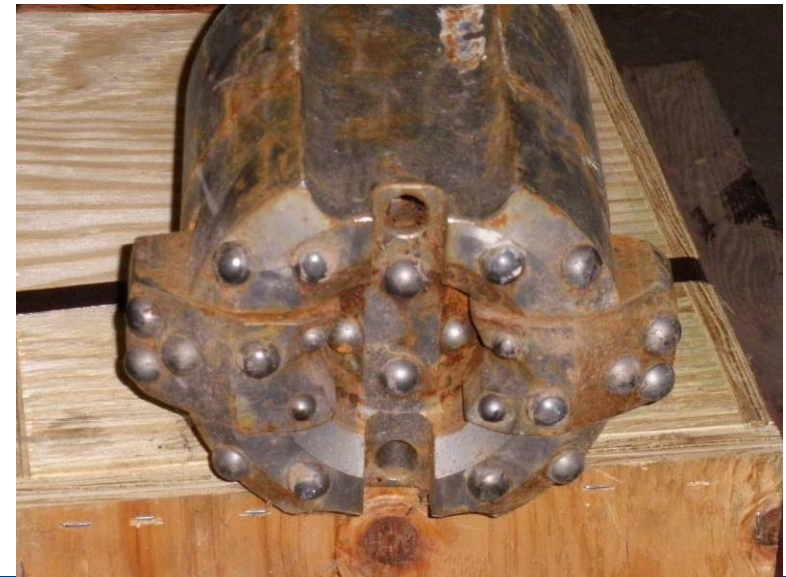
- Sacrificial test pile and anchors
- Test pile installed using concentric overburden system
  - Rock socket diameter incr. to 197 mm
  - Cased length 22.8 m, 4.9 m bond length

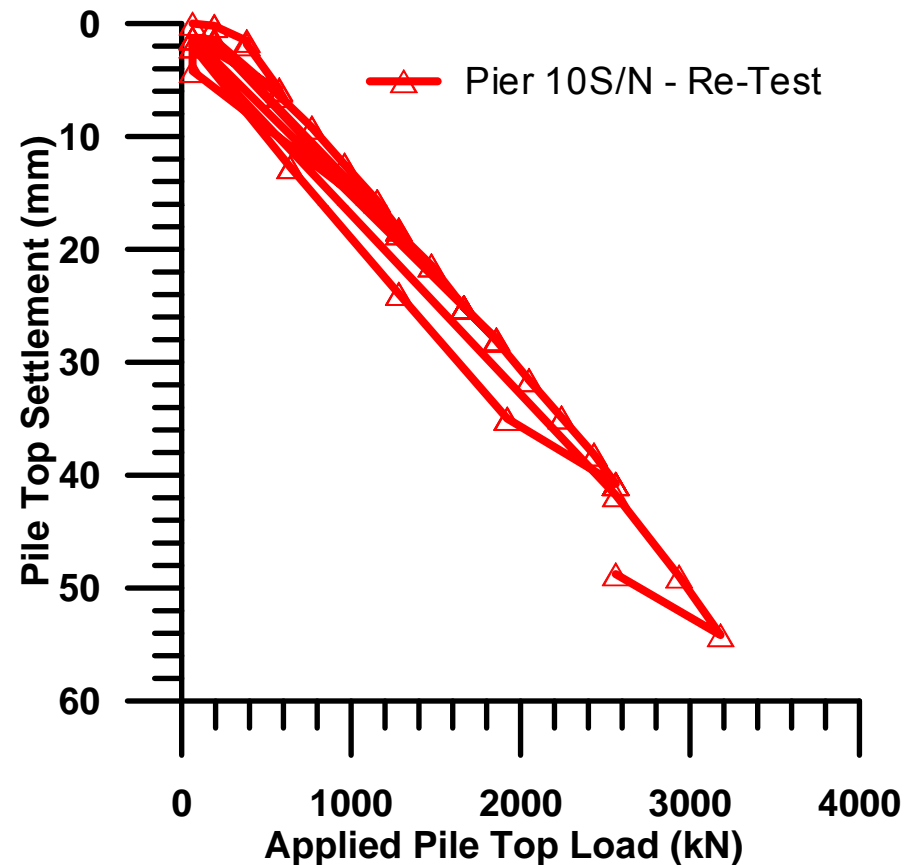
- Re-test of original test pile to substantiate higher design load of 1,280 kN for Pier 10N with intention to test to failure
  - Max. test load 3,180 kN
  - Total settlement 18 mm at DL, 54 mm at TL, approx. 3 mm residual.

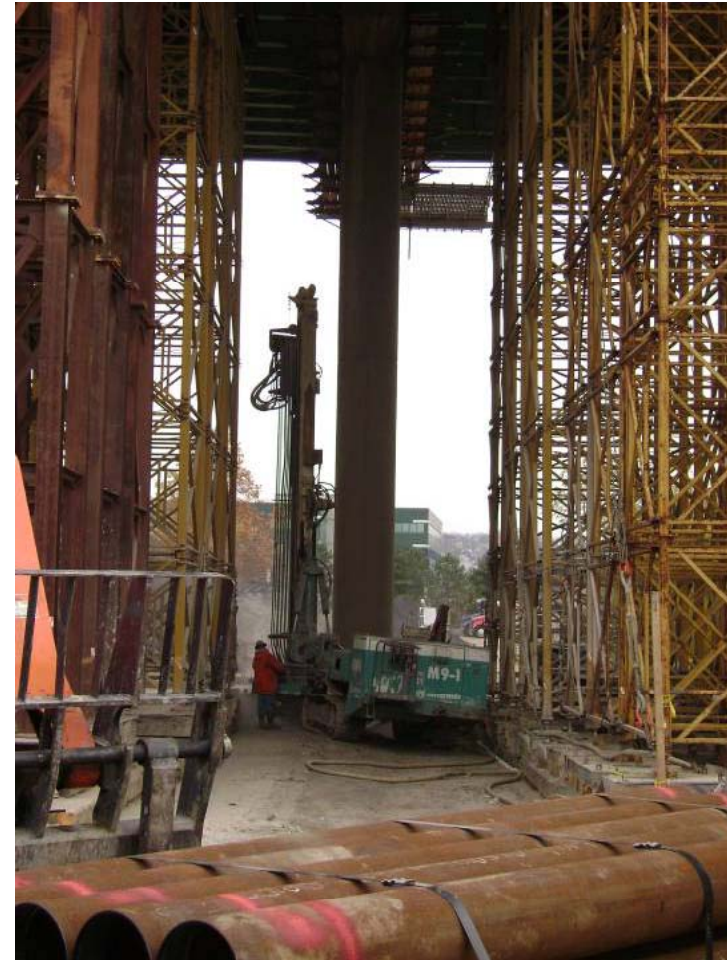
- Began work at Pier 10S pre-drilling through existing pile cap
  - DTHs, overburden systems
  - Only single layer of reinforcement at cap bottom
- Average total pile length of 25.6 m

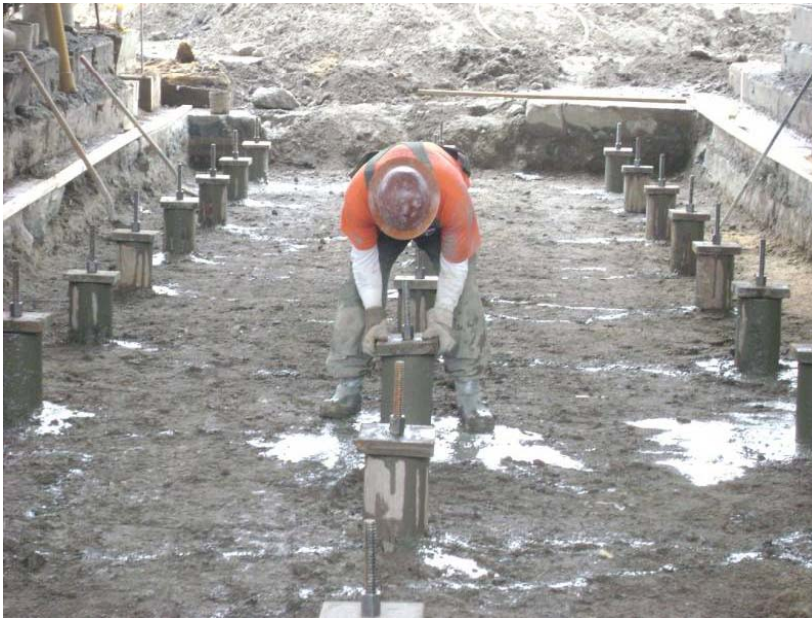
- Pier 10S → conventional bearing plate connections

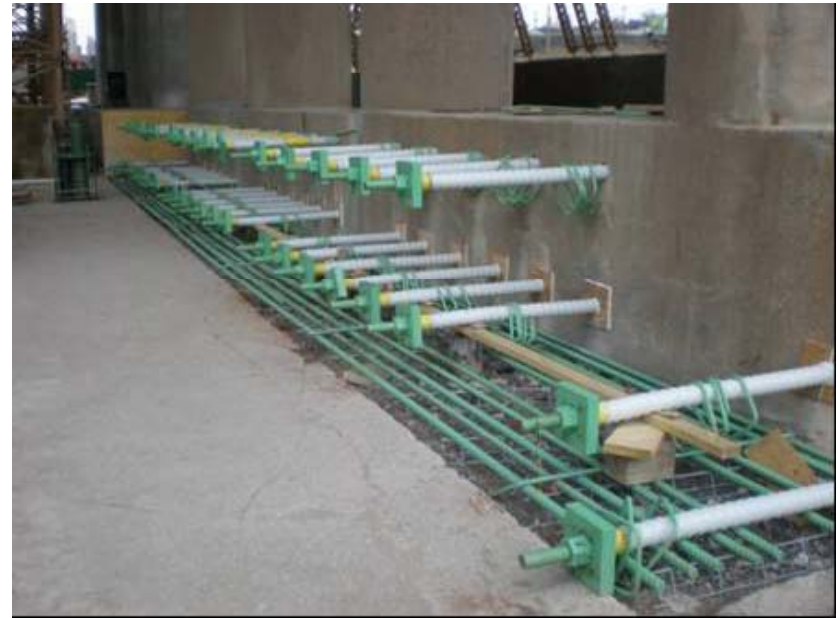
- Pier 10N → Need to tie micropiles into existing cap and crash wall with post-tensioning bars

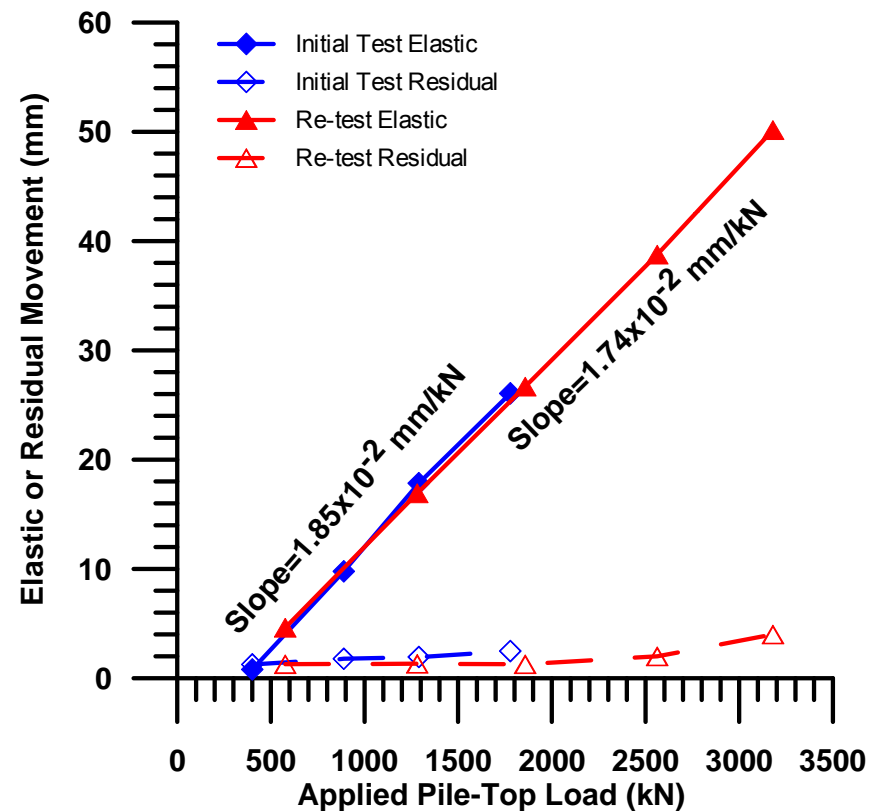
- Cyclic load tests offer opportunity to examine pseudo-elastic behaviors
  - Separated elastic and residual displacement
  - Apparent elastic length of total pile and in rock socket
  - Incremental load transfer behavior

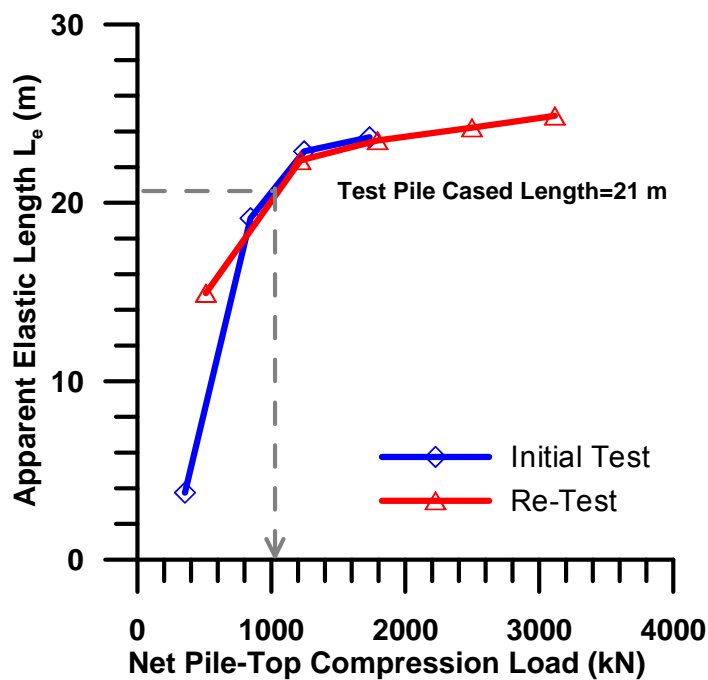
- Total elastic length calculated using net applied load, assumed constant  $E_p A_p$
- Decomposition possible to separate rock socket behavior

Development of total apparent elastic length  $L_e$

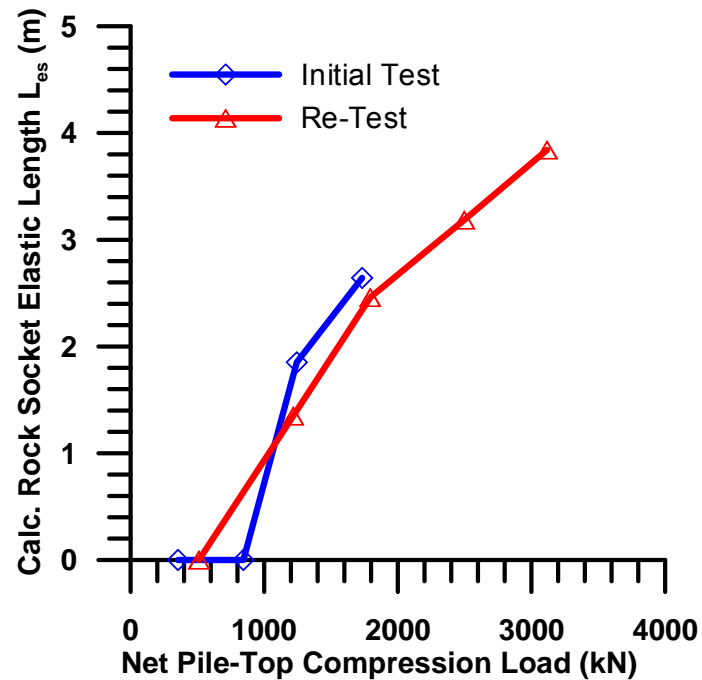
Development of apparent elastic length  $L_{er}$  in the rock socket

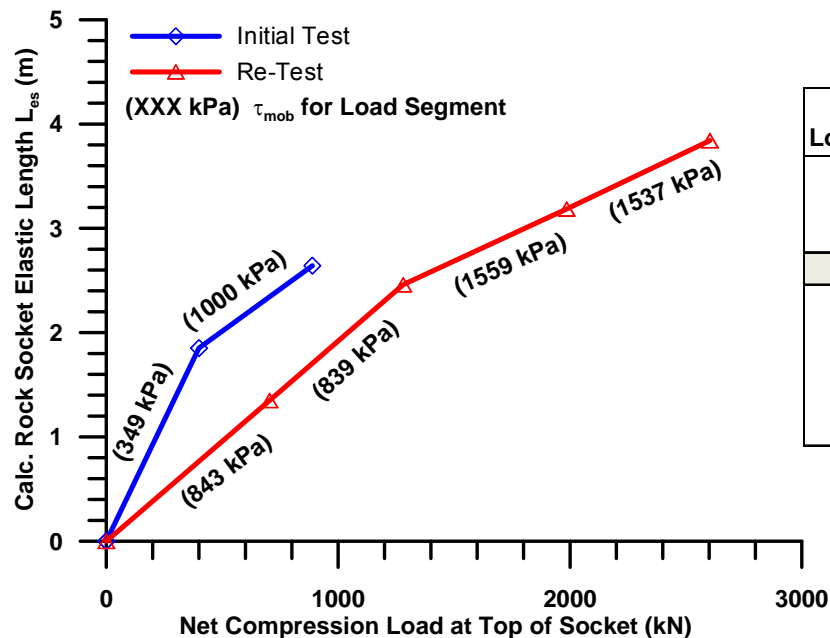
- Apparent elastic length data can be used to estimate mobilized uniform bond stress within rock socket
- Note that  $L_e$  did not approach cased pile length until net load of 844 kN applied
  - Very significant load was transferred from casing to surrounding soils (up to  $\frac{1}{4}$ )

Load Cycle	Net Pile Top Load (kN)	Net Load at Top of Socket (kN)	Calc. $L_{es}$ (m)	Calc. LTR (kN/m)	Calc. Ave. $\tau_{mob}$ (kPa)
Initial	844.3	0.0	0.00	-	-
	1244.3	399.9	1.85	216	349
	1733.1	888.8	2.64	336	543
Re-Test	512.4	0.0	0.00	-	-
	1217.0	704.6	1.35	522	843
	1793.5	1281.1	2.46	521	841
	2498.1	1985.7	3.19	623	1007
	3116.4	2604.0	3.84	678	1095
