MALCOLM DRILLING COMPANY INC.

**SEISMIC RETROFIT OF AN
UNDERGROUND RESERVOIR**

SAN FRANCISCO, CA

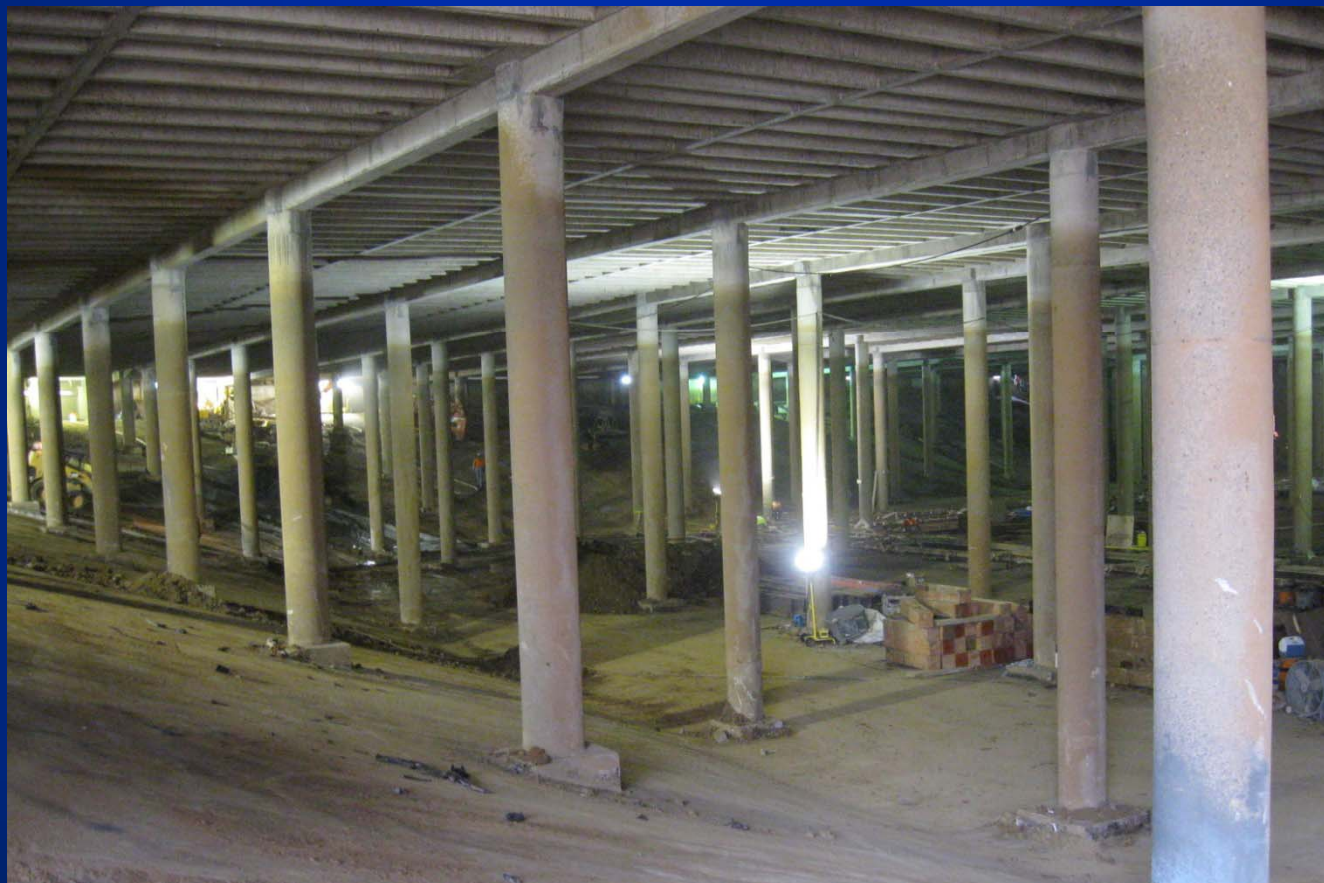
- Primary concern during seismic event was structural:
 - Reservoir Roof and Supporting columns
- Embankment fills evaluated but ground improvement not required.

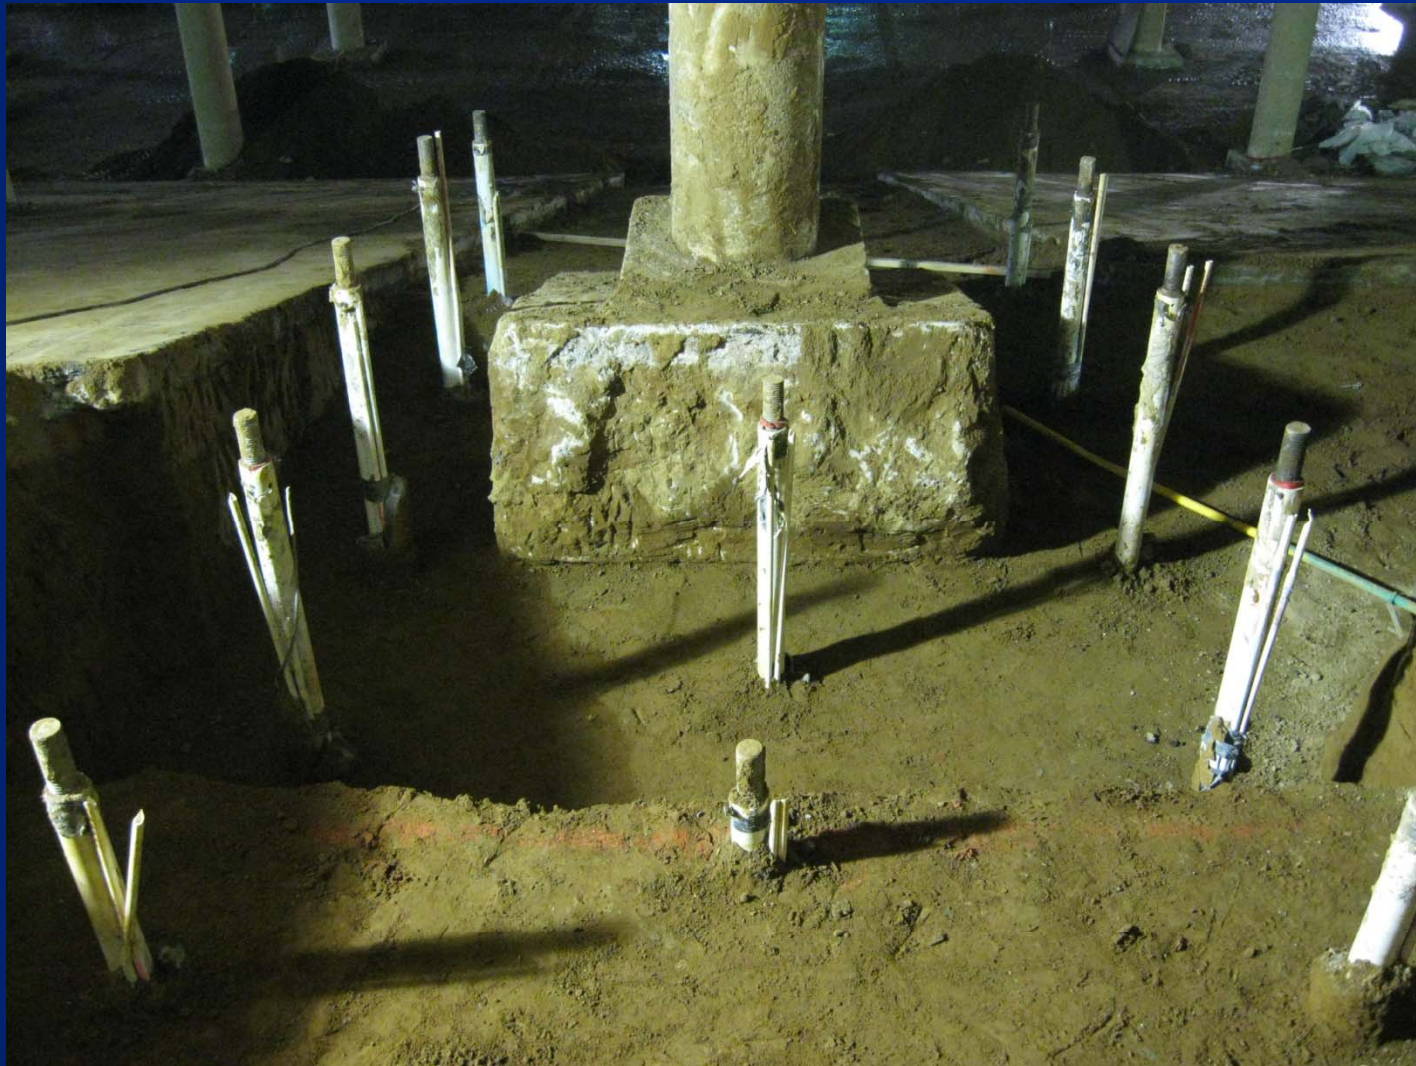
Pile Cluster at Columns, Stepped Pile Cap matches slope

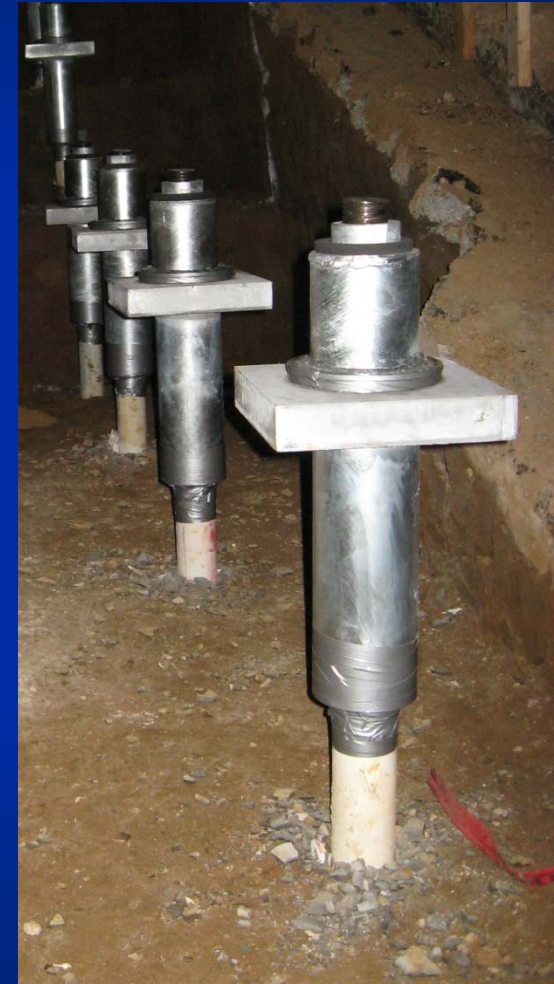
- Bond lengths
 - 9 M – Franciscan formation
 - 12 M – Colma sands
- Unbonded lengths
 - 3 M – dense native soils
 - 5 M – embankment fills
- Developed detailed schedules to minimize pile lengths

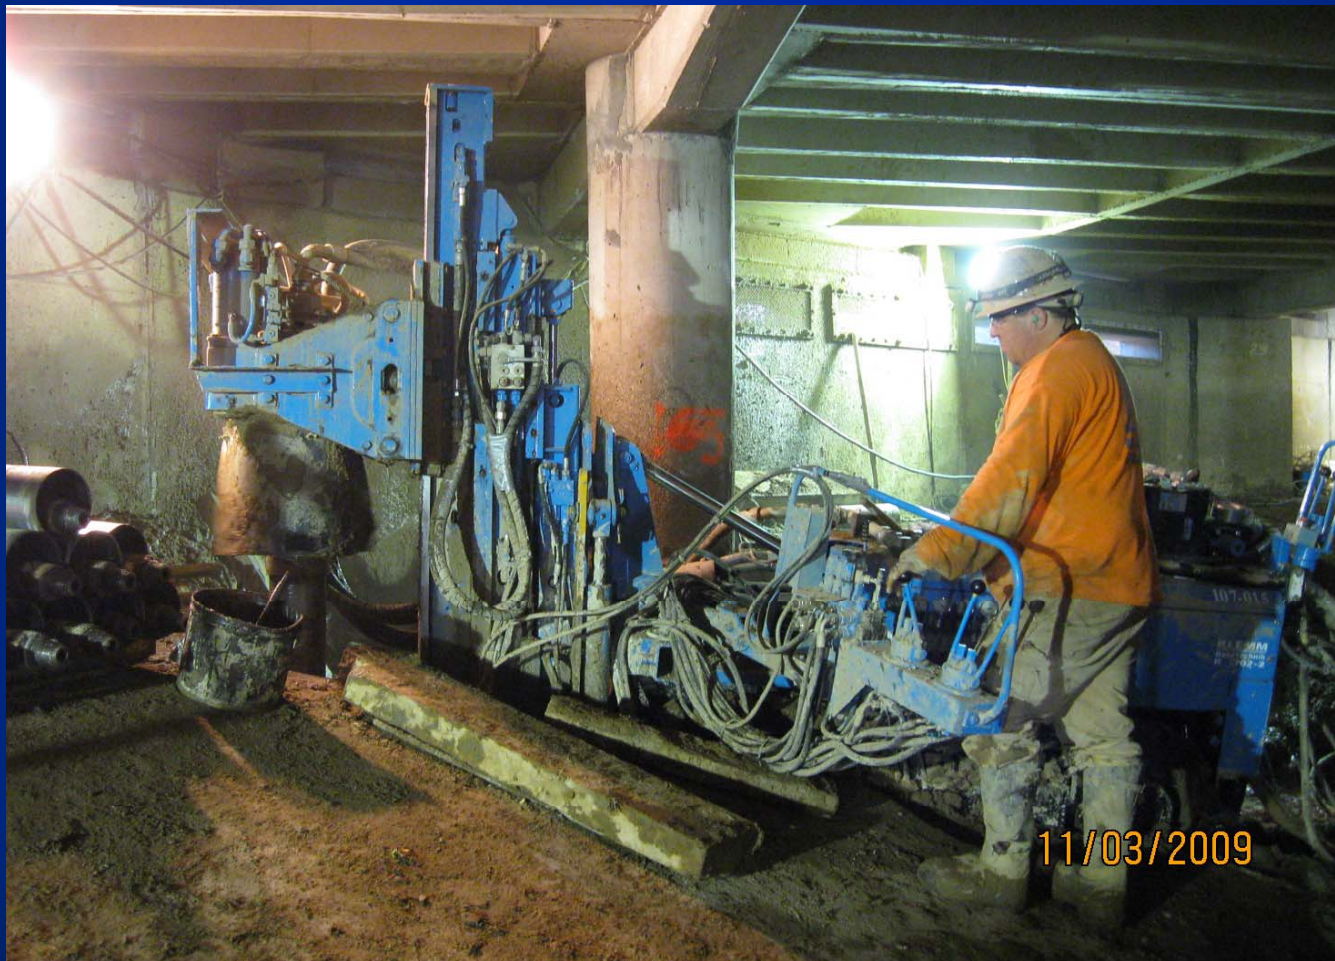
- Low overhead clearances (range from 2.3 M to 8.5 M)

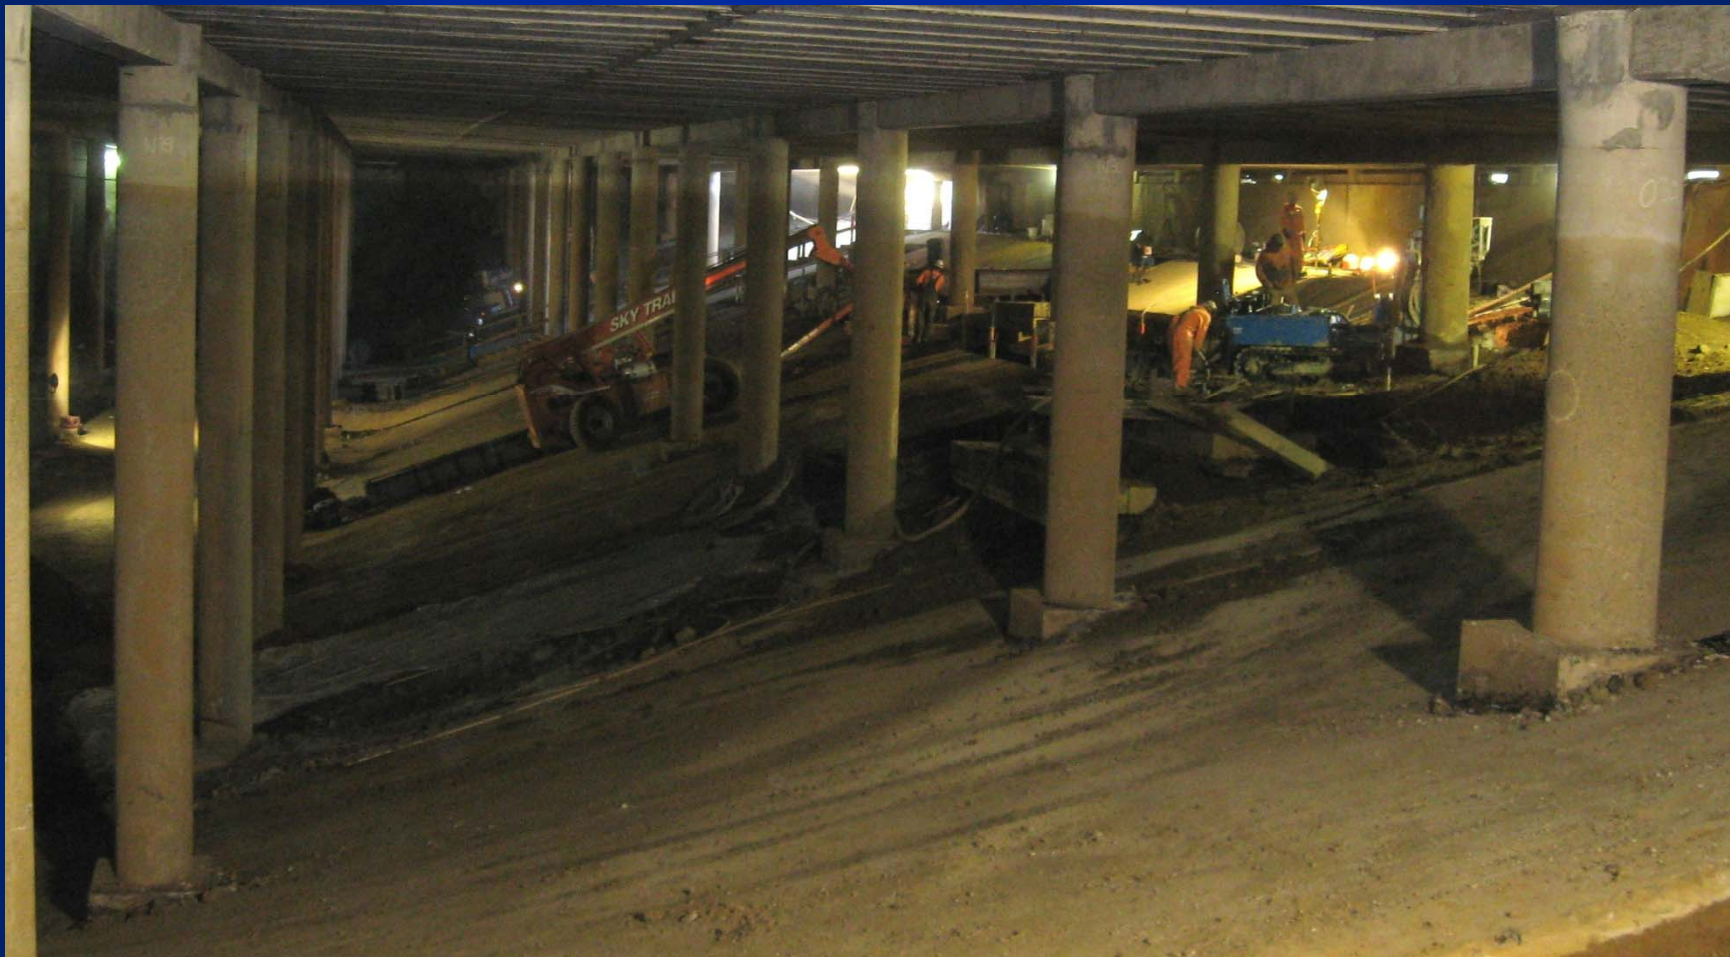
- Pile caps located on a 3:1 slope (18°)

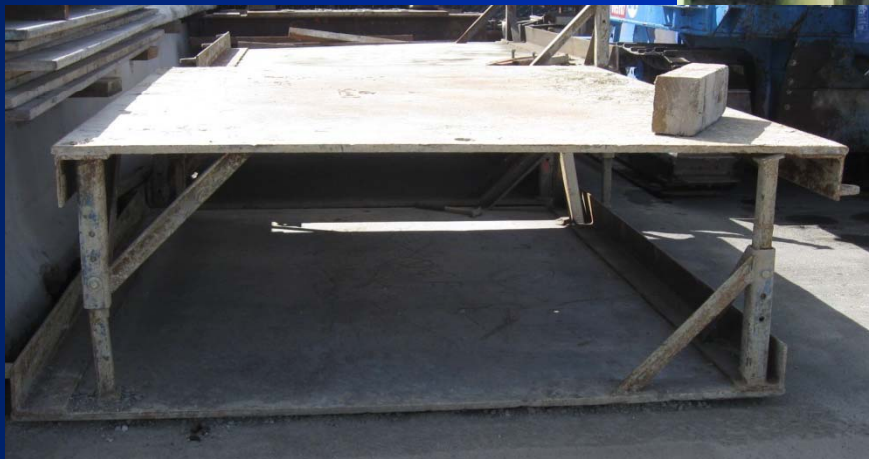
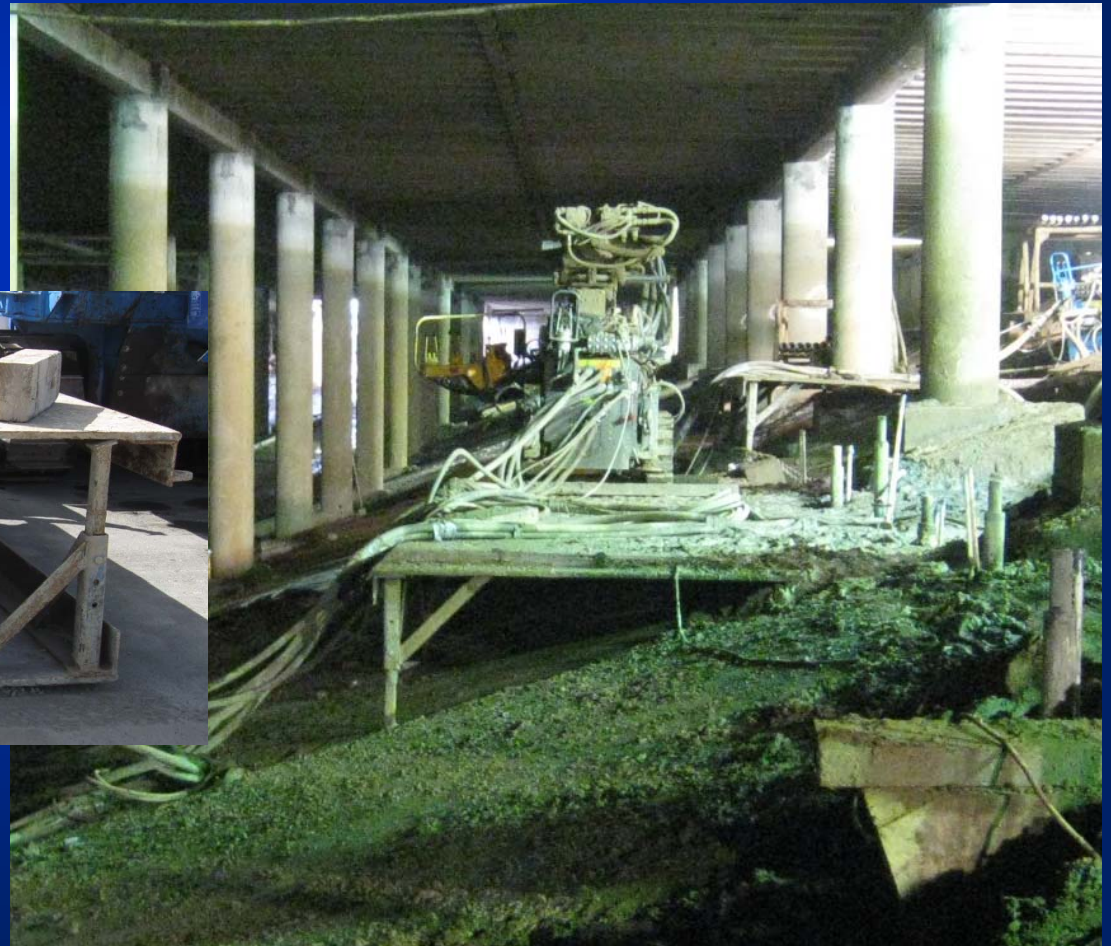
- Fabricated adjustable drilling platforms

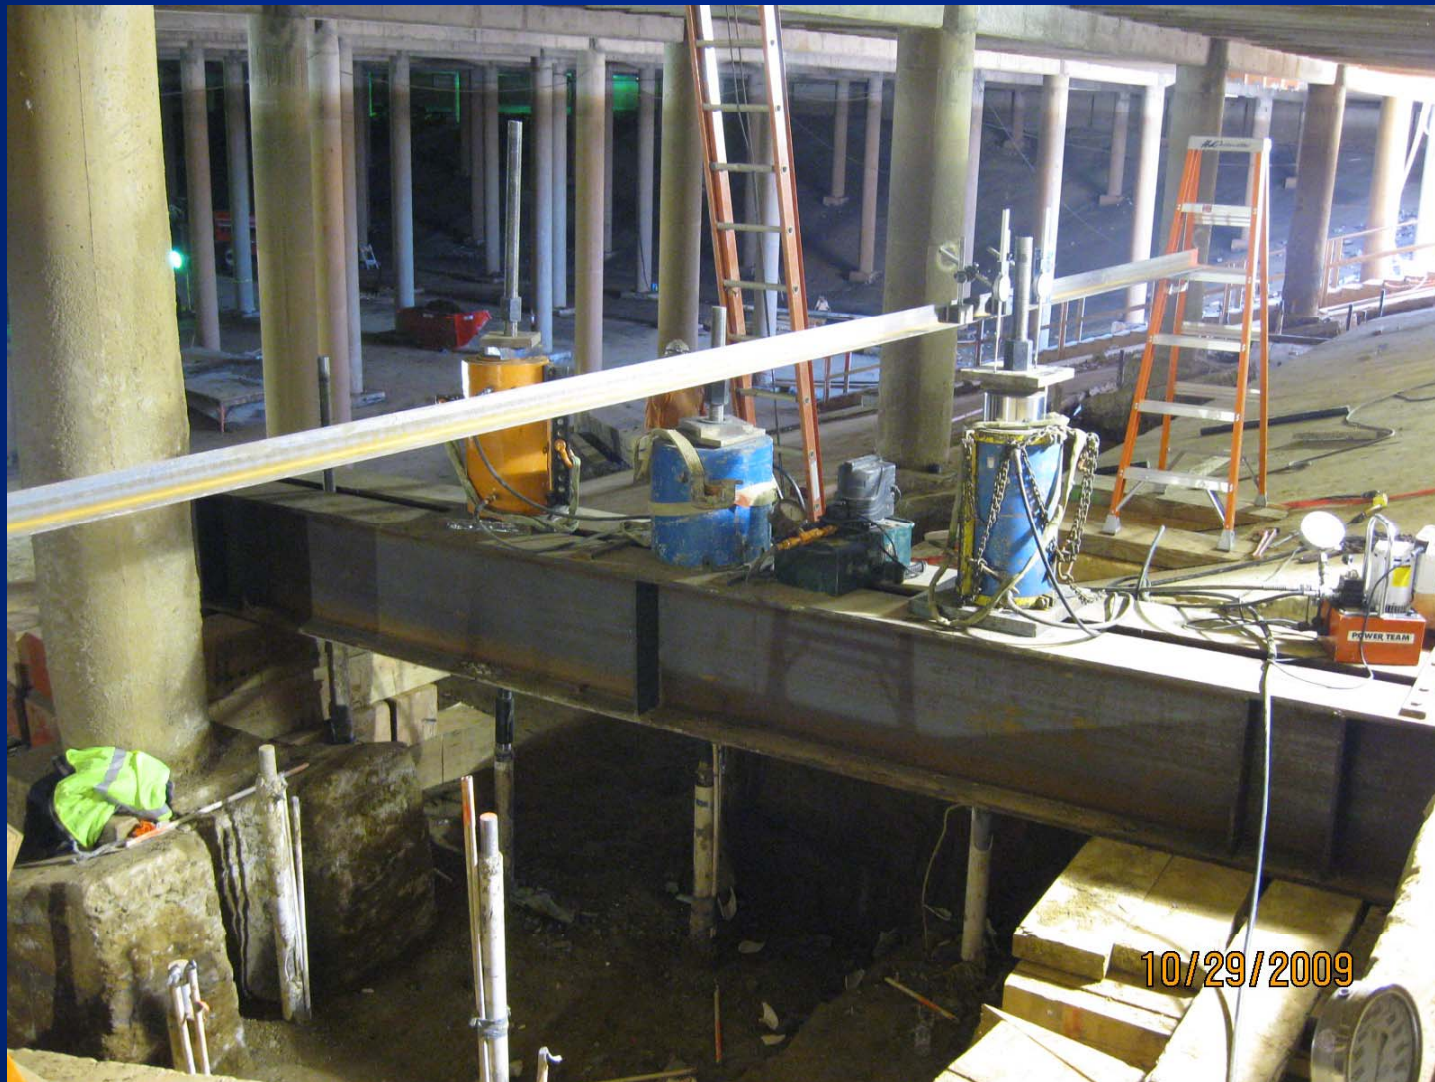
Multiple setup configurations – 100% of piles tested

- 100% testing of all installed micropiles
- Tension test to 1780 KN
- No load into existing columns and footings
- 5% performance tested
- 1 extended creep test

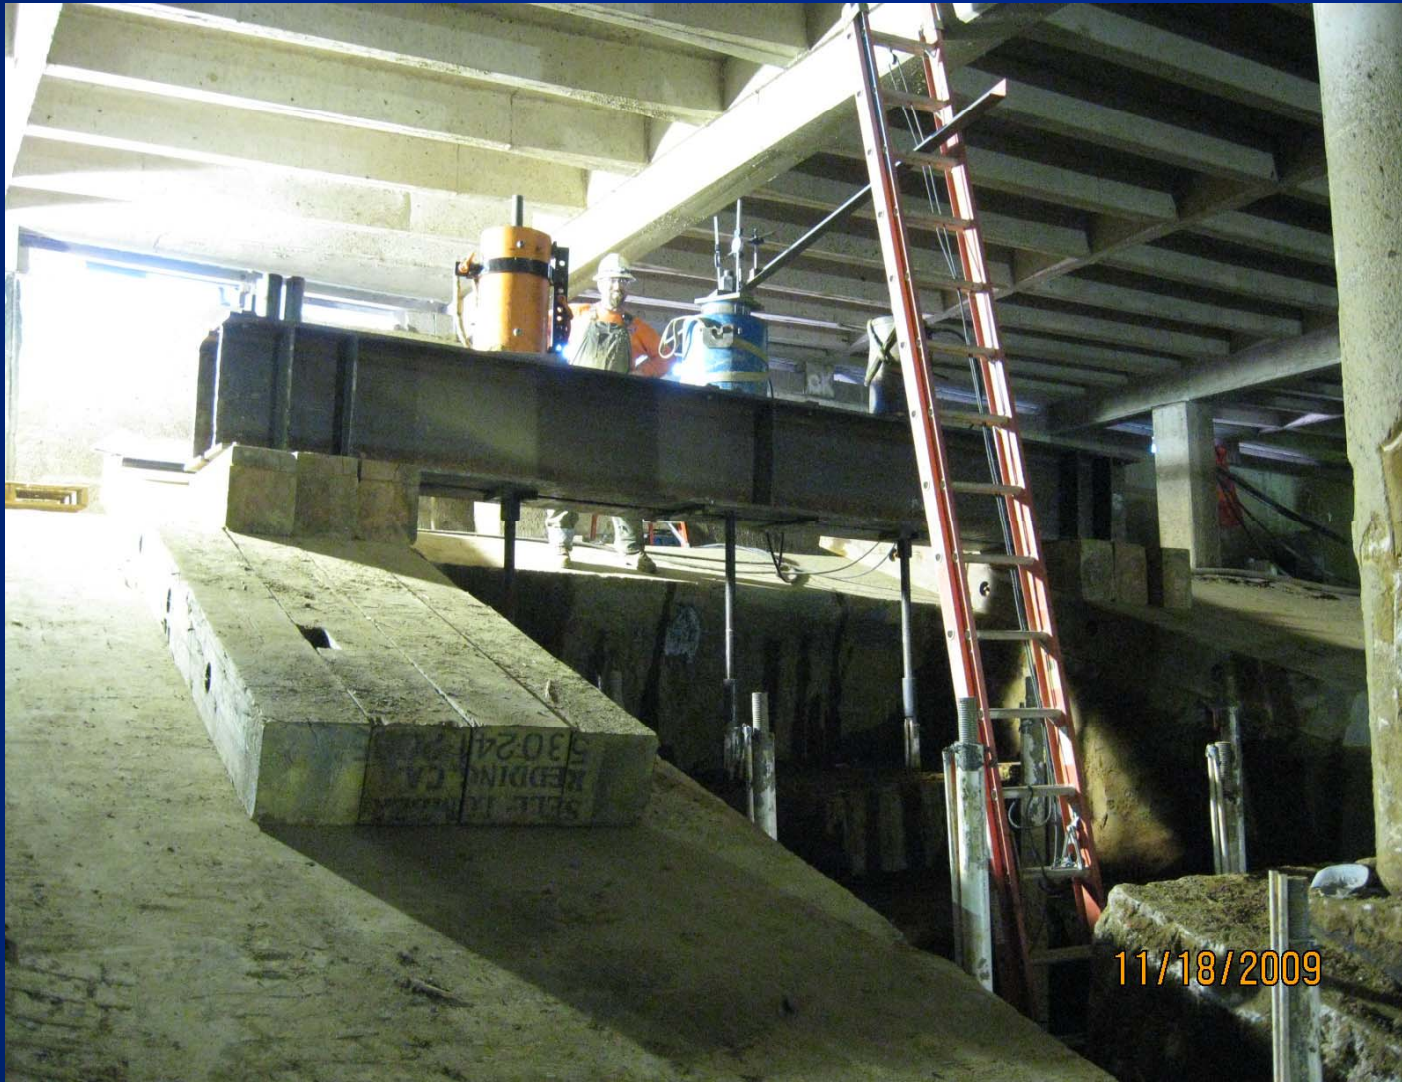
Multiple setup configurations – 100% of piles tested

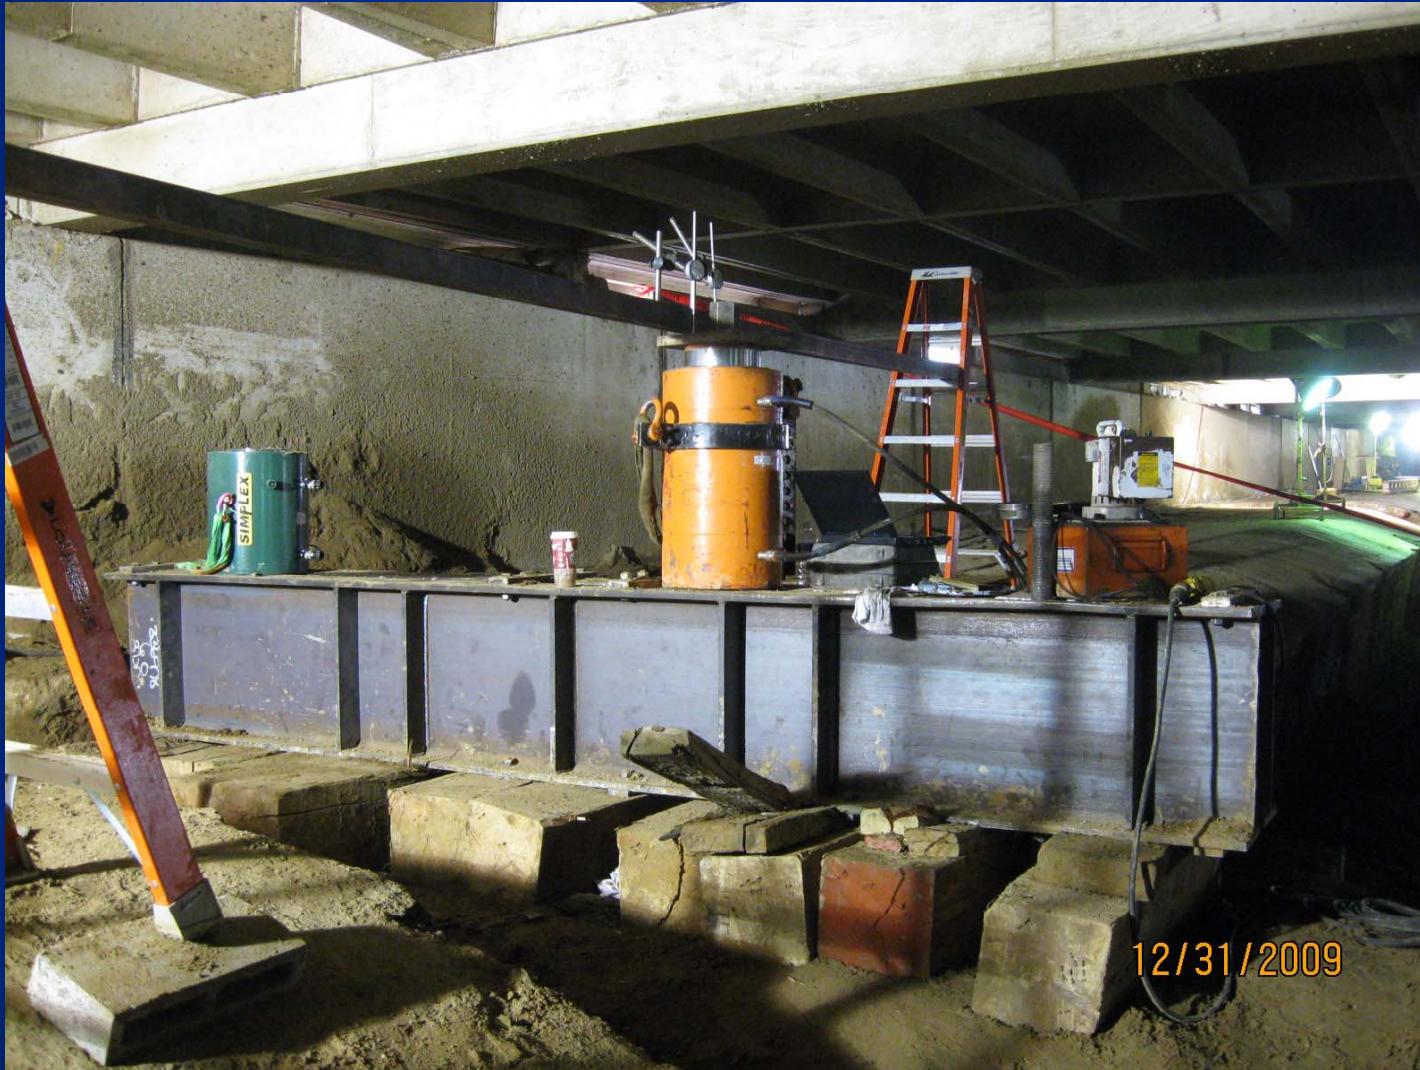
Multiple setup configurations – 100% of piles tested

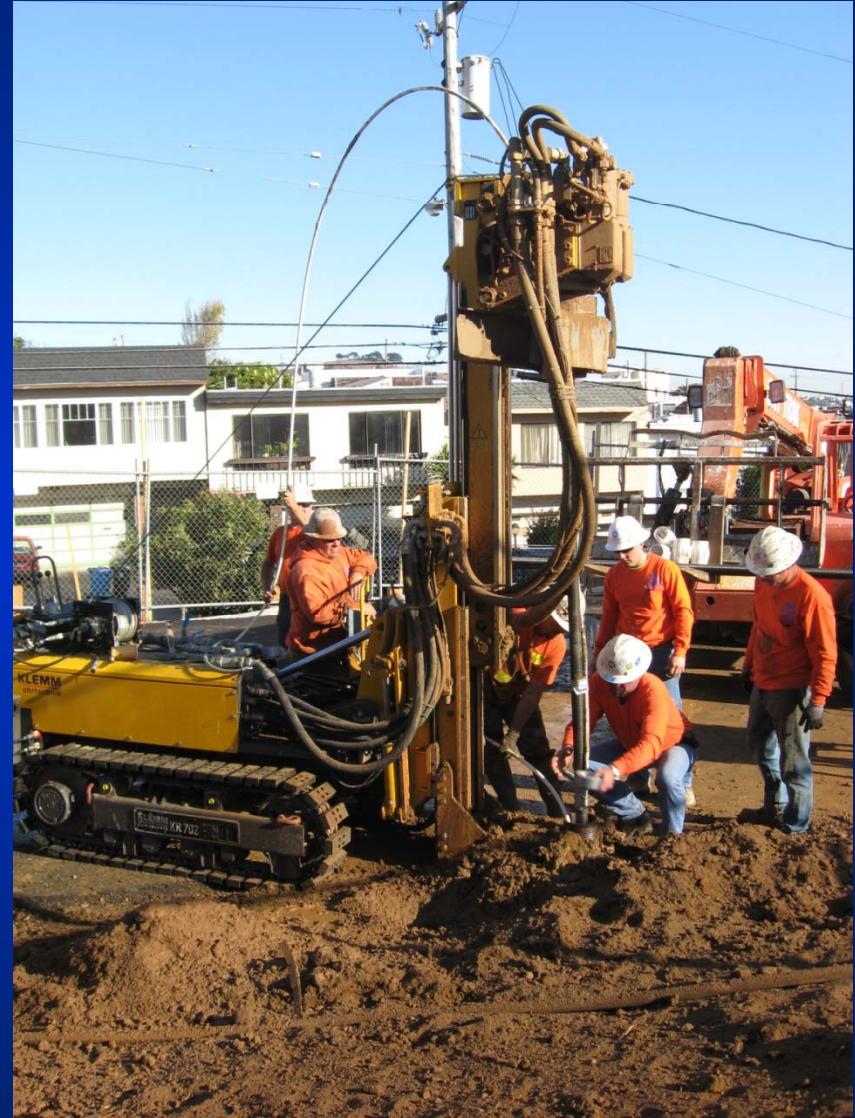
- Installed at contractor's option
- Only 1 location available
- Confirm selected drilling methods
- Verified assumed geotechnical load transfer

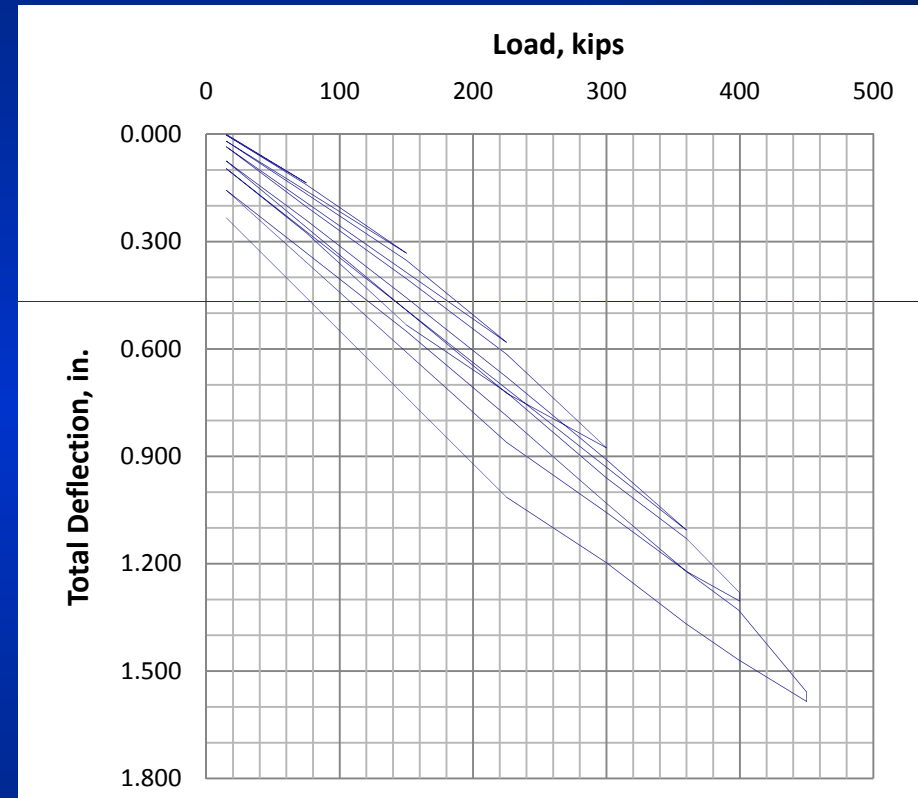
- Bond Length = 12 M
- Unbonded Length = 4.5 M
- Jacking Length = 2.3 M
- $5.9\text{M} < L_a \text{ (spec)} < 12.9 \text{ M}$

- $L_a = 8.4 \text{ M}$ at 1780 kN
- $L_a = 8.8 \text{ M}$ at 2000 kN
- Max creep = 0.6 mm at 10 min hold

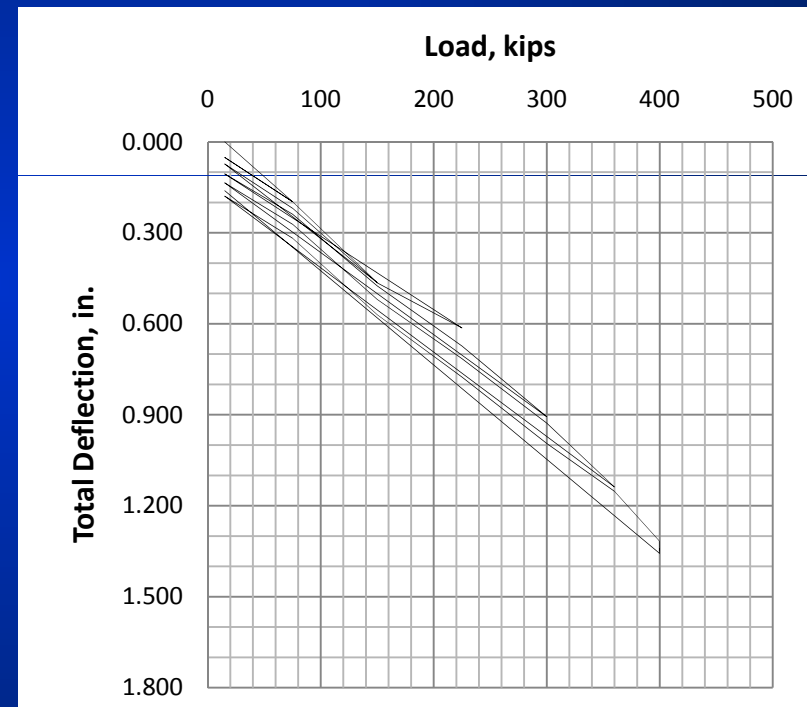
#9-32 Pile

- Franciscan rock

- Similar pile performance behavior
- Elastic behavior

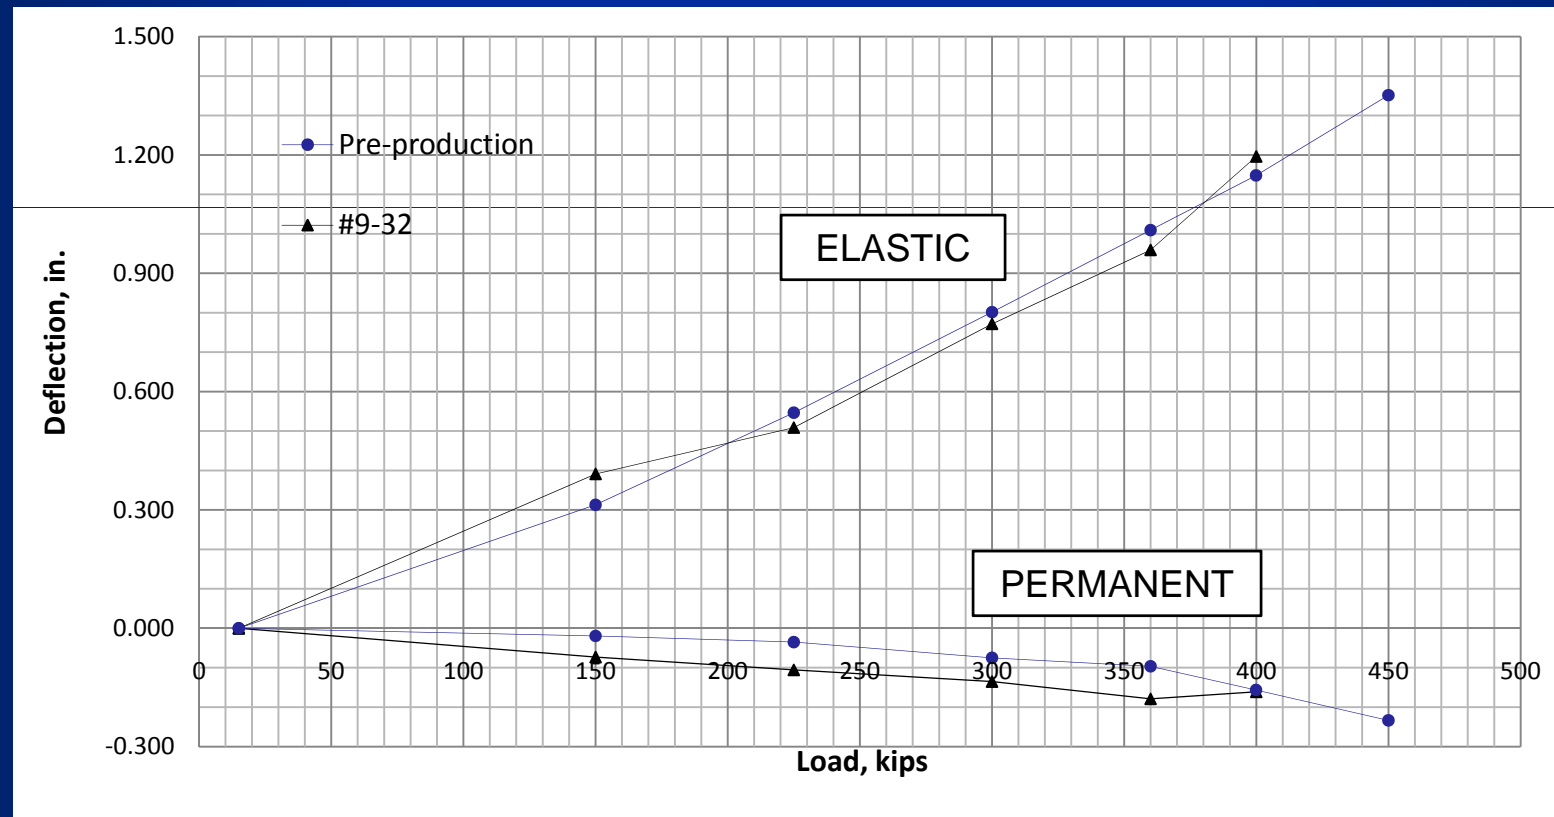
Correlation of Pre-Production to Production Performance Tests

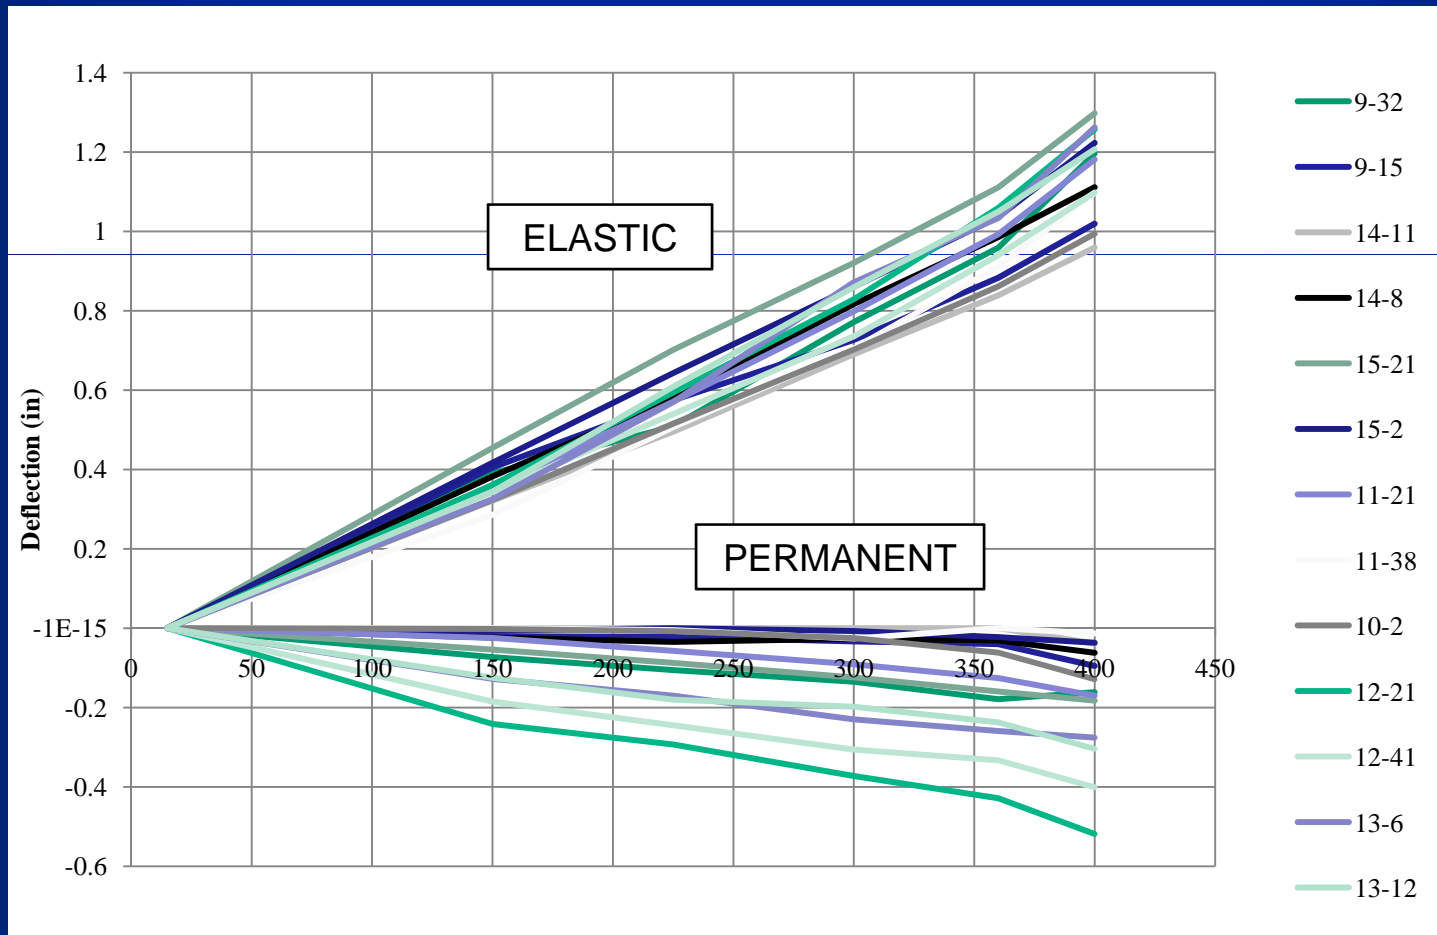
Elastic vs. Permanent

- Total deflection increases south to north
- Relatively uniform elastic elongation of piles
- Greater permanent set in piles at north end (zone +/- 500ft)
- More deflection to mobilize bond in Colma vs. Franciscan

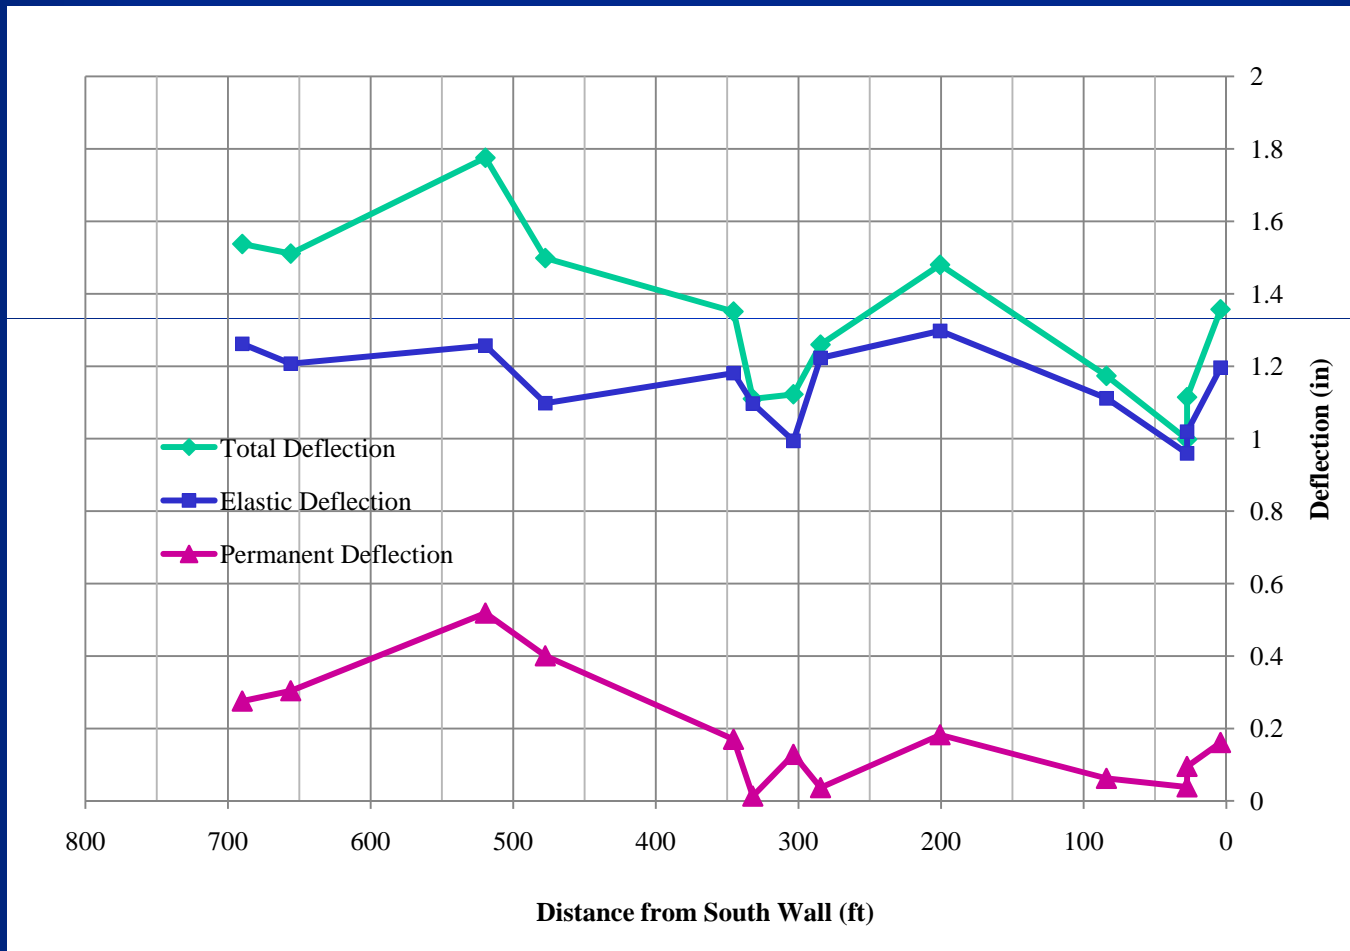
Distance from South Wall

Colma Sands

Franciscan Formation

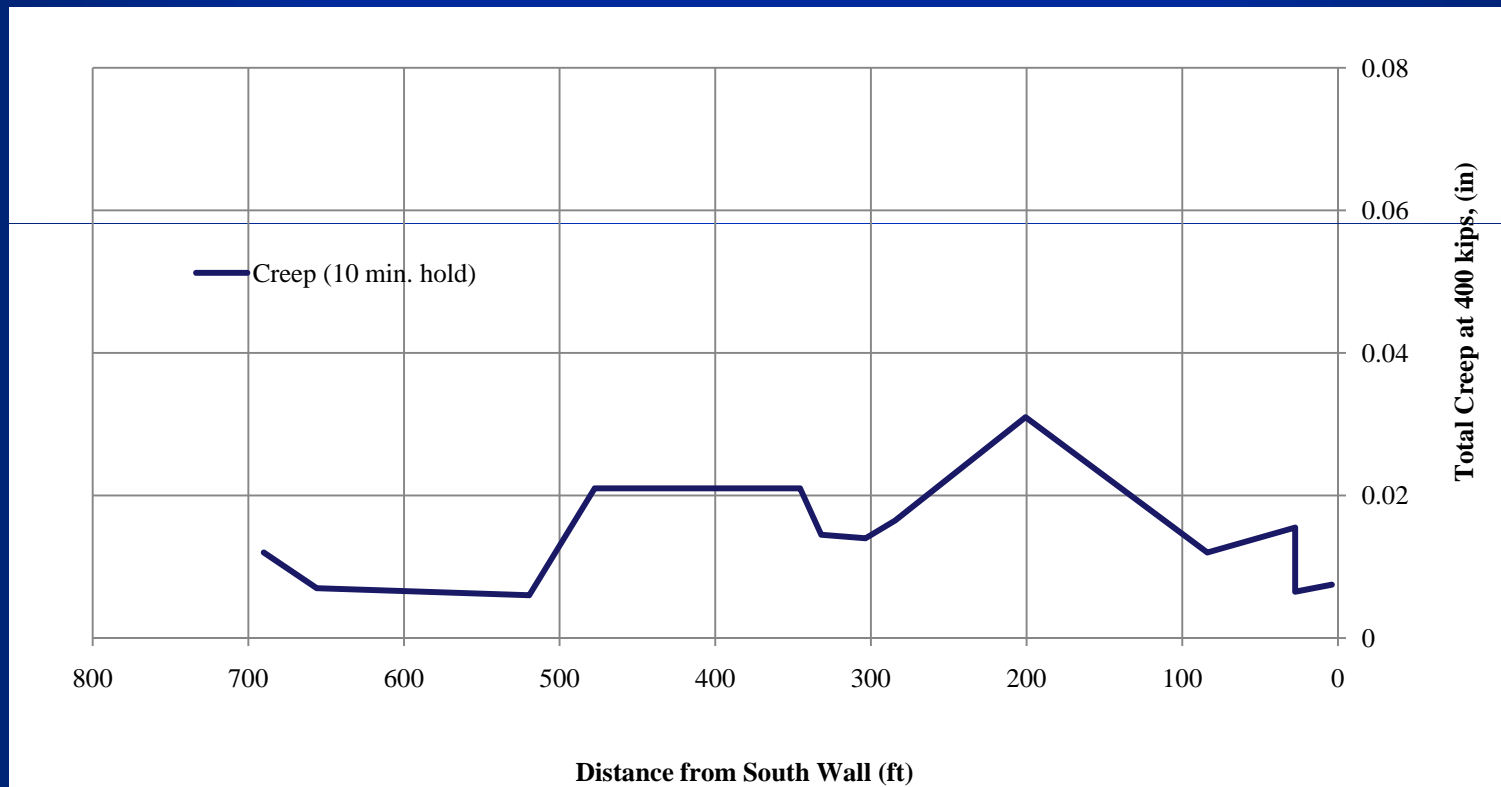
Creep at 400 kips

**Colma
Sands**

**Franciscan
Formation**

- Excellent load transfer in both Colma and Franciscan
- Low creep even at maximum test load – 1780 kN
- Piles did not appear to approach geotechnical failure
