Micropile Application in Salmon River Road Slope Stabilization

Gary A. Quinn, P.E.¹ and Rich Barrows, P.E.²

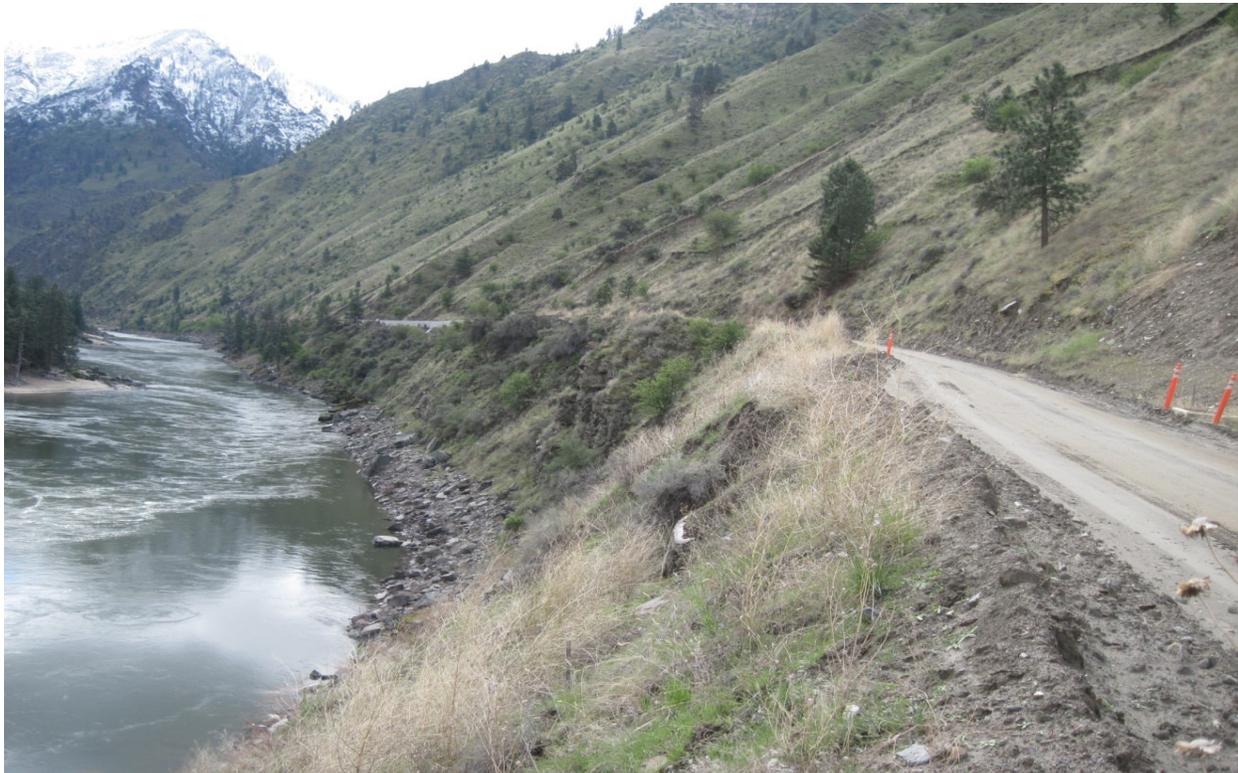
Figure 2 – Wall 8-9 area looking upstation with shallow slides right and irregular outboard

Project geotechnical study has been on-going since 1999 with various reconnaissance, drilling, and analysis efforts taking place as the project design has evolved. This particular segment of the project alignment from approximate Stations 9+195 to 9+370 was originally designed with MSE wall sections (Walls 8-9) extending over the outside shoulder of the existing alignment to provide increased width for the proposed roadway section. This improvement was intended to widen the roadway from the existing section of little more than a one lane to the proposed 5.4m traveled way. The original design philosophy had been to gain necessary width without disturbance to the inside cut slopes where shallow instability was evident as seen in Figure 2.

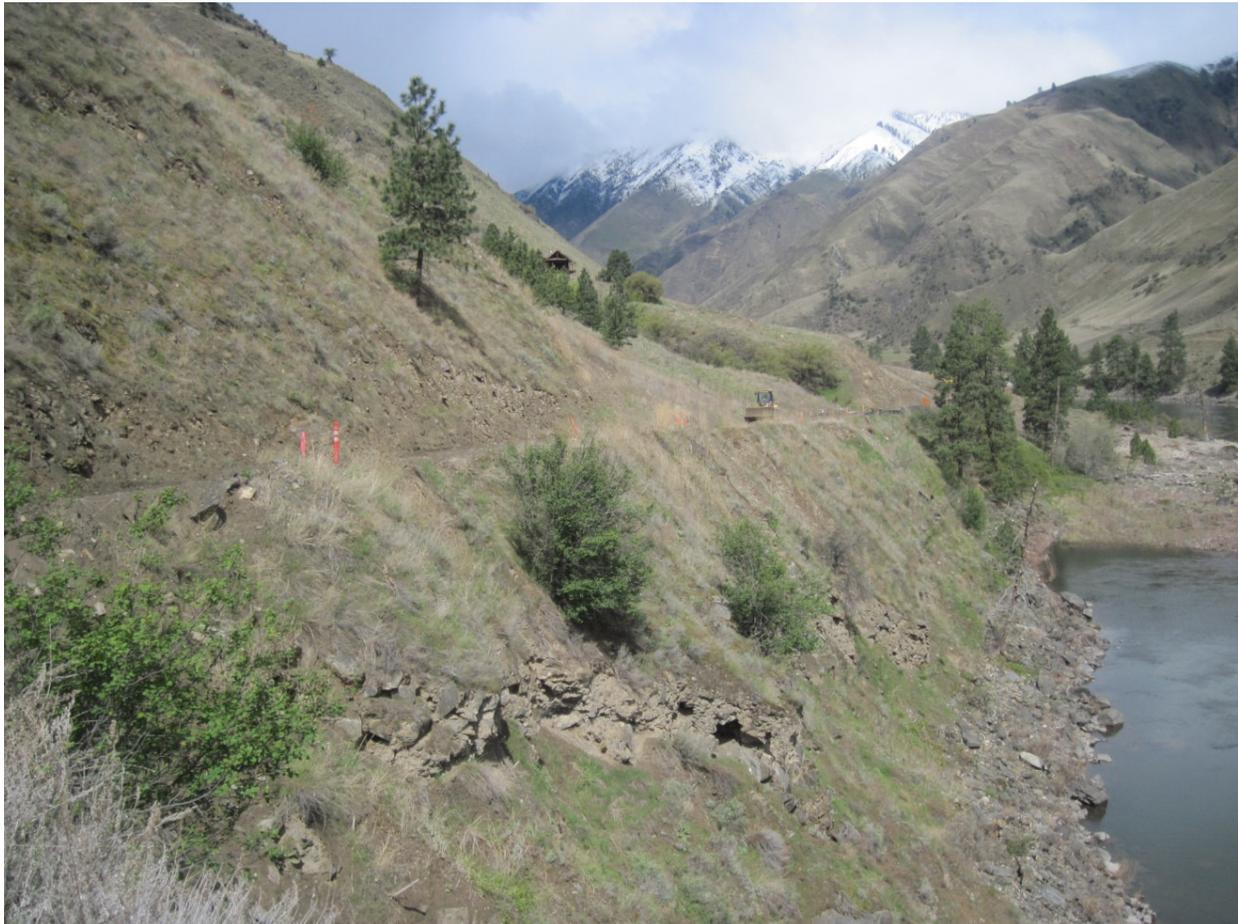
Figure 3 – Close-up view of irregular downslope terrain in Shoulder Stabilization
