# SLOPE STABILIZATION BY MICOPILES ON EXISTING ROADS IN NORTHWESTERN TUNISIA

S. KHEDIRI (\*), S. HAFFOUDHI (\*\*), K. ZAGHOUBANI (\*\*\*)

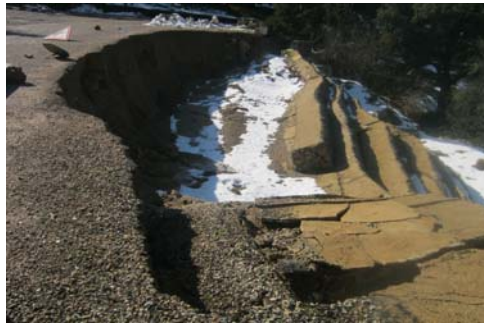
Photo 1: Old landslide reactivated, previously stabilized by a flexible gabions wall

Pre-failure landslides (slow soil movements, deformations are observable but still acceptable), landslides where failure occurred, and reactivated landslides (reactivated old landslides).

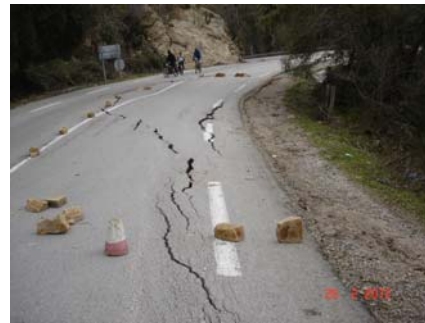
Photo 2: Landslide: pre-failure

Examples of calculation results are given in the following figures (calculation is given for the landslide in photo n°2, § 2):

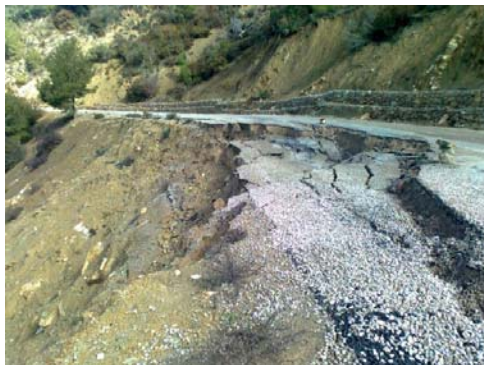
Photo 3: Landslide: failure occurred

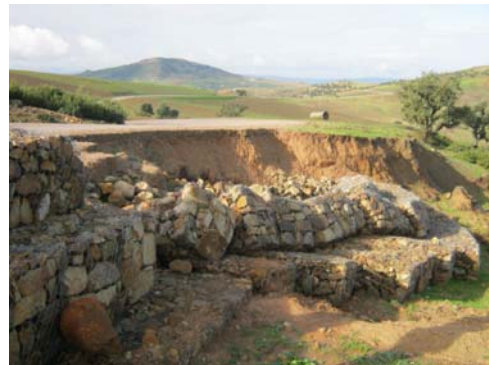
Photo 4: Old landslide reactivated previously stabilized by gabions wall

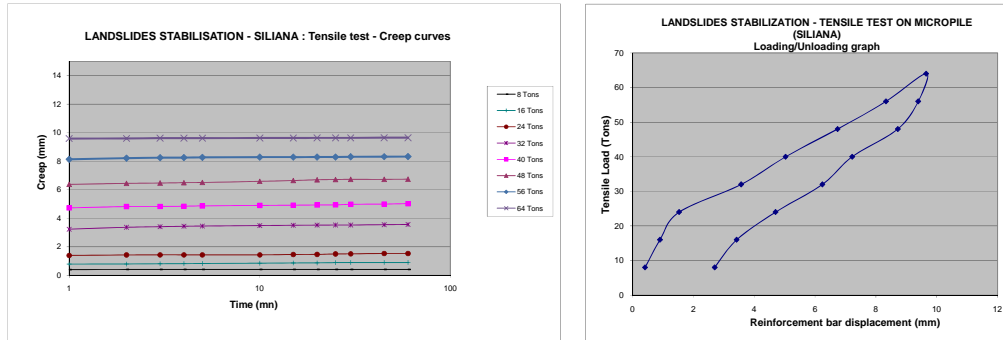
In addition of the ongoing work control on site, tensile tests were performed on test micropiles to validate the design bearing capacities. Those tests were loaded to twice the service load. Examples of test results are given in figure 4, 5 and 6.

Fig. 4. Tensile test : creep resistance not reached
