## **Micropiles Counter Unbalanced Loading During Partial Building Demolition**

Helen Robinson, P.E. and Nate Dumas, P.E., Schnabel Engineering, Donna Adams, P.E., Dunbar Milby Williams Pittman and Vaughan

### **ABSTRACT**

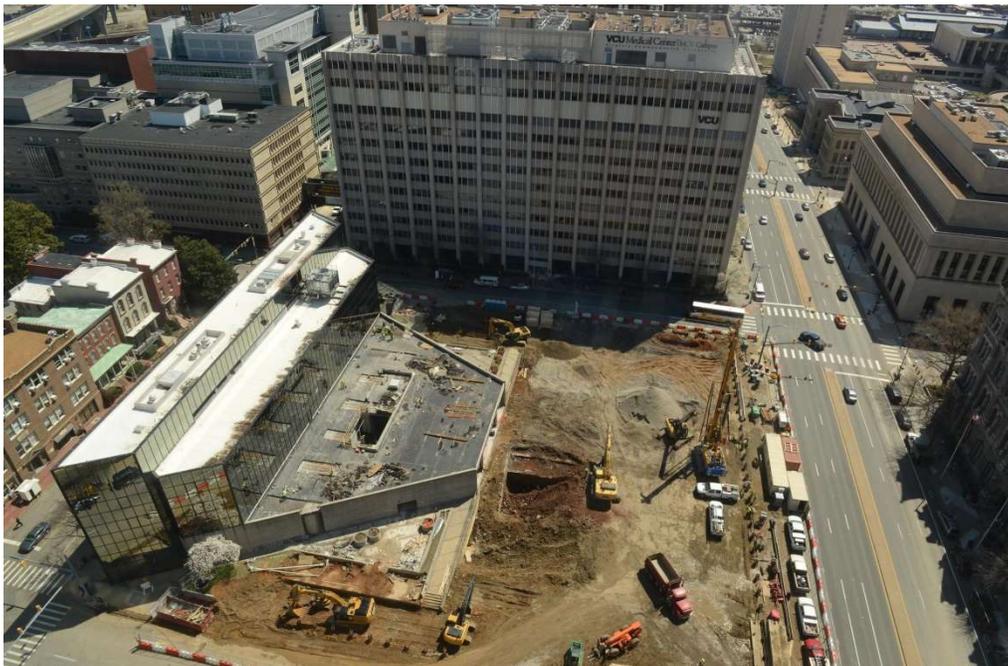
Figure 2. Existing Building Prior to Demolition (credit Elmquist)

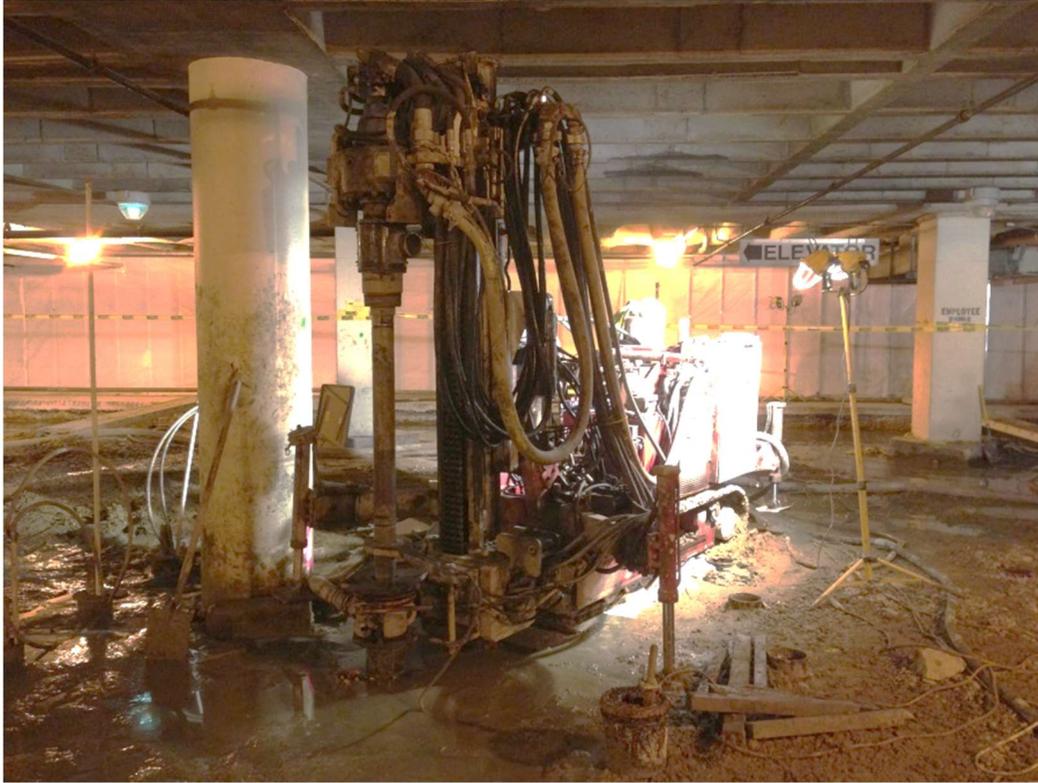
Figure 9. Micropile Installation

In order for the system to work as intended, an installation sequence was specified. All vertical and battered micropiles were installed before any new construction progressed. Once the micropiles were installed (see Figure 9), the new grade beams, shear walls, and buttresses were constructed. In addition, the horizontal post-tensioned ties were cast into the new tie beam and tensioned after the concrete had achieved the specified strength. This was done prior to advancement of the adjacent excavation in order to reduce movements. Lastly, the structural connections between the buttresses and shear walls were installed. Once this was complete the battered piles in the A-frame systems were tensioned and the portion of the structure to be demolished was removed.
