**MATERIALS USED IN MICROPILES IN JAPAN**  
**Mr. Shimazu, Japanese Association for Steel Pipe Piles, Japan**

# Experimental Study On Ultimate Behavior Of Steel Pipe Pile Group

HYOGOKEN-NAMBU EARTHQUAKE

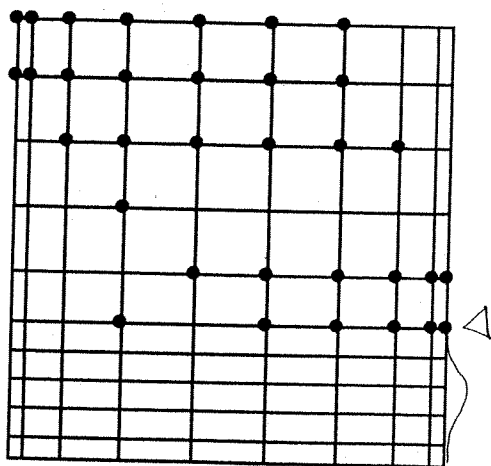
Fig.12 Contact Point between Steel and Concrete (CASE-20B)

Fig .12 shows the contact point between steel and concrete and Fig.13 shows stress distribution of the filled concrete in CASE -20B. The pipe deformed outside at the top of the inelastic buckling , but deformed inside above the inelastic buckling. The compressive stress transferred from the steel pipe to the concrete mainly just above the inelastic buckling.

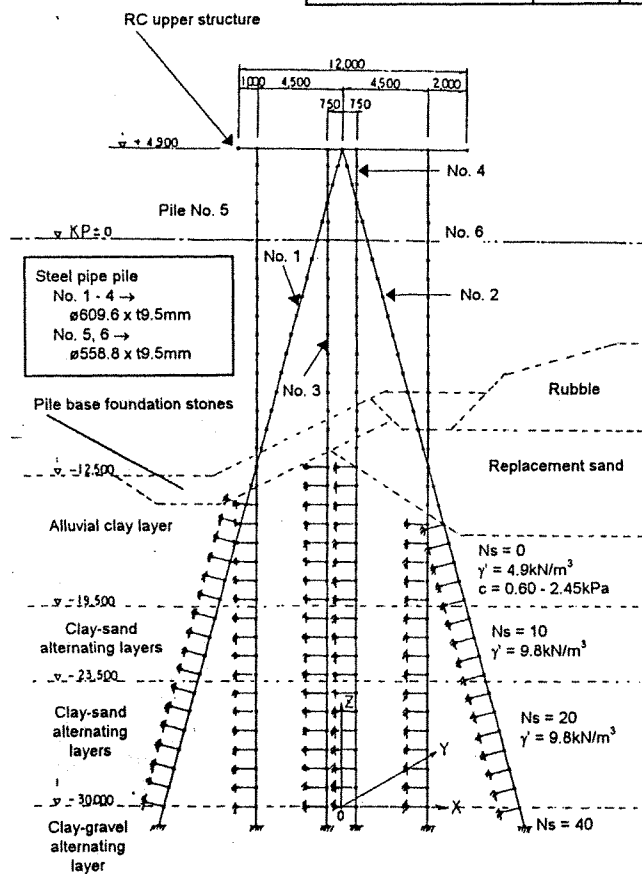
Fig. 6 Model formation and ground conditions

For structural models, materials were assumed as shown below, and, as shown in Fig. 6, the pier was transformed into 2-dimensional plane models for the purpose of analysis.

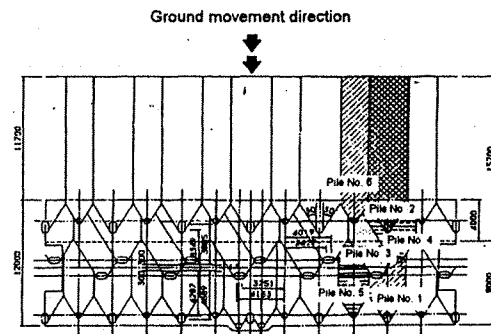
Fig. 7 Areas of horizontal forces shared by respective piles S= 1:200

Further, it was presumed that the load from ground deformation was caused by the movement of the rubble and the foot protection stone within a certain area. The actual scope of ground movement could not be specified so it was presumed that under the pier the rubble and the foot protection stone moved as a whole, and behind the pier, an approximately 2m thick rubble layer between the pier and the sea wall moved as a whole. Further, it was assumed that the magnitude of the horizontal force attributable to such movement is proportional to the seismic intensity. Furthermore, judging from the ground movement direction and the steel pipe pile disturbance, piles on the sea wall side are thought to have received more horizontal force. Accordingly, it was assumed that for each pile, depending on its layout position, shear and horizontal force caused by the movement of the rubble and the foot protection stone layer were as shown in Fig. 7.

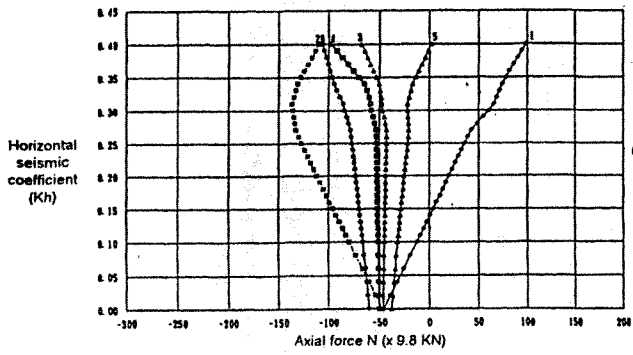
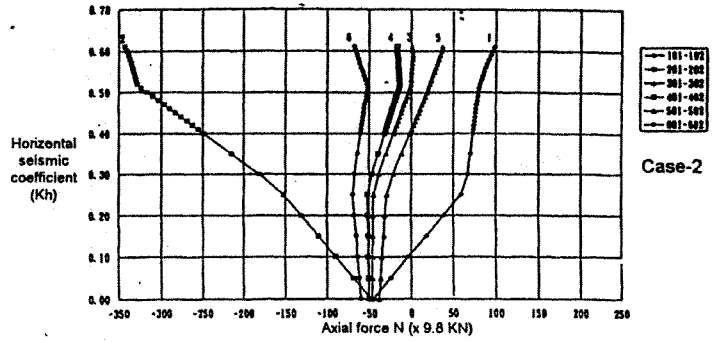
Fig. 9 Axial force transition of pile tip (CASE-9)

Of the eight (8) cases of analysis, CASE-8 most resembled the actual damage condition of the pier. In comparison with CASE-2, wherein the effect of ground movement was not considered, the displacement diagrams and the bending moment of the piles of both cases are shown in Fig. 8, and the transition of the pile tip axial forces are shown in Fig. 9.

This pier had been designed by the allowable stress method to withstand an external force of a horizontal seismic coefficient of  $K_h = 0.15$ . However, according to the analysis results of CASE-2, wherein the structural inertial force alone is increased, when  $k_h = 0.30$  or so, the pile extraction force reaches its maximum, as can be seen from Fig. 8 and Fig. 9, but the pier is still not close to such condition as failure. The pile head at last reaches the yield point when approximately  $K_h = 0.40$  is reached.
