TILTING PREVENTION OF A FOUR FLOOR RESIDENTIAL BUILDING WITH THE ASSISTANCE OF MICRO-PILES BENEATH THE FOUNDATION

Assoc. Prof. **CHAVDAR KOLEV** PhD, University of Transport, 1574 Sofia, 158-Geo Milev Str, Tel: 359 885 256 905, e-mail: ch_kolev@abv.bg

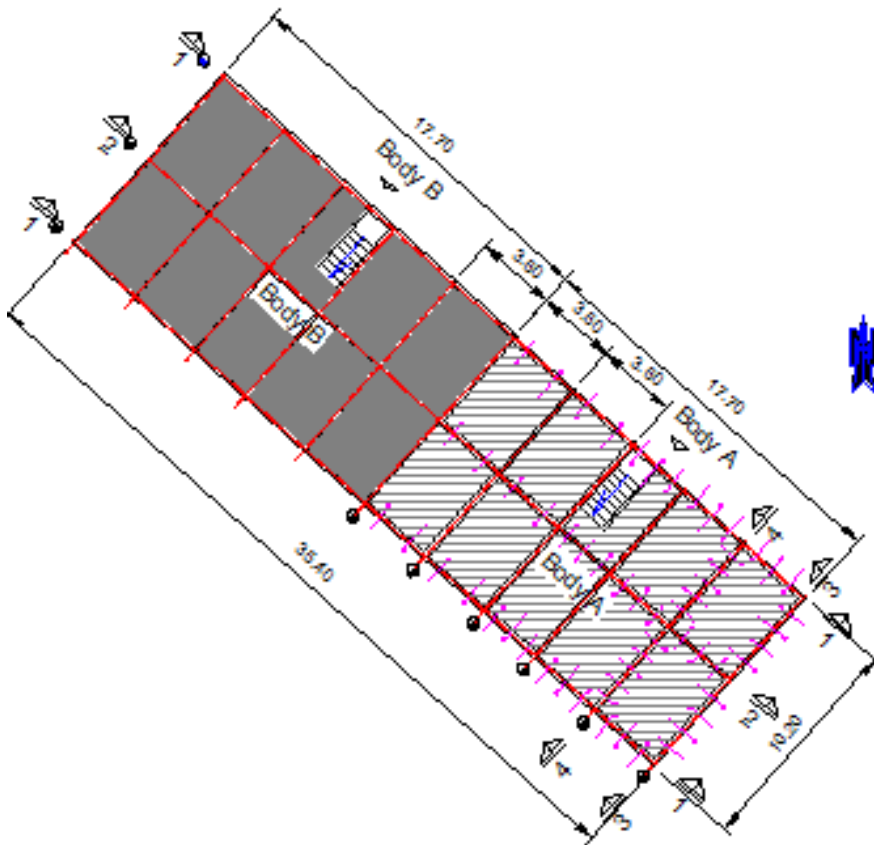
Fig. 1: Plan of the Building

- A building with 2 entrances (no deformation joints between them); 4 floors (walls -2.7m high); 3 apartments per floor; flat roof; basement walls - 2.20m high;
- Form of a rectangle 10.20 x 35.40 m with 11 frame axes in transverse direction and 3 axes in longitudinal direction;
- Framing of load-bearing transverse walls, scheme similar to herringbone;
- Basement of solid concrete (walls - 24cm tick);

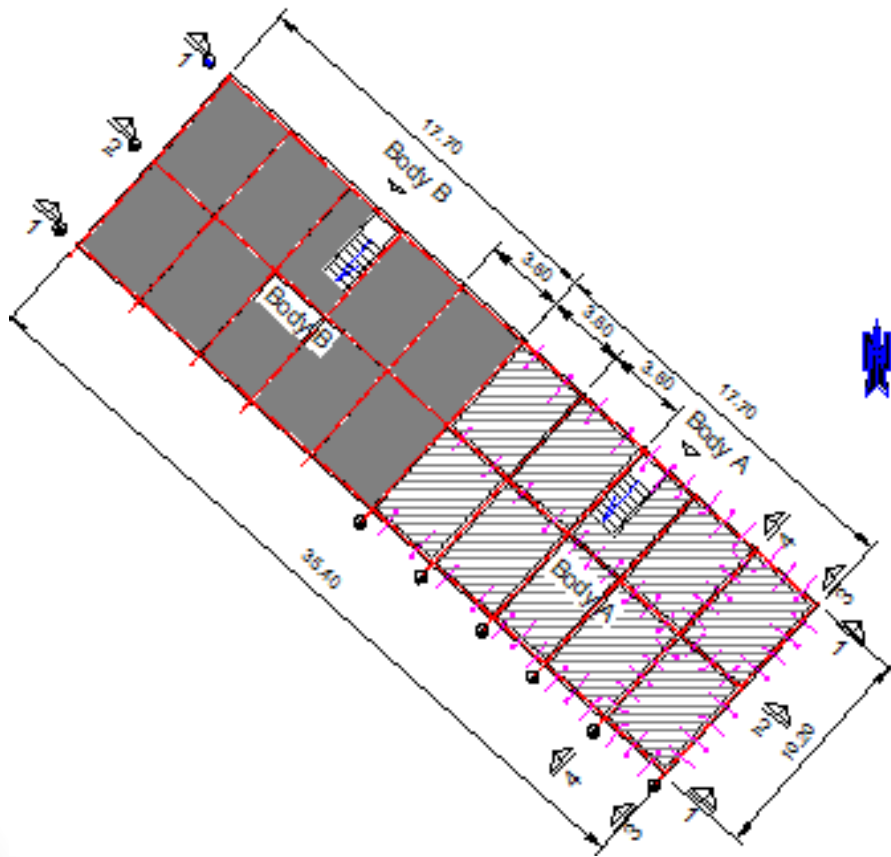
Fig. 1: Plan of the Building

- Foundations of strip concrete with width of:
 - 70 cm for the median foundation;
 - 74 cm for transverse foundations (excl. end ones);
 - 45 cm for the end foundations;
 - 45 cm for foundations beneath the facade.
- Foundations depth – up to 1.70m below ground level;
- 20cm concrete base under the foundation slab (1.90m trench beneath ground level).
