TILTING PREVENTION OF A FOUR FLOOR RESIDENTIAL BUILDING WITH THE ASSISTANCE OF MICRO-PILES BENEATH THE FOUNDATION

Chavdar Kolev¹

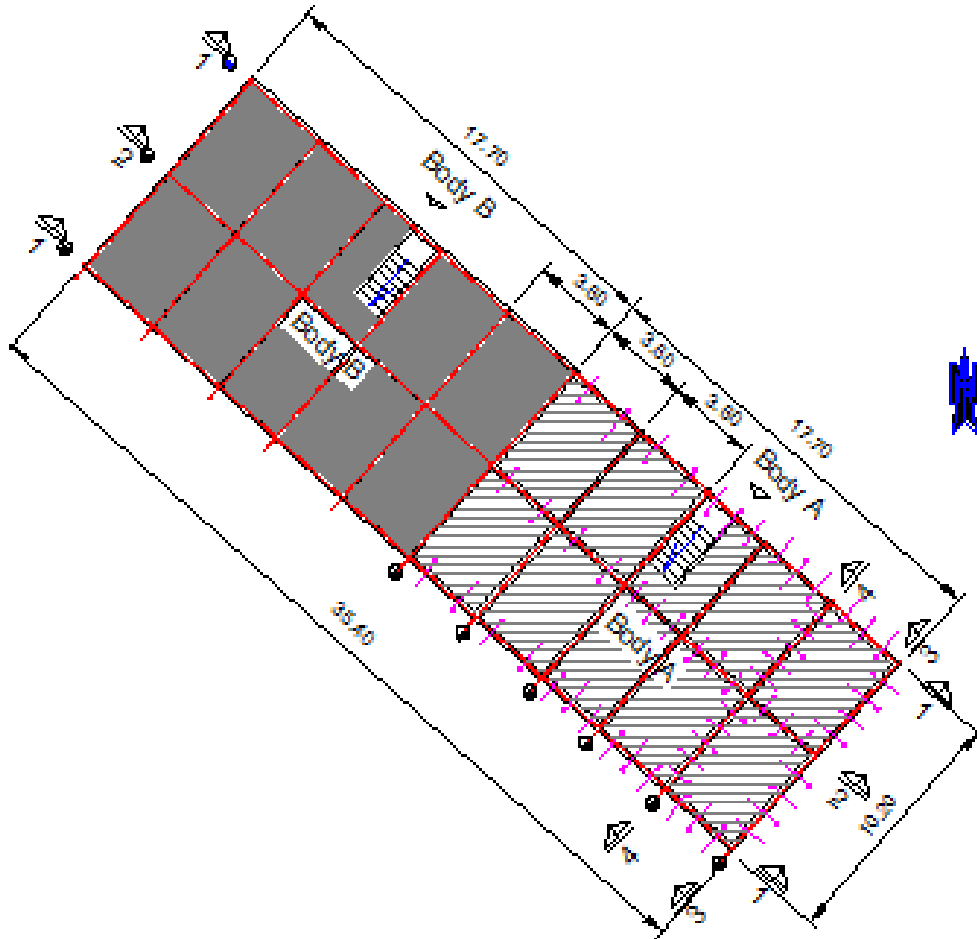
Fig. 1: Plan of the Building

The building depicted is a true rectangle, sized 10.20 m x 35.40 m. In the transverse direction, frame axles are 11, located in 3.60 m from each other. Axes in the longitudinal direction are 3 with 5.10 m for each (Fig.1).
